The effectiveness of FRP strips in repairing moderately and severely damaged RC beam–column connections

Rijun Shrestha

Scott T. Smith

Bijan Samali

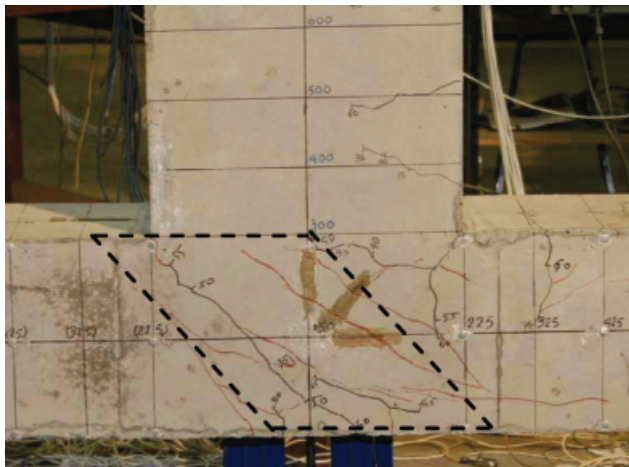
considerable shear cracking in the joint region, although, the damage was not excessive, as shown in Figure 4(a) (see diagonal cracks in the boxed area) and Figure 5. This connection is herein referred to as 'moderately damaged' and distinction is made in Figure 5 between major cracks (cracks of large width) and minor cracks (cracks of small width). Prior to application of the FRP, the loose concrete in the cracked joint region was removed and the surfaces cleaned by spraying with compressed air; however, it should be noted from Figure 4(a) that little or no concrete cover in the joint region had fallen off, thus indicating the less severe nature of the damage. Voids left after removal of damaged concrete were filled with an epoxy adhesive, known as Megapoxy PF, prior to application of the FRP repair. According to the manufacturer's specification, the epoxy adhesive had a setting time of seven minutes and attained more than half of its ultimate strength within 15 min of mixing. As the extent of damage and the size of the major cracks were not excessive, repair adhesive, as opposed to repair mortar, was deemed suitable to patch up the damaged region sufficiently for the FRP repair to be adequately applied.

Figure 4. Column strip repair: moderately damaged connection: (a) pre-repair (UM1); (b) post-application of FRP repair (RM1); (c) close-up view of RM1 after repair

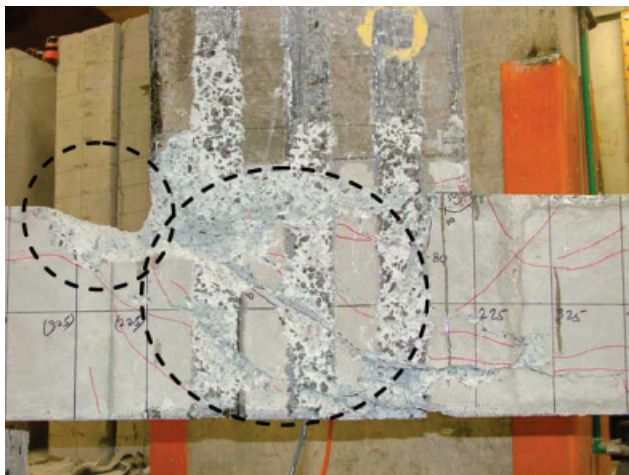
consisted of three two-layered FRP strips oriented parallel to the beam and applied to both faces of the joint region. The FRP strips were continuous across the width of both joint faces and over the back face of the column, and anchored at both sides of the beam by wrapping, as shown in Figure 2(b). Connection SM2 reached a peak load of 122 kN at 39.1 mm displacement, and was then loaded until the load-carrying capacity had decreased to 40% of the peak load (i.e. load = 52 kN and deflection = 92 mm). Such considerable deformation produced quite extensive damage to the joint region and the immediate vicinity of the adjoining column and beams (herein 'severe damage'). At the peak load level of SM2, all three FRP strips had debonded, and when a deflection of 92 mm was reached all three strips had ruptured, generally in the bend portion around the joint edge.

Figure 6. Beam strip repair: severely damaged connection:
(a) pre-repair (SM2 after removal of beam strips);
(b) post-application of repair mortar; (c) post-application of FRP
repair (RM2)

To repair connection SM2 before being tested as connection RM2, all the loose and broken concrete was removed after the connection was unloaded and removed from the test frame. Owing to the severe level of damage, large voids remaining after removal of the damaged concrete were filled with repair mortar. Figure 6(a) shows the connection prior to the application of the repair mortar (heavily damaged areas circled with concrete cover removed), while Figure 7 is a detailed schematic of the cracking, damage and extent of repair mortar. After application of the mortar (Figure 6(b)), the connection was then repaired with FRP strips which were again oriented parallel to the beam (Figure 6(c)).

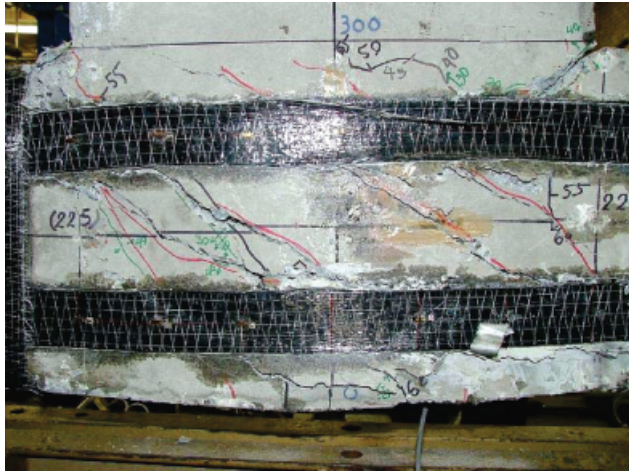
much lower load). A peak load of 106.6 kN was achieved at a displacement of 29.3 mm when complete debonding of FRP strip 1 on both faces of the connection between the end wraps occurred simultaneously, followed by the joint diagonal cracks opening widely, with spalling of the concrete at the column face adjacent to the beam. Failure can best be summarised as complete debonding of FRP strip 1 on both sides of the joint followed by joint shear failure. The test was stopped upon separation of the side cover on the beam at the beam-column interface. No clear debonding in strip 2 was observed and the final crack pattern is shown in Figure 8(a).

Figure 8. Photographs of failed repaired specimens: (a) RM1; (b) RM2

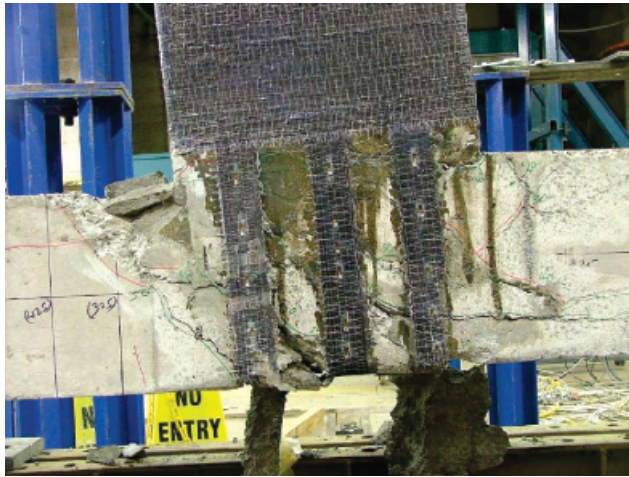
(b)

Separation of repair mortar was the primary mode of failure for repaired connection RM2, followed by FRP rupture and joint shear failure. Figure 8(b) shows the specimen post-test. No cracks were observed at the first load step; however, cracks started to appear at the beam column corner as the load was increased to 20 kN. Existing cracks re-opened as the load was increased to 40 kN and as no new cracks were observed the connection was then loaded continuously to failure. Repair mortar separated from the compressed beam-column corner at a load of 55 kN, upon which the load dropped but then started to increase again with no noticeable debonding of the FRP. A second peak load of 63.8 kN was reached when more of the repair mortar separated from the back side of the column. Rupture of FRP strip 1 followed shortly afterwards, owing to excessive rotation of the joint region. Further loading resulted in rupture of strip 3, after which the load-carrying capacity of the connection was significantly lost and severe cracking in the joint region could be seen.
