## A large landslide in Zigui County, Three Gorges area

F.C. Dai, J.H. Deng, L.G. Tham, K.T. Law, and C.F. Lee

**Abstract:** On 13 July 2003, a landslide with a volume of approximately  $20 \times 10^6 \text{ m}^3$  occurred on the left bank of the Qinggan River, Zigui County, Hubei Province, China. As a result, 14 people died and 10 people are missing. A landslide dam was formed, blocking the Qinggan River. A channelized diversion was constructed for prevention of upstream flooding and damage downstream caused by dam breaching. The landslide was a typical translational rockslide in weathered shale and sandstone, a block of which slipped down along the bedding plane. It is estimated that the landslide was caused by the combined effect of the following factors: (i) a bedding plane between incompetent weathered shale and competent sandstone that daylighted at or is shallowly buried at the bottom of the Qinggan River; (ii) a thin layer of clayey soil acting as the slip plane that is likely a preexisting shear surface; (iii) excavation of the shale as raw material for brick fabricating on the slope; and (iv) a combination of prolonged rainfall and reservoir impounding.

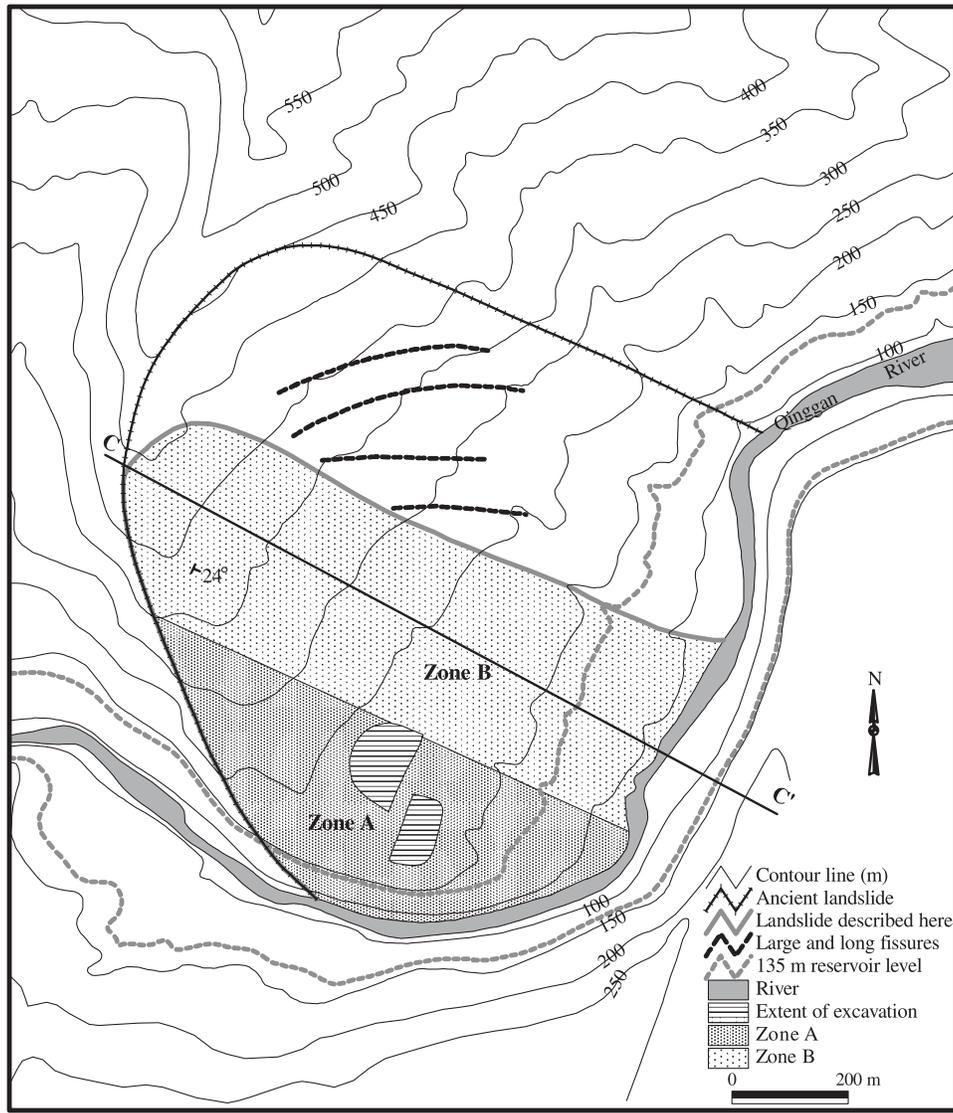
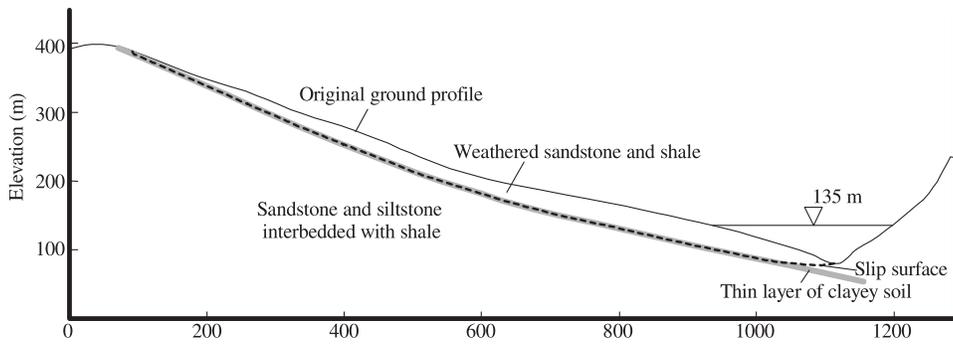
**Fig. 2.** (a) Sketch map showing the extent of the landslide. (b) Cross section at C-C' in (a).

landslide with a volume of about  $6 \times 10^6 \text{ m}^3$ , as indicated as zone A in Fig. 2, slid down along the bedding plane. It is estimated that for this event the slip plane may daylight at the riverbed, resulting in a high-speed rockslide. The rock mass block travelled a distance of about 240 m. The frontal part of the rock mass ran up the opposite bank of the reservoir, generating a wave. The wave of water was pushed up the opposite steep bank, leaving a trace on the vegetation cover at an elevation of about 150 m (Fig. 4a), and then bounced back to the landslide mass and swept away all erodible materials, including a house, grass, and superficial deposits with a maximum elevation of about 165 m (Fig. 4b). The walk-over survey, however, indicated that vegetation at an elevation of approximately 175 m fell to the ground due to the wave of water (Fig. 4c). This event blocked the Qinggan River completely and formed an irregular landslide dam (Fig. 3). The landslide debris entering the river was shifted downstream due to obstruction of the steep slope. The landslide dam above the 135 m water level had maximum and minimum heights of about 178 and 149 m, respectively. In the second event, the left portion of the landslide (zone B in Fig. 2) slid down along the bedding plane with a maximum travel distance of approximately 180 m. Field observations showed that for this slide event, surface features such as houses and highways tilt backward against the landslide scar (Fig. 5). This may indicate that the second slide event was less translational than the first slide event. Other evidence includes extensive fissures in the frontal part of the slide mass, indicating extensive deformation in this area. This block of the landslide mass did not dam the Qinggan River.

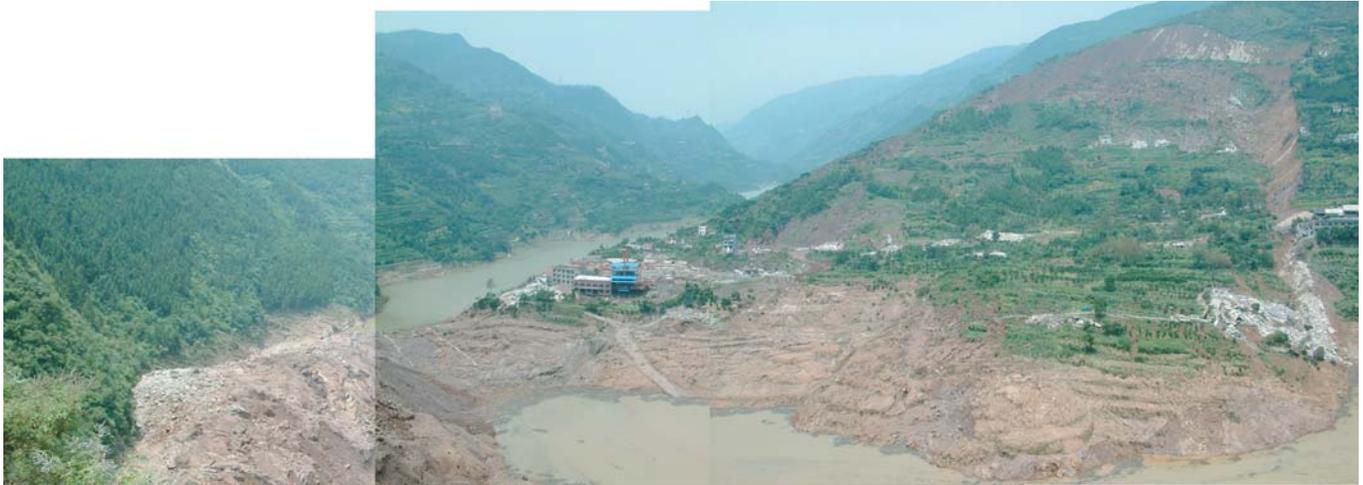
At around 0:20 am (Beijing time) on 13 July 2003, a large landslide occurred on the left bank of the Qinggan River (Figs. 2, 3). Witness accounts showed that it took less than 5 min to complete the whole process of landsliding. The landslide has a volume of  $20 \times 10^6$  m<sup>3</sup>, with a maximum width of 800 m and maximum length of 1100 m. It is estimated that the maximum failure depth is approximately 30 m. The landslide can be classified as a translational rockslide, following Cruden and Varnes (1996). The displaced block of weathered sandstone and shale slipped down along the bedding plane, following the dip direction of the bedding plane, and formed both a main scarp and a surface of rupture.

**Fig. 3.** An overview of the landslide.

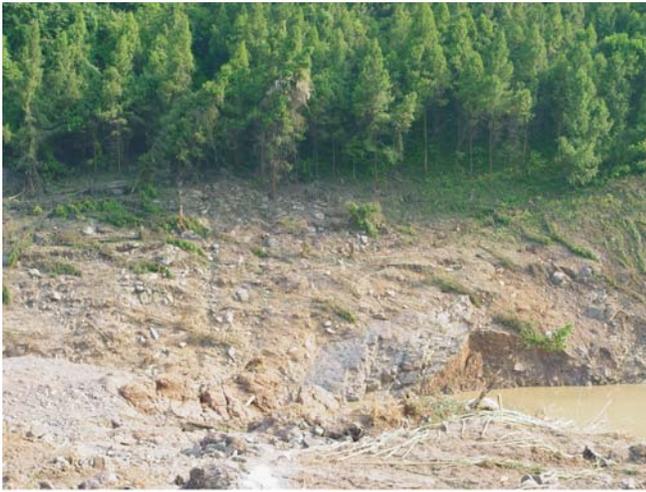
The wave of water generated by the landslide overturned five boats located upstream and 17 boats downstream, with 10 people missing.

**Fig. 4.** (a) A trace left on the vegetation by the wave of water on the opposite bank of the Qinggan River. (b) Erosion caused by the wave of water on the frontal part of the landslide. (c) Fallen vegetation caused by the wave of water.

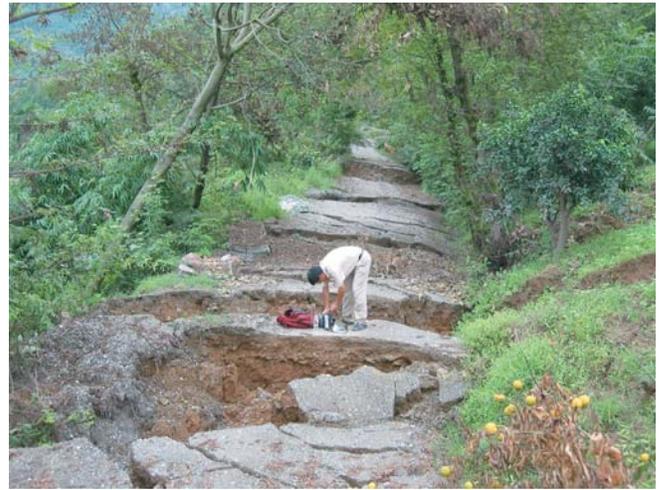
**Fig. 5.** Ground cracks and tilting observed on the right portion of the landslide.

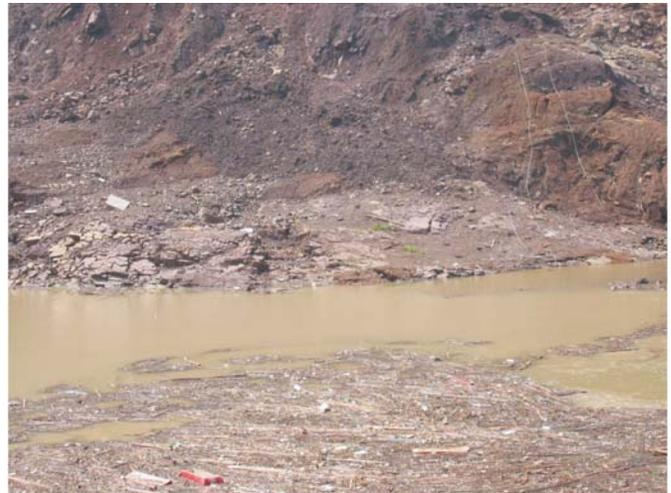
The debris deposits consisted mainly of angular coarse clasts surrounded by finer fractions intensely disintegrated from the shale. Though the rock in the debris accumulation is highly fractured, the accumulation retains its bedding plane with an opposite dip compared with that of its original bedding (Fig. 6a). The pebble deposits can be observed on the top of the landslide debris (Fig. 6b). This indicates that the surface of rupture was below the bed of the river and thus the landslide pushed the preslide bed toward the opposite side of the river.

**Fig. 6.** (a) Landslide debris deposited on the opposite bank of the Qinggan River. The bedding plane can be seen below the landslide debris. (b) Pebble deposits on the top of landslide debris accumulation.

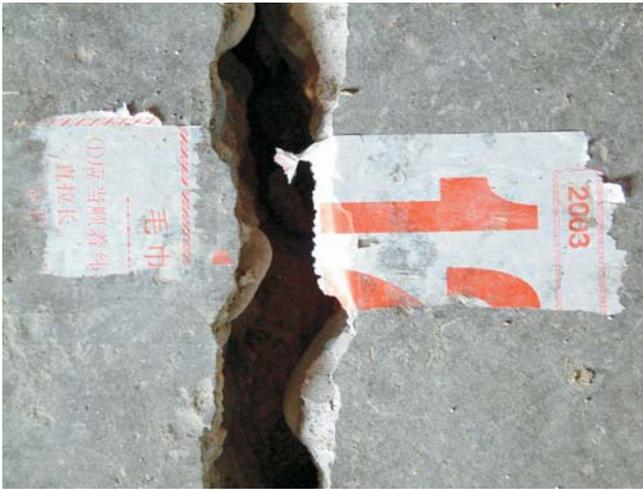
**Fig. 7.** Paper pasted across a fissure. The paper was torn into two pieces when the fissure started to widen.

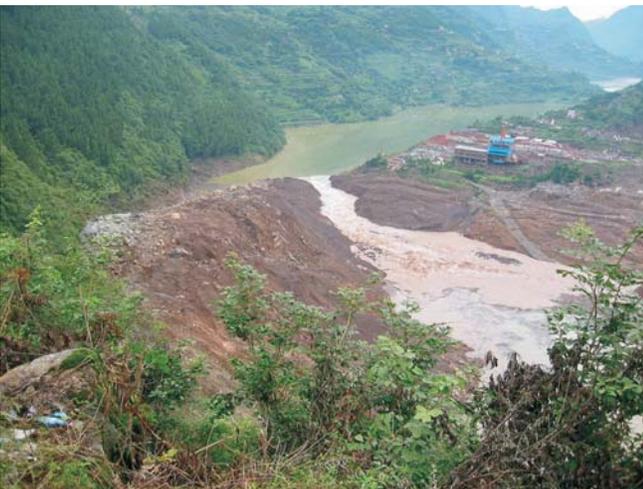
**Fig. 8.** A channelized diversion excavated for prevention of up-stream flooding and possible damage downstream.

At 5:00 pm on 20 July, a channelized diversion with a width of 13 m was successfully excavated at the saddle of the dam (Fig. 8). The total volume of landslide debris excavated for the diversion was about 3360 m<sup>3</sup>. This prevented upstream flooding and any possible damage downstream that could be caused by dam breaching.

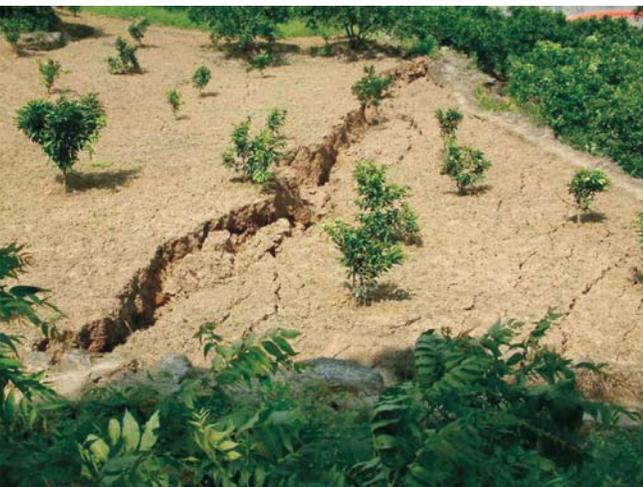
**Fig. 9.** A long fissure observed on the remaining slope on the left side of the landslide.

After the landslide, an extensive distribution of tension cracks was observed within a zone 1200 m long and 500 m wide on the remaining slope on the left side of the landslide, as shown in Fig. 2 (see also Fig. 9). Some simple observations on three major cracks were initiated to understand the

changes in these cracks. The horizontal widths of these three major fissures increased from 28.5, 53, and 86 cm at 12:10 pm on 15 July when the observations were initiated to 29, 54, and 96 cm, respectively, at 6:40 pm on the same day. Because of concern over the possibility of new landsliding, the local government decided that the 34 people living in this zone should be evacuated.

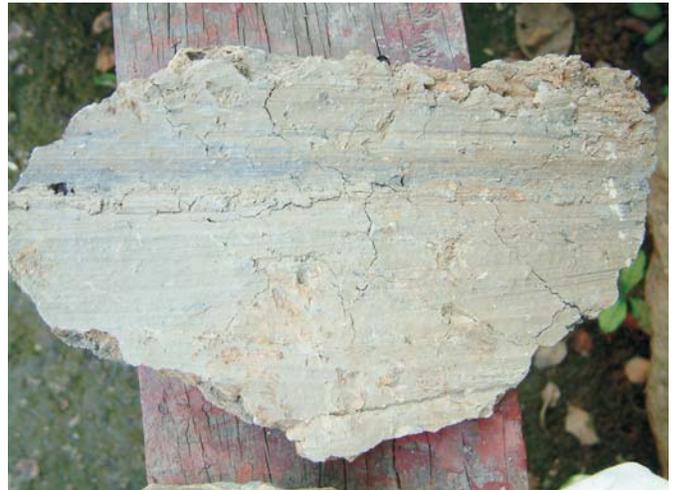
**Fig. 10.** (a) Slickensided shear surface. (b) Slickensided clayey soil.

planes of the lithology and daylighting or shallow burial of the bedding plane in the bed of the Qinggan River render the slope prone to failure. Field observations revealed that the slip plane was along a thin layer of clayey soil with a thickness of several centimetres underlying the weathered sandstone and shale. The bedrock underlying the slip plane is in a relatively intact state compared to the overlying weathered sandstone and shale. It is also important to mention that the present slide is likely a reactivation of an old translational rockslide whose scarp is evidenced by the old scarp shown on the topographic map. The slip zone may have low shear strength as a preexisting shear plane. The weathered sandstone and shale might have acted as highly permeable material that led to the formation of a perched groundwater table in the slip zone above. The slip surface is smooth and slickensided (Fig. 10).

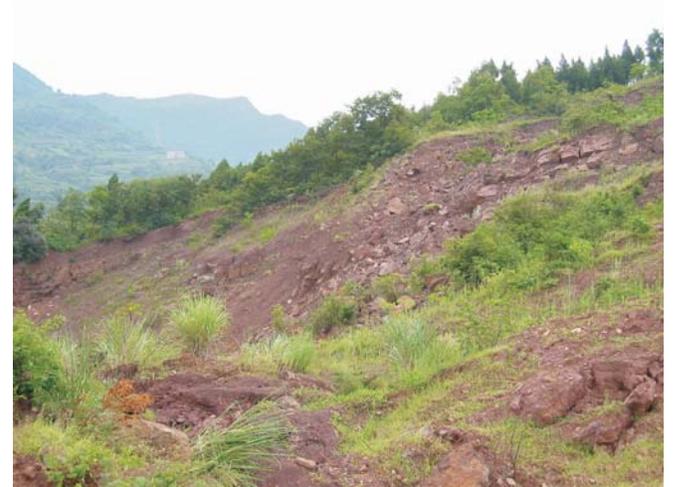
**Fig. 11.** Site of the excavation of shale as raw materials for brick fabrication.

Excavation of the shale as raw material for brick fabrication (Fig. 11) at the middle part of the slope is also a factor contributing to the slope failure. The excavation was carried out in zone A, as shown in Fig. 2, with a depth ranging from 2 to 8 m. The excavation removed the support and created tension cracks on the upper slope. These cracks, wide open joints, and loose overburden on the slope facilitated percolation of water into the slope, thus increasing the pore-water pressure.

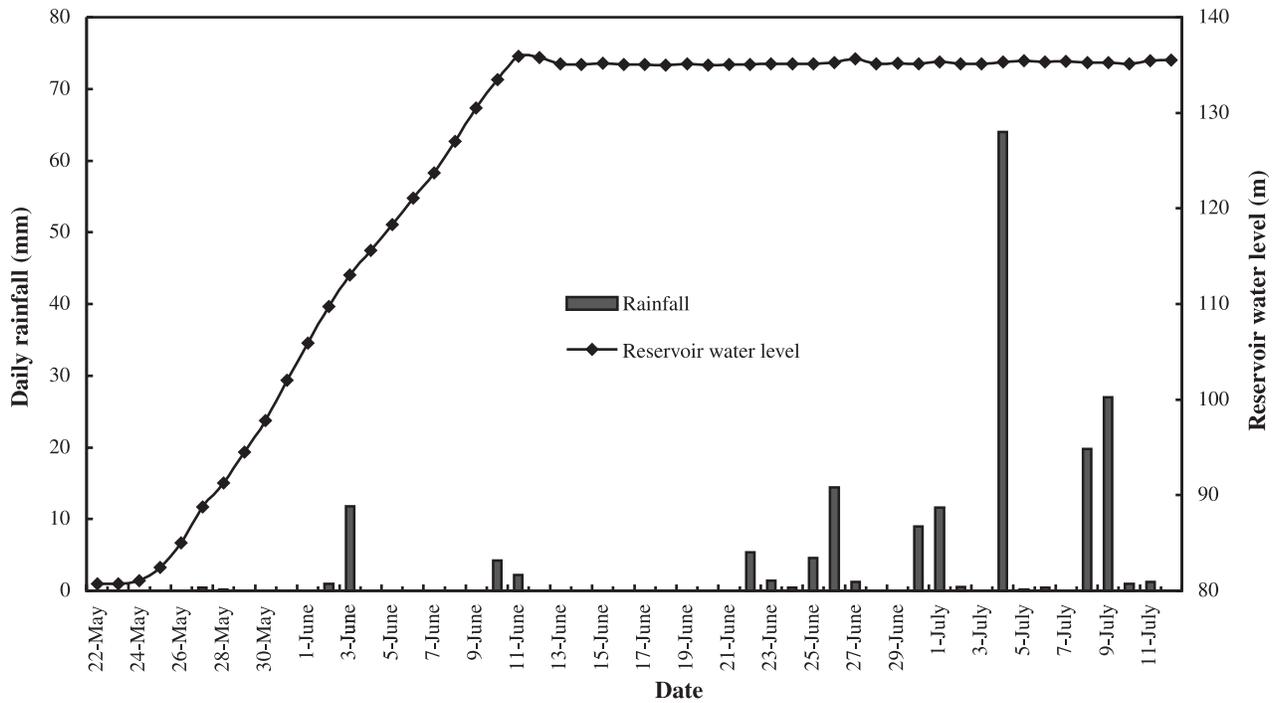
**Fig. 12.** Daily rainfall and reservoir water level change recorded at Xietao.

Rainfall was a major trigger of this failure. In the period between 22 June and 11 July, the rainfall recorded at Xietan, located 5.5 km north of the landslide site, was 162.1 mm (Fig. 12). The prolonged seepage of water through the weathered rock could have increased the pore-water pressure and critically reduced the shear strength of the rock mass along the slip plane. Field observations carried out 1 week after the failure showed that groundwater was seeping out from the bedrock underlying the slide mass (Fig. 13). This could have produced an upward seepage force and high pore-water pressure at the slip plane. The initial impounding of the Three Gorges reservoir raised the water level to 135 m on 10 June at a rate of approximately 3.3 m/day (Fig. 12). The rise in reservoir water level drove up pore pressures in the lower part of the shale layers, reducing its strength. It is estimated that a combination of prolonged rainfall and reser-

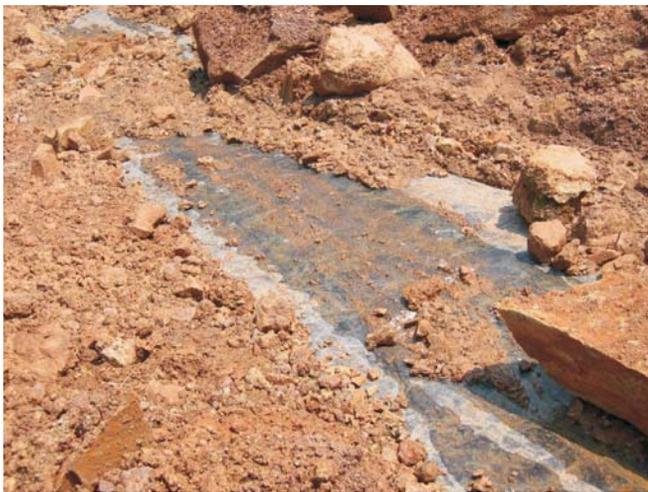
**Fig. 13.** (a) Groundwater seeping out from the bedrock underlying the slide mass. (b) Small pond of water observed in the landslide debris.
