**The crooked rod sign: a new radiological sign to detect deformed threads in the distraction mechanism of magnetically controlled growing rods and a mode of distraction failure**

**Study Design:** Case report

**Objective:** To report a unique mechanical failure of magnetically controlled growing rods (MCGR) that is related to continuous rod slippage.

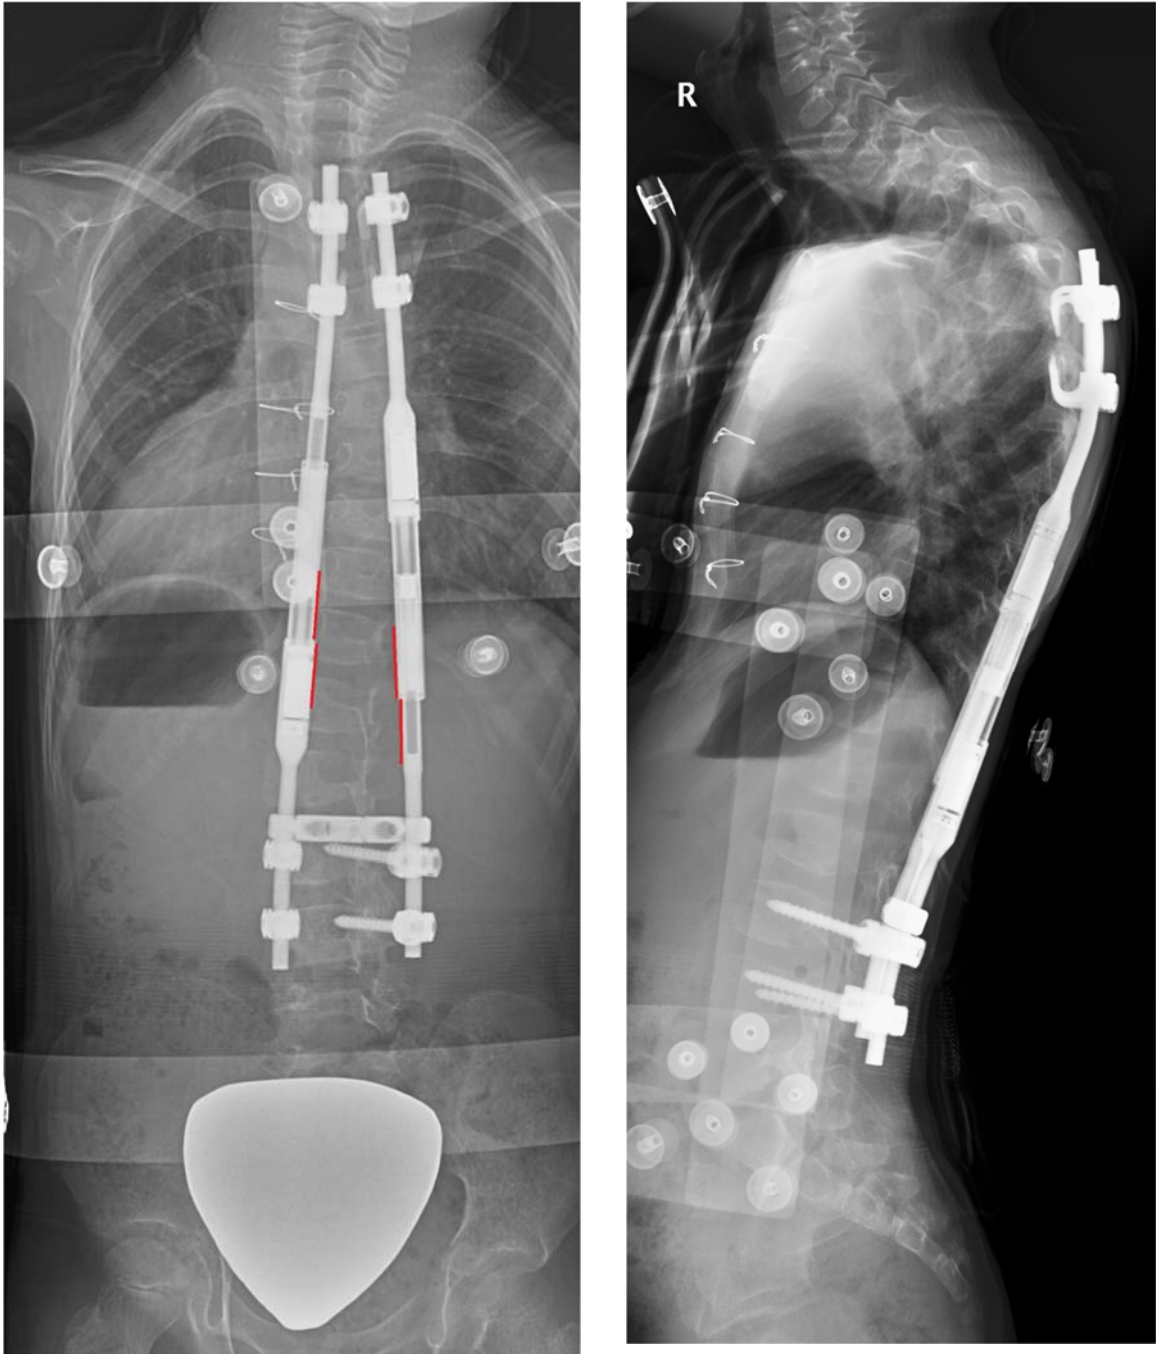
**Figure 3:** Posteroanterior (A) and lateral (B) radiographs immediately prior to continuous rod slippage showed no rod angulation (marked by lines).

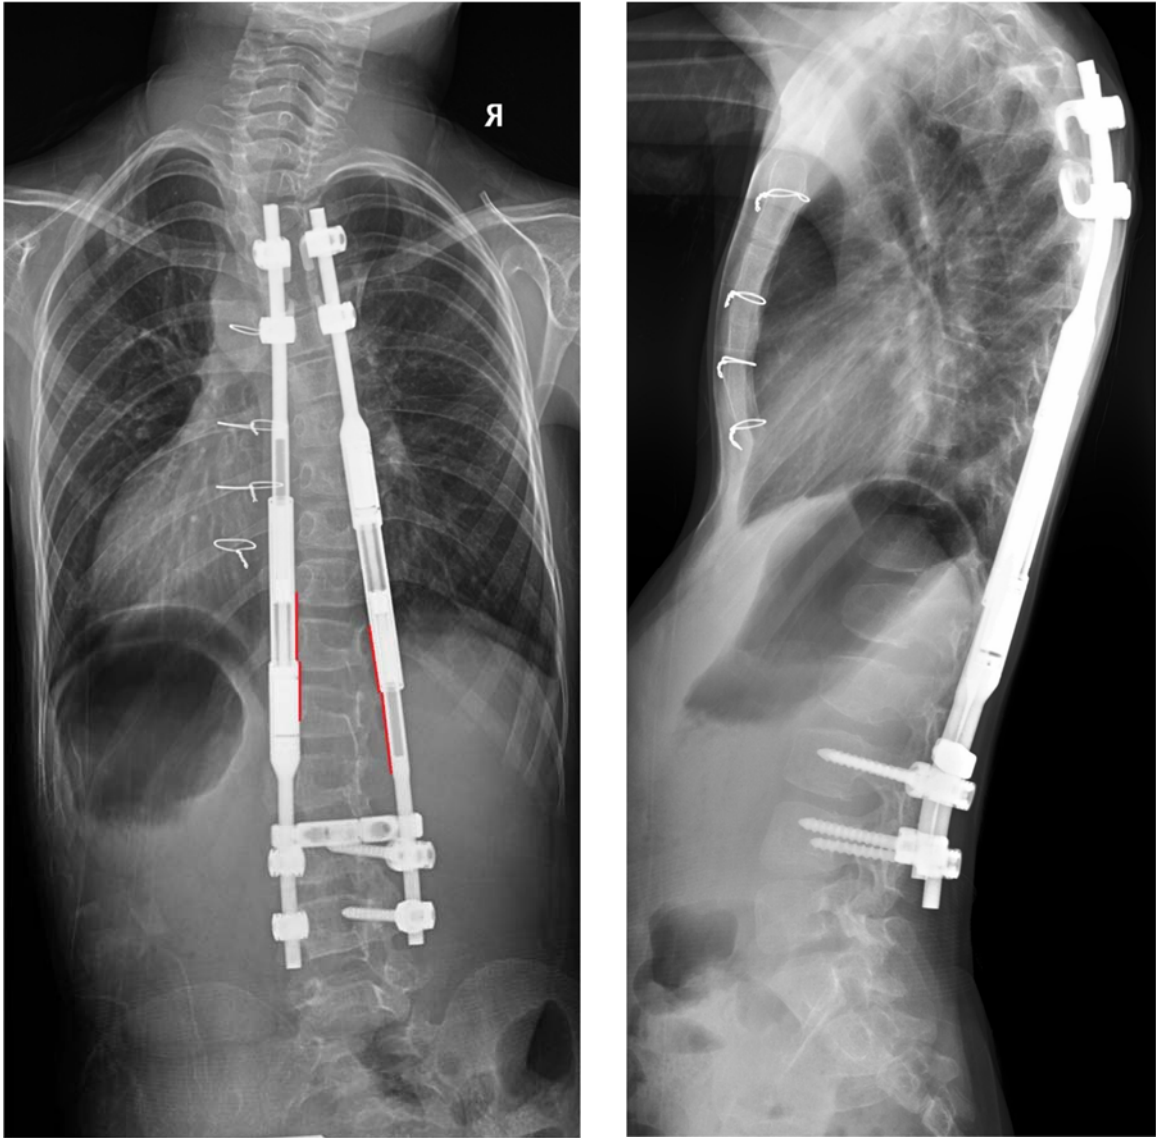
8         Retrospective examination of the radiographs acquired prior to the sedation procedure  
9 revealed rod angulation between the actuator and the extendable portion of the rod (**Figure 4**).  
10 Upon review of other patients in our series who have experienced distraction failures and  
11 continuous rod slippage (n=8), none observed similar crooked rod sign on follow-up radiographs.  
12 The extracted MCGRs were studied in our mechanical laboratory. Externally there was no rod  
13 fracture but there were many wearing marks at the junction between the extended portion of the  
14 rod and the actuator (**Figure 5A**). Rod angulation was also observed by placing the rod next to a  
15 straight bench edge (**Figure 5B**). After the extended portion and the actuator were dissected, it was  
16 revealed that the threads of the internal screw providing the distraction were no longer in-line with

**Figure 4:** Posteroanterior (A) and lateral (B) radiographs obtained during the admission for distraction under sedation showing rod angulation at the right rod (marked by lines).

1 distraction sessions. Subsequently, a distraction session under sedation was performed to eliminate  
2 the soft tissue resistance contributed by muscle contraction. Despite successful distraction on the  
3 left rod, continuous slippage was still observed on the right rod. As further lengthening was  
4 unsuccessful, rod exchange was performed with proximal extension to T3-T4 to control the  
5 proximal junctional kyphosis. Intraoperatively metallosis was observed around the screw-rod  
6 junction. After rod exchange, smooth distractions were again observed for both rods. The patient  
7 is now two years after the rod exchange with monthly successful lengthenings.

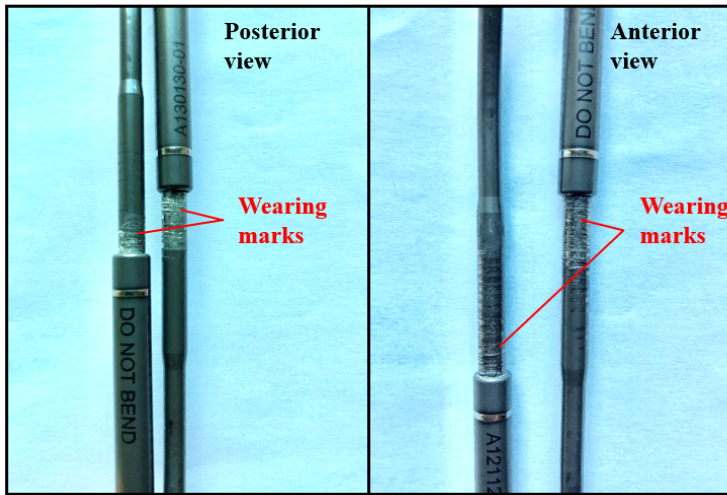
**A: MCGR wearing marks**

**Figure 5:** The explanted rod appearance with wearing marks (A) and rod angulation (B).

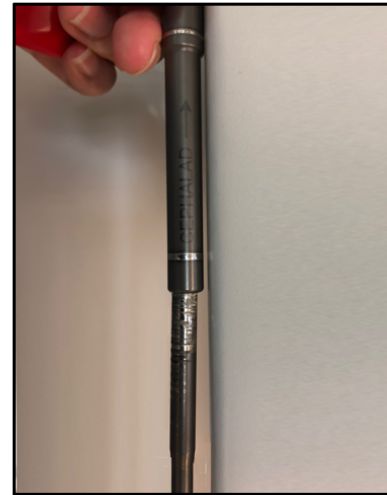
**B: MCGR angulation**

10 a very subtle finding that is only apparent to us with assessment of the rod at the laboratory (**Figure**  
11 **5B**) and of the radiographs on retrospective review. Nevertheless, this is one visible sign that can  
12 be identified on plain radiographs that warrants revision surgery. This finding is perhaps more  
13 obvious with projection of a line drawn along the border of the actuator and another along the  
14 border of the extended portion of the rod. If these lines intersect then a deformed thread  
15 complication may be present. Due to the overlap of the dual rods on lateral radiographs, this may  
16 only be apparent on the posteroanterior radiographs.

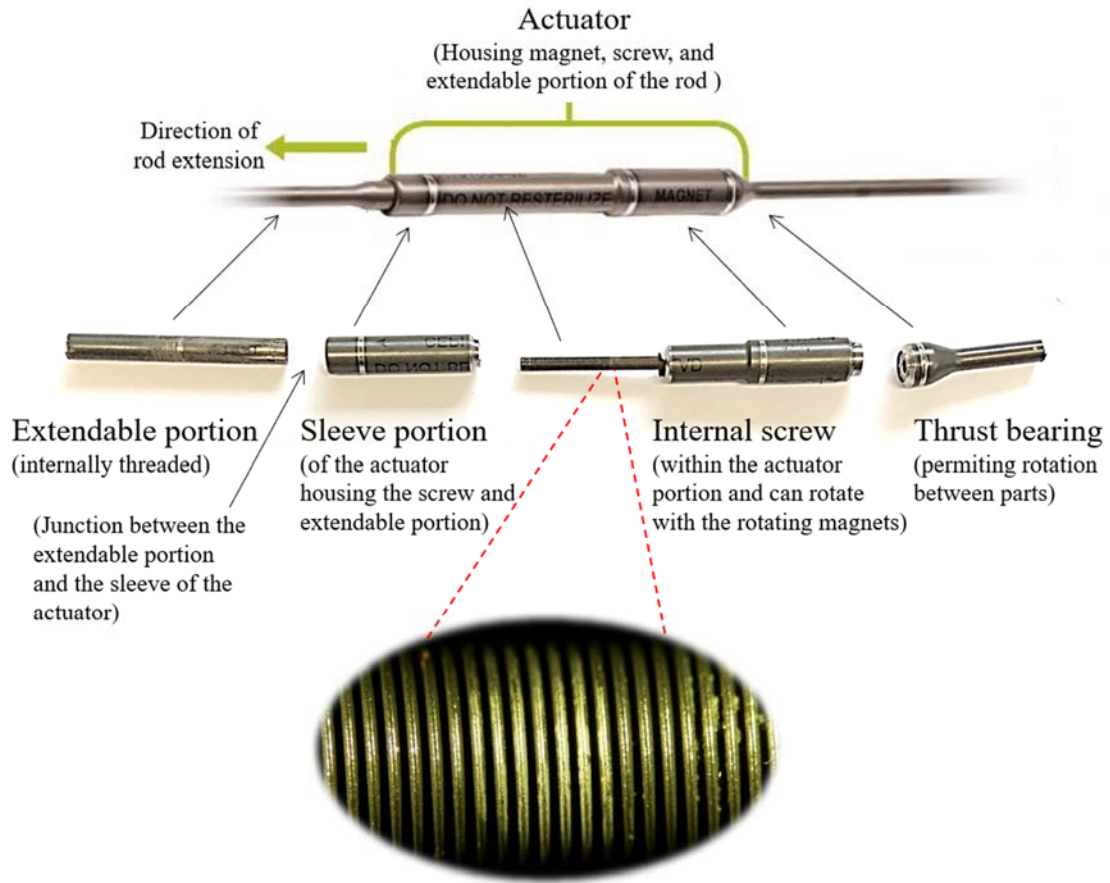
17 such deformation (**Figure 6**) and thus the screw refused to rotate with external magnetic force due  
18 to the increased resistance. After the screw was dislodged and re-inserted along the correct threads,  
19 the screw was able to rotate manually under external force and the distraction resumed.

**Figure 6:** The explanted rod after dissection with indications of the thread design and deformed threads. Microscopic analysis of the deformed threads with deformations shown by changes in the color.
