# Slope failure in underconsolidated soft soils during the development of a port in Tianjin, China. Part 1: Field investigation

S. Li, Z.Q. Yue, L.G. Tham, C.F. Lee, and S.W. Yan

*Key words:* port development, land reclamation, dredge excavation, landslide investigation, soft soils, case studies.

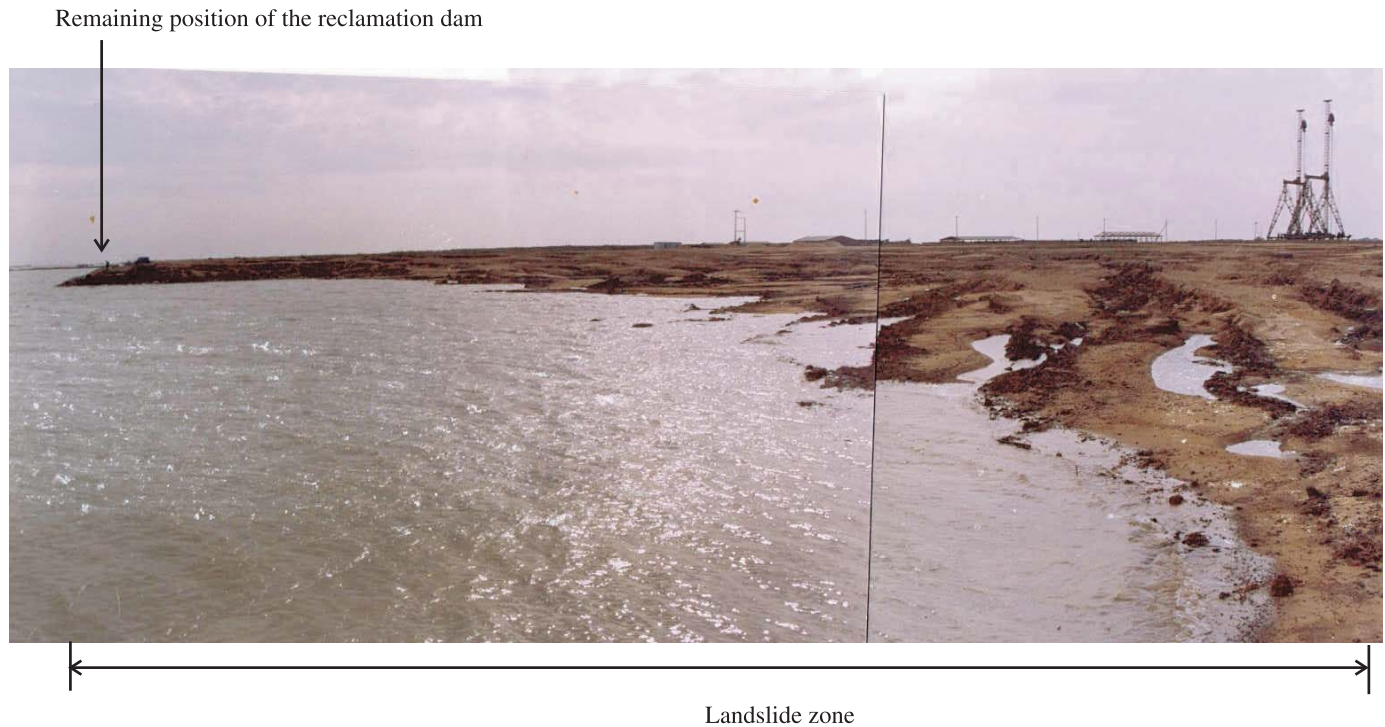
**Fig. 5.** Site photograph showing the failed reclaimed area submerged in seawater during a tidal rise.

From Figs. 5 and 6, it is evident that the main body of the landslide zone was submerged. The main failure zone became a seawater bay within the reclaimed land. Part of the landslide zone was above seawater. A number of long, arcuate tension cracks and slipped terraces could be clearly observed in the land portion of the landslide zone immediately above the seawater bay. These tension cracks and slipped terraces followed the seawater boundary of the submerged failure zone.

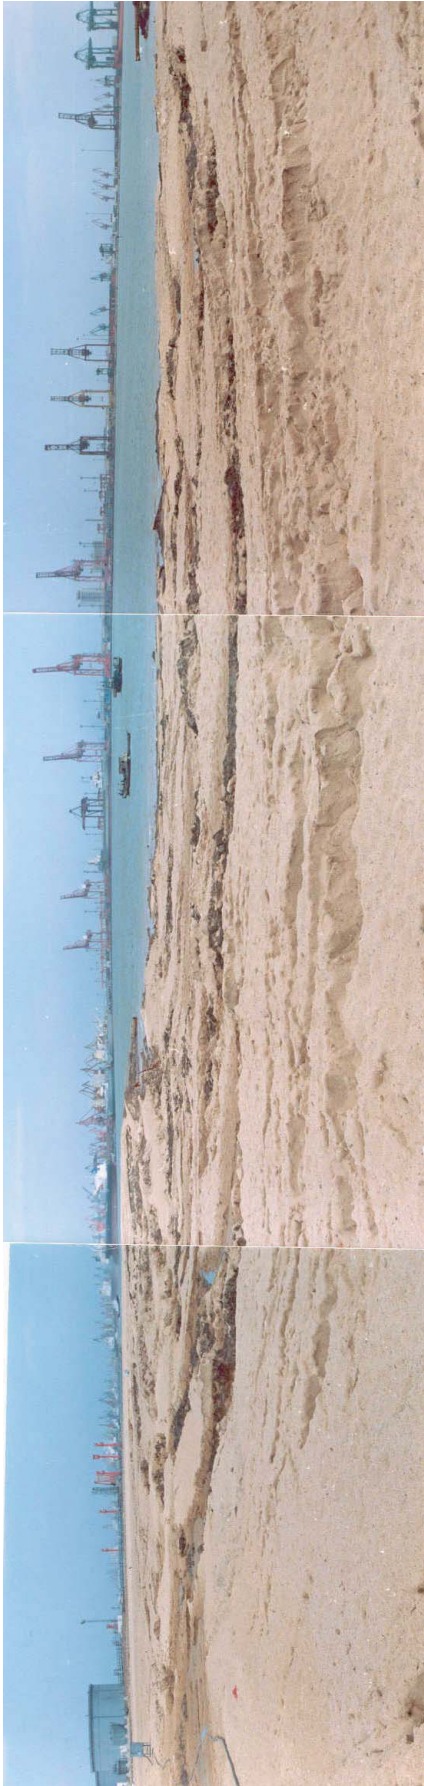
Fig. 6. Site photograph showing the slipped reclaimed land.

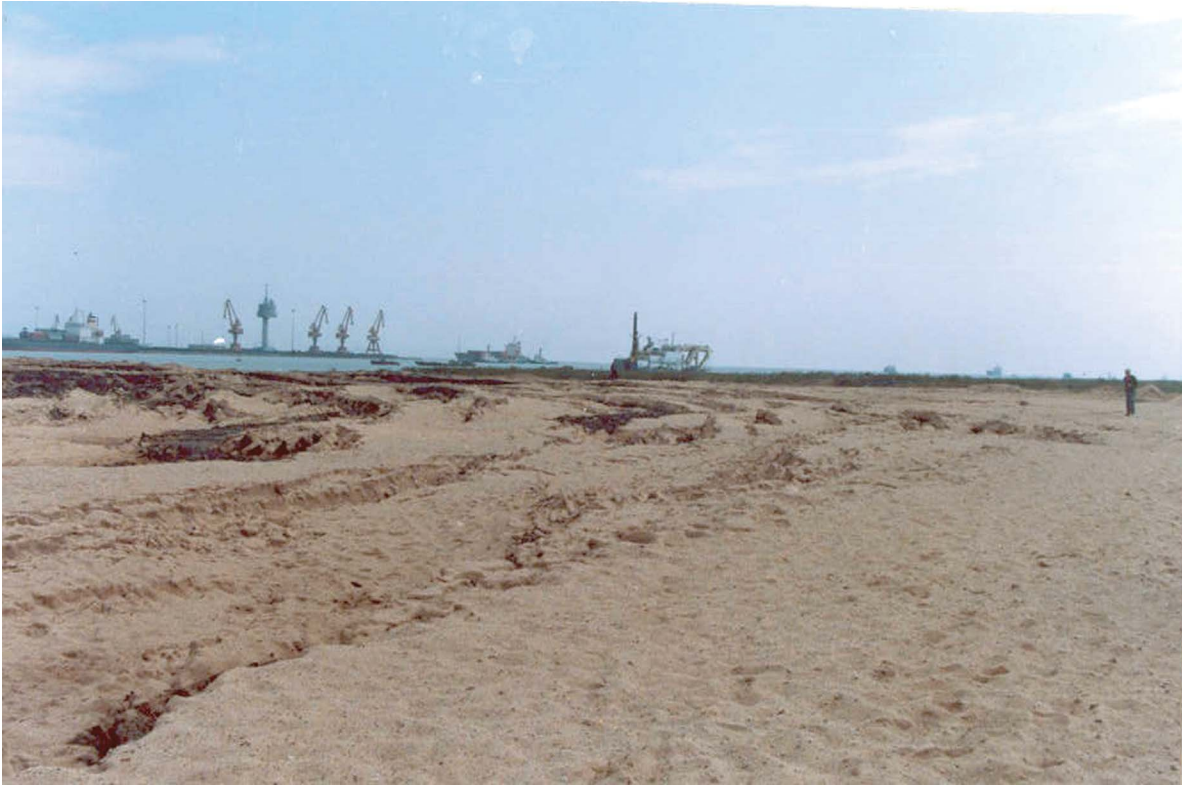
In Figs. 8–11, it can be seen that the widths and depths of the arcuate tension cracks in the reclaimed land above the seawater are variable. The tension cracks had their non-smooth surfaces dipping toward the centre of the seawater bay. Seawater could also be observed in some cracks

**Fig. 8.** Site photograph showing long and arcuate tension cracks and slipped terraces in the reclaimed land.

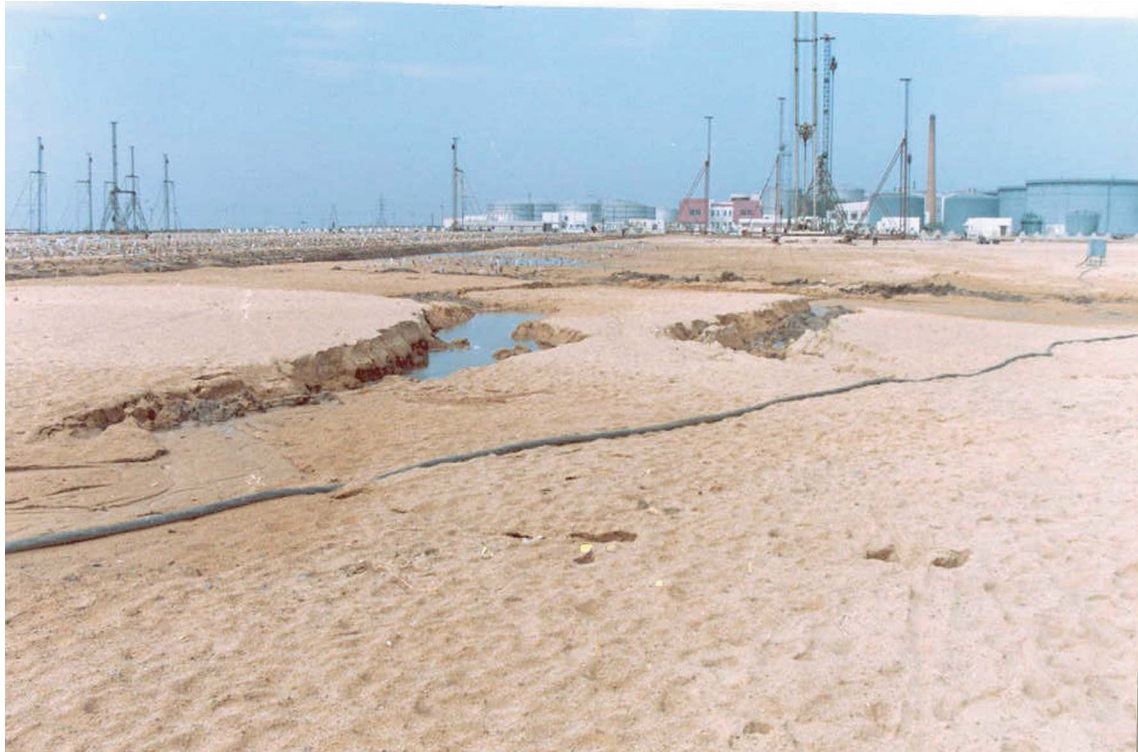
(Fig. 9). The slipped soils in front of the tension cracks took the form of a number of terraces. The terraces were about 5–10 m wide and had different heights. In general, the terrace heights were greater in the central region of the landslide zone and less in the two side regions. The central region includes cross sections B–B, C–C, and D–D; and the two side regions, cross sections A–A and E–E (Fig. 7). In Figs. 10 and 11, it is also evident that the sand cushion was overlaid on the general fill.

**Fig. 9.** Site photograph showing water in the tension cracks in the reclaimed land.

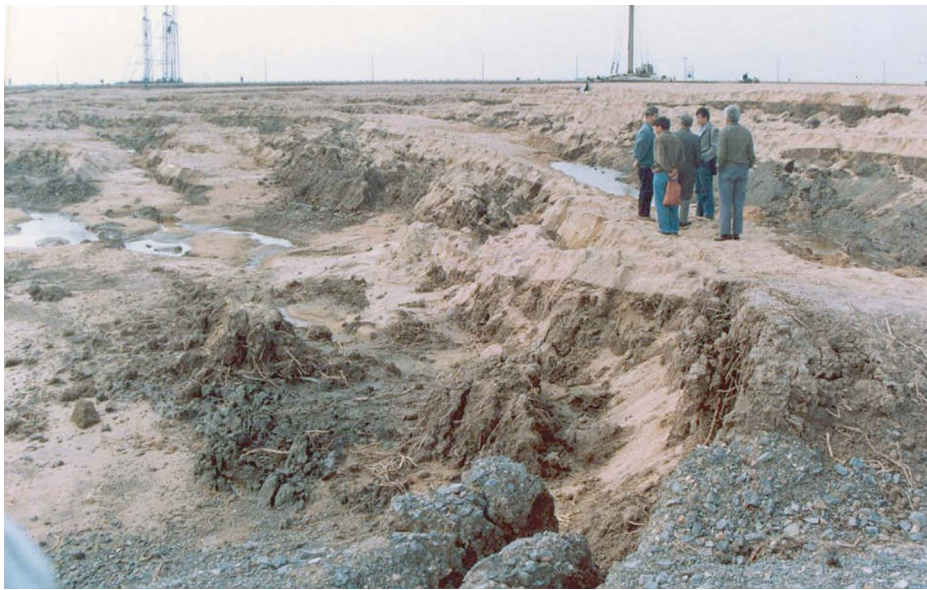
**Fig. 10.** Site photograph showing slipped terraces and their associated tension cracks in the reclaimed land.

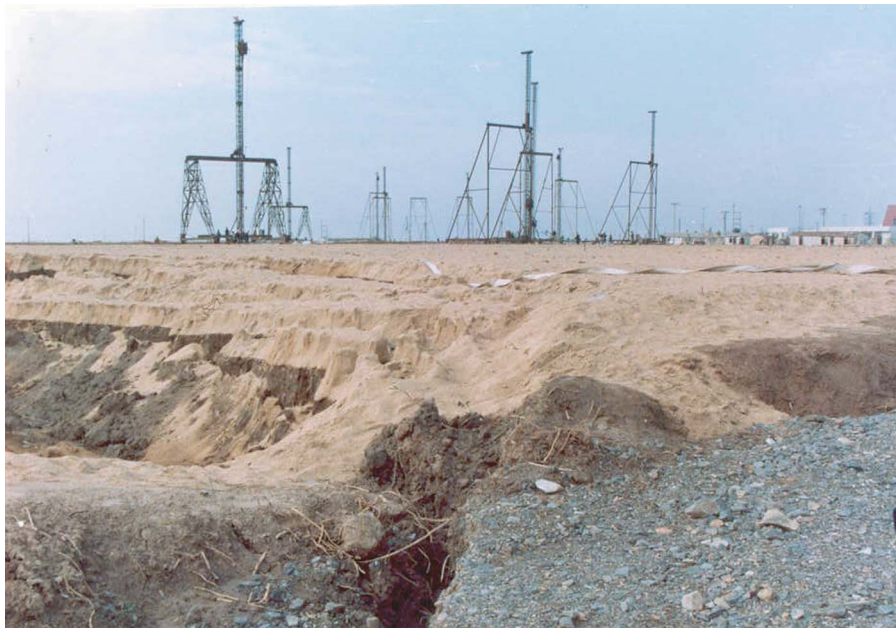
**Fig. 11.** Site photograph showing slipped terraces and their associated tension cracks in the reclaimed land.

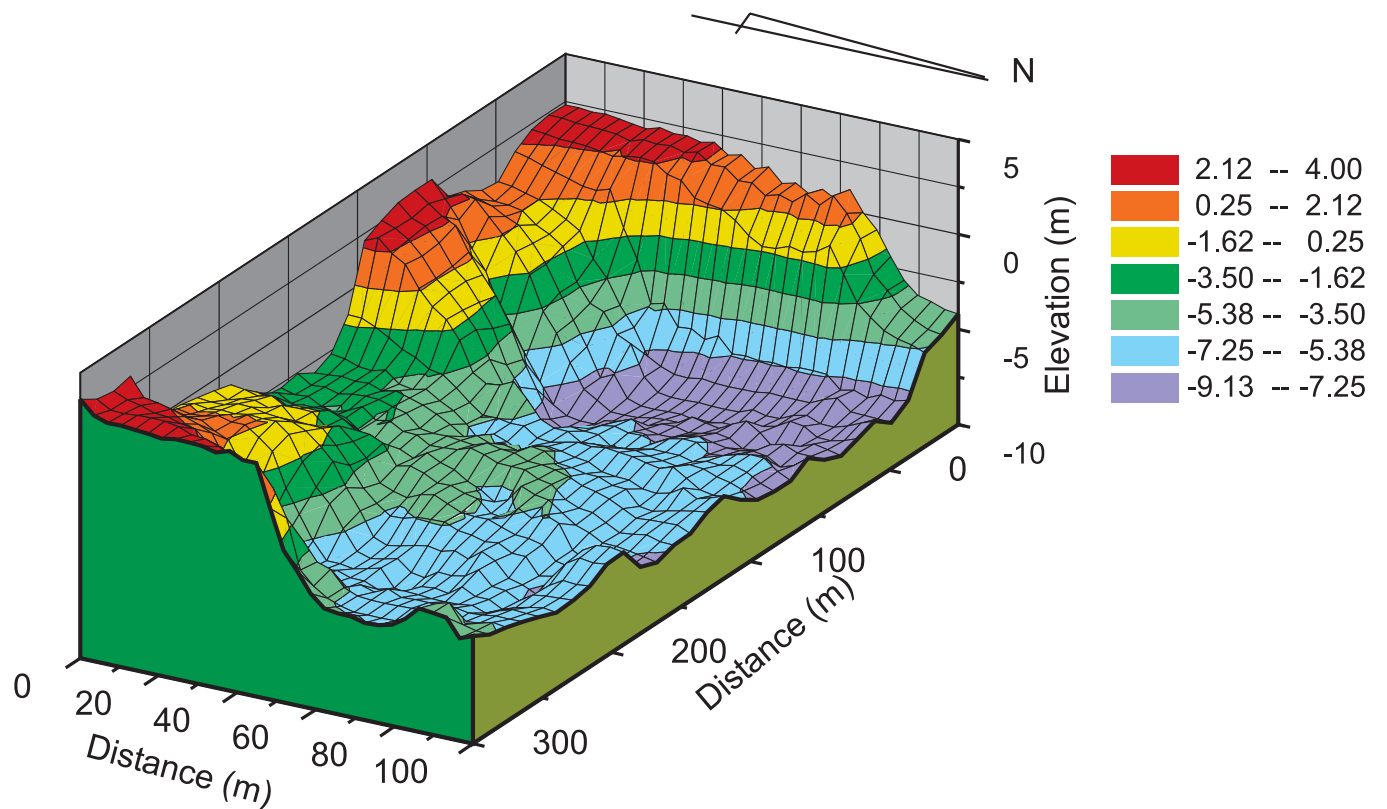
A topographical survey was carried out immediately after the landslide to examine the submerged landslide debris. Figure 13 shows the three-dimensional topography of the remaining dredged slopes and the landslide debris submerged in the sea. Figure 14 shows the two-dimensional topography of the landslide zone and its surrounding area.

Comparing the topographies in Figs. 12–14, we can observe the changes in the ground surface profiles of the submerged slope and berth. The landslide occurred between 100 and 250 m along the shoreline coordinate. This region was the central region of the slope and berth. The western part of the slope and berth, between –50 and 100 m along the shoreline coordinate, was slightly affected by the landslide, whereas the eastern part of the slope and berth, between 250 and 300 m along the shoreline coordinate, was affected significantly. As noted above, there were 55 driven piles installed in the western part of the dredged slope (see Fig. 3). The much smaller degree of damage in the western part of the dredged slope may indicate that the driven piles had some stabilizing effect on the western dredged slope.

**Fig. 13.** Three-dimensional topography of the failed cut slope and berth submerged in seawater after the landslide.

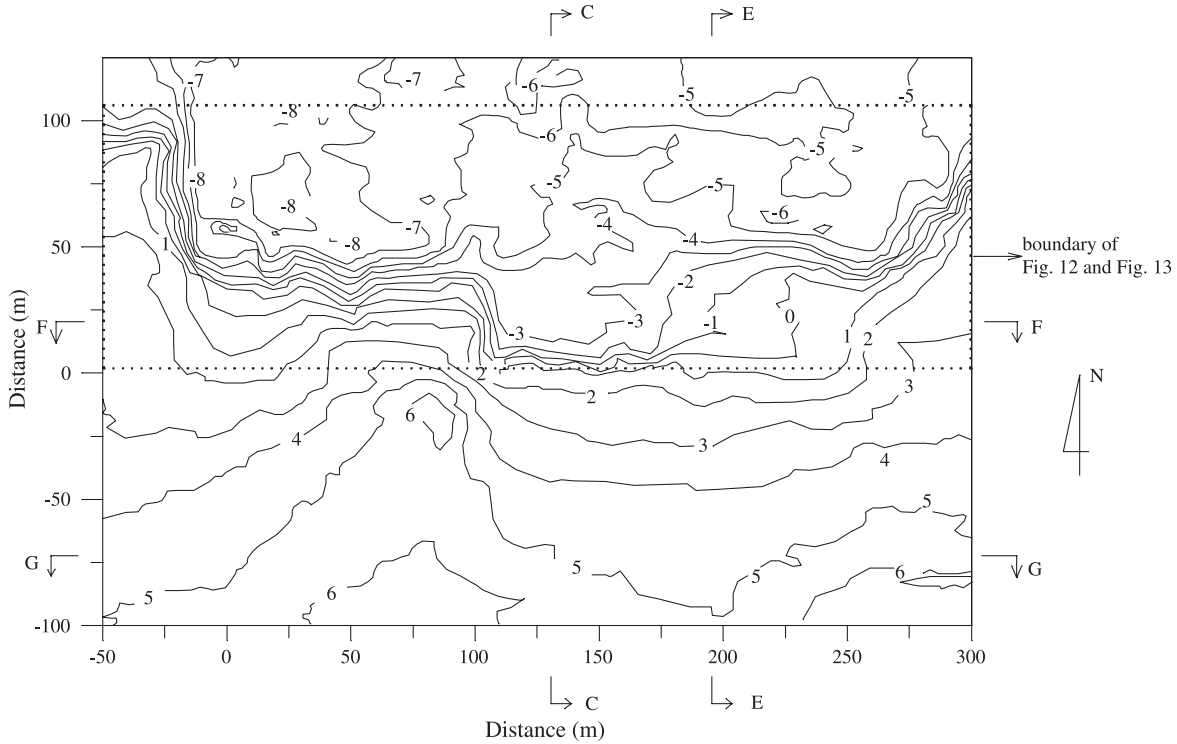
The landslide debris travel distance was about 80 m into the dredged open space in the sea. The landslide debris was deposited over an enlarged area in the berth and on the dredged slope. The overall slope of the landslide debris surface was very gentle and about  $3.0^\circ$ . The angle of the debris flow from the dredged slope crest to the far front of the debris deposit in the berth was about  $6.8^\circ$ . The runout distance normalized to the height drop was between 8.4 and 19.1 and was within the lower limits of recorded submarine slides comprising soft soils (Lacasse 2001). The depth of the berth base was increased from the original elevation of –8 m a.m.s.l. to about –4 m a.m.s.l. The debris was not uniformly deposited in the western and eastern regions of the berth. The eastern region of the berth had more debris deposition.

**Fig. 14.** Two-dimensional topography of the failed land in seawater and on land after the landslide.

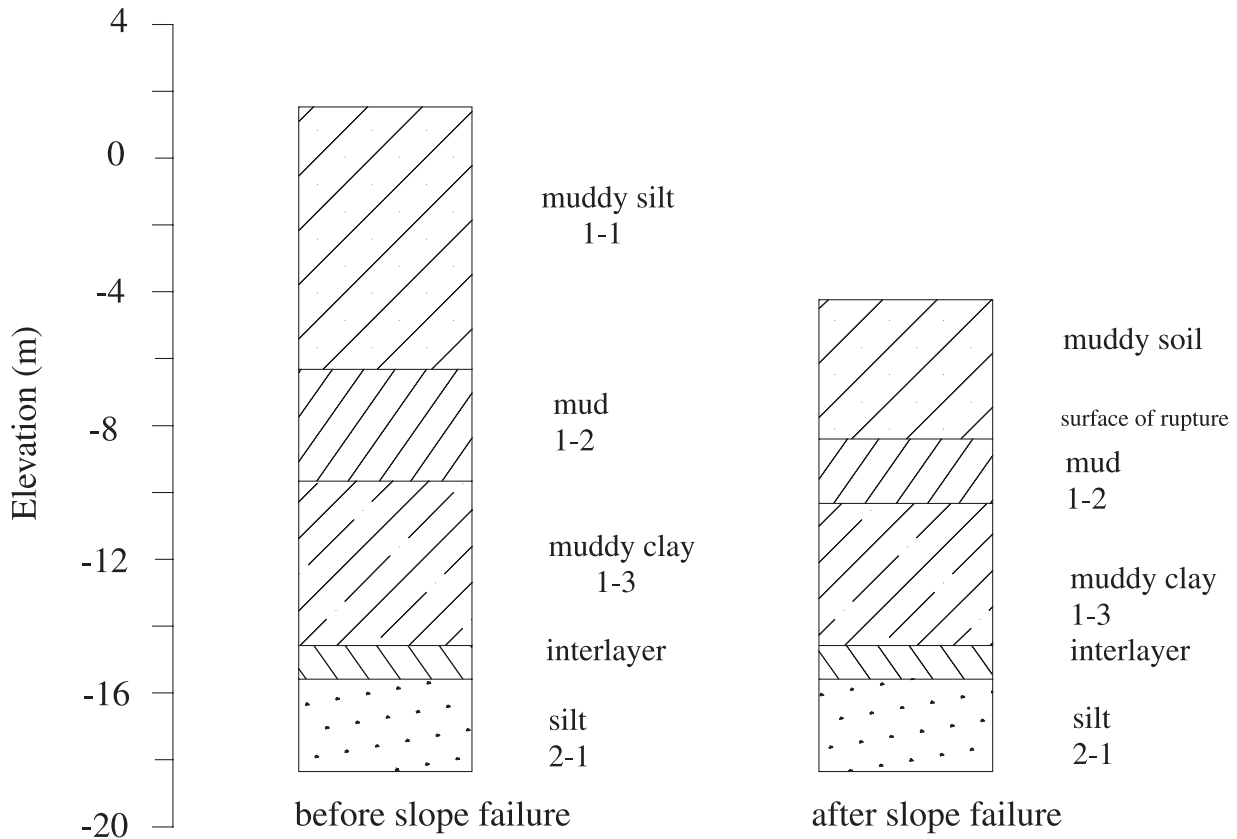
Furthermore, borehole logs from before and after the landslide were used in examining the rupture surface, because the soils above the slip surface should have been disturbed by the landslide. A typical example is given in Fig. 18, which compares the logs of boreholes M11 and B17. Borehole M11 was drilled before the landslide; and borehole B17, after the landslide. As shown in Fig. 7, the M11 and B17 locations were close to each other and also close to cross section C–C. The examination revealed that the soil above the mud sublayer and above elevation  $-8.5$  m a.m.s.l. had been substantially disturbed. The disturbed soil, which may be called muddy soil, did not have the same thin

**Fig. 18.** A comparison between the soil strata in borehole M11 before the landslide and in borehole B17 after the landslide.

seam structural patterns as observed in the original mud. Below  $-8.5$  m a.m.s.l., the soils in M11 and B17 had such structural patterns. Consequently, the rupture surface was at about  $-8.5$  m a.m.s.l. at this location.

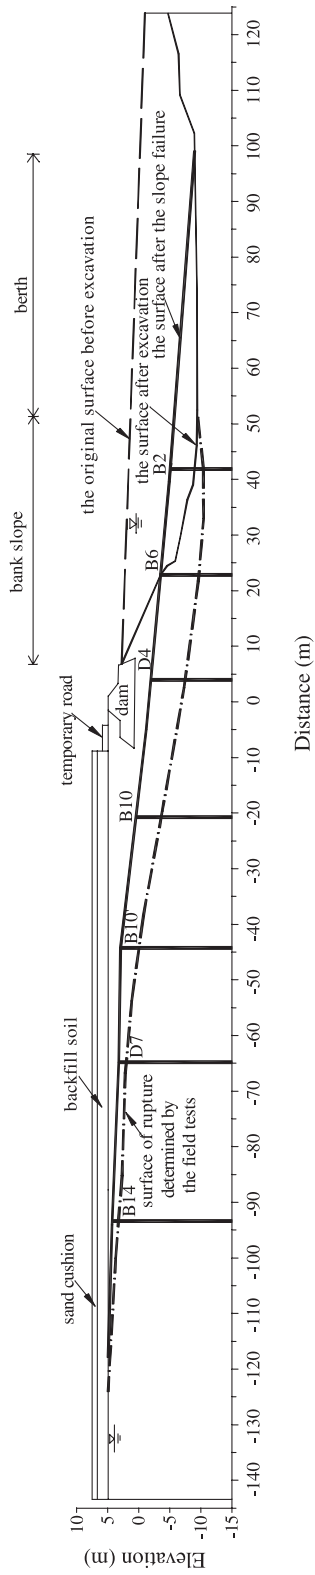
We further summarized the findings on the rupture surface along cross section C–C in Fig. 19. The rupture surface was deep in the dredged slope region and became shallower and shallower as the distance to the dredged slope increased in the reclaimed land. It terminated at the boundary of the landslide zone (see Figs. 3 and 7). The rupture surface was about 200 m long and had a very gentle slope of about  $3.3^\circ$ . In Fig. 19, we also present the ground surface profiles, from before and after the dredging, and the profile of the landslide debris. The landslide debris was located below the ground surface after the slope failure above the rupture surface.

Fig. 19. Soil profile along cross section C-C before and after the landslide.

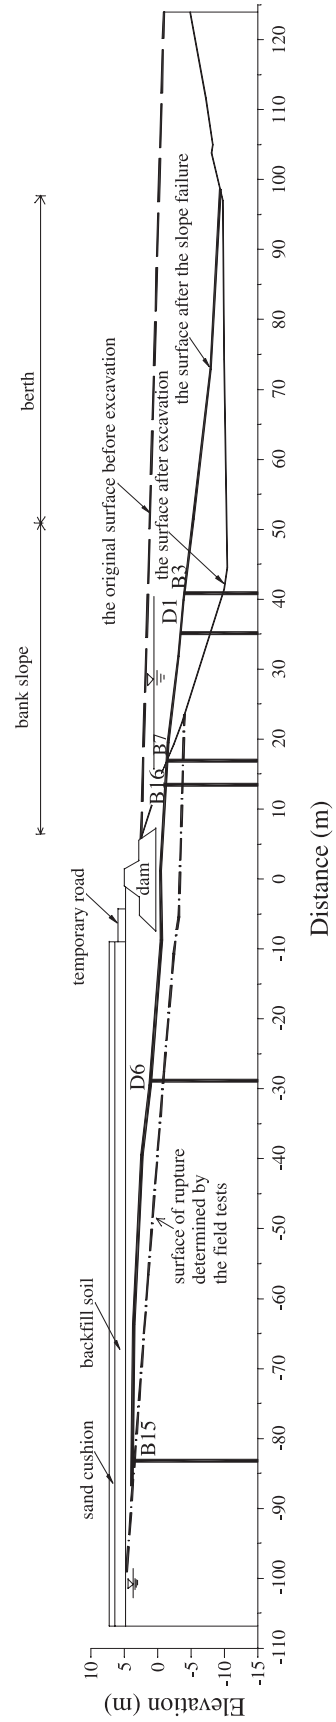
neared the eastern and western boundaries of the landslide zone. Cross sections A–A and E–E had similar rupture surfaces. The surfaces of rupture along cross sections A–A and E–E were at about  $-4.0$  m a.m.s.l. in the submerged region and about  $+1.0$  to  $+2.0$  m a.m.s.l. in the slipped land. Using cross section E–E as the representative section, we summarized the findings of the landslide investigation in Fig. 20. The rupture surface began at the middle level of the dredged slope and became shallower and shallower as the distance to the dredged slope increased in the reclaimed land. It also terminated at the boundary of the landslide zone. It was about 140 m long and had an overall slope of about  $4.0^\circ$ . Similarly, in this figure, we also present the ground surface profiles from before and after the dredging, as well as the profile of the landslide debris. The landslide debris was located below the ground surface after the slope failure above the rupture surface.

Fig. 20. Soil profile along cross section E-E before and after the landslide.

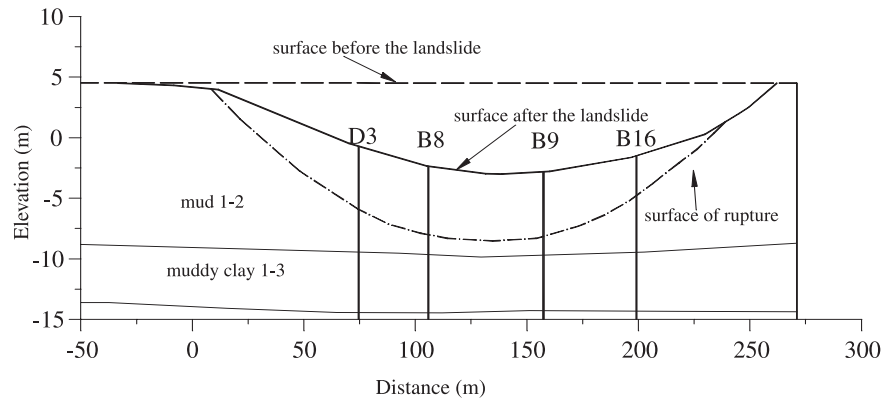
To examine the lateral spreading of the landslide, we present two additional cross sections, F–F and G–G in Figs. 21 and 22, respectively. As shown in Fig. 7, these two cross sections are parallel to the shoreline and perpendicular to the main direction of the landslide movement. Cross section F–F is located below the dredged slope crest; and cross section G–G, at the middle of the landslide zone behind the dam. The rupture surfaces in these two cross sections were deeper in the central region and gradually rose to the ground surface at the two side boundaries. The rupture surface in cross section F–F was generally much deeper than that in cross section G–G. In these two figures, we also present the ground surface profiles from before and after the dredging, as well

**Fig. 21.** Soil profile along cross section F–F before and after the landslide.

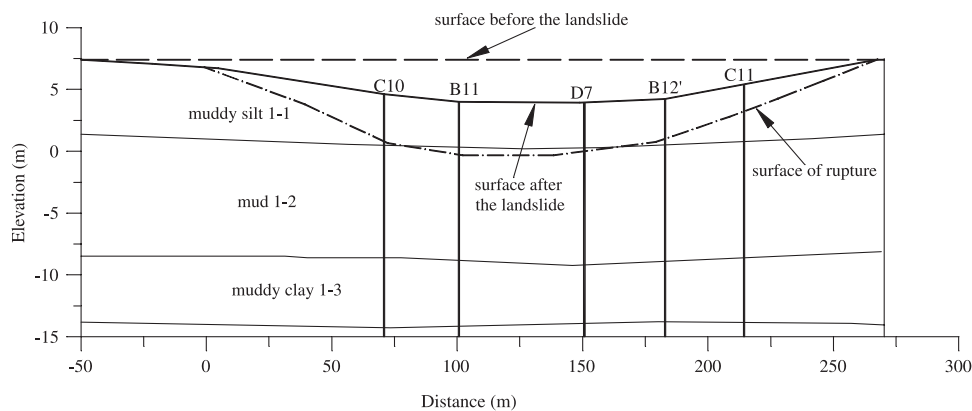
**Fig. 22.** Soil profile along cross section G–G before and after the landslide.

as the profile of the landslide debris. The landslide debris was located below the ground surface after the slope failure, above the rupture surface.

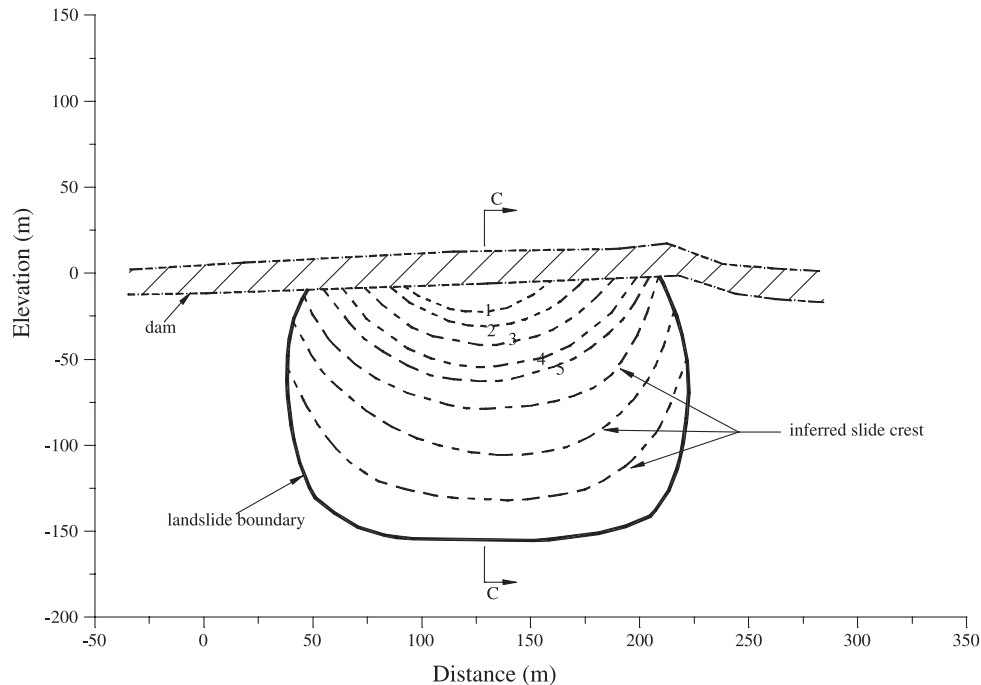
On the basis of the above discussions and findings, we reconstructed the model of slide extensions into the reclaimed land in Fig. 23. Basically, the landslide started when the first slide occurred. Subsequently, the second slide occurred. Then the third slide occurred. Other slides continued to occur in sequence until the last slide occurred at the observed boundary of the landslide zone in the reclaimed land. In Fig. 23, the first slide crest line was based on the observations of witnesses (see Fig. 3). The last few slide crest lines were based on field inspection of the reclaimed land (e.g., Figs. 5, 6, 8–11). The second to fifth slide crest lines were inferred from the relevant data and the analytical studies presented in the companion paper (Li et al. 2005).

**Fig. 23.** Inferred kinematical model of failure extension into the reclaimed land during the landslide.
