A plane slide that occurred during construction of a national expressway in Chongqing, SW China

Z.Q. Yue and C.F. Lee

Quarterly Journal of Engineering Geology and Hydrogeology 2002; v. 35; p. 309-316
doi:10.1144/1470-9236/01004

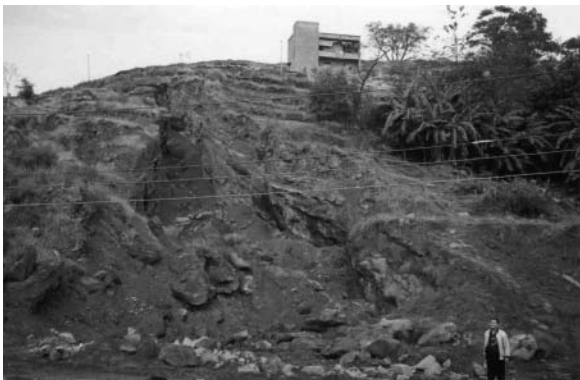
Fig. 4. The open gap and vertical and undulating tension cracks associated with the plane slide during construction of a national expressway in southeastern China, looking east. The open gap measured 6 to 8 m high, by 2 to 7 m wide and 53 m long in weathered mudstone overlying sandstone.

Site investigation revealed that the sliding basal plane was the upper bedding surface of the thick sandstone unit that underlies the thick weathered mudstone. The sandstone surface was exposed on the upper hillside adjacent to the two-storey house shown in Figure 4. The thick sandstone might have acted as an impervious or relatively impermeable bottom layer that led to the formation of a perched ground water table in the weathered mudstone above, as evidenced by the water seeping out of the bedding interface in Figure 7. The thick sandstone strata adjacent to the landslide site can also be observed in Figures 5 & 7.

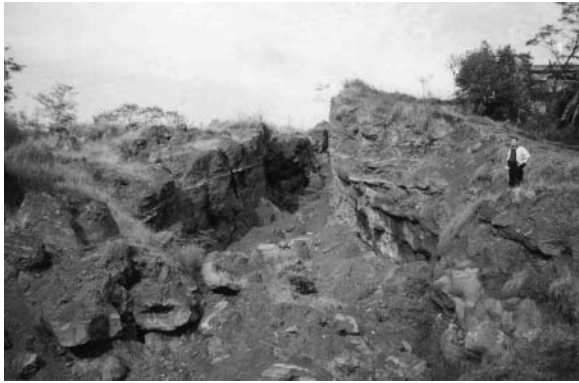
Fig. 6. A close view of the open gap and vertical and undulating tension cracks in the weathering mudstone with monoclinical beddings, looking east. Seepage from the bedding planes of the weathered mudstone is visible.

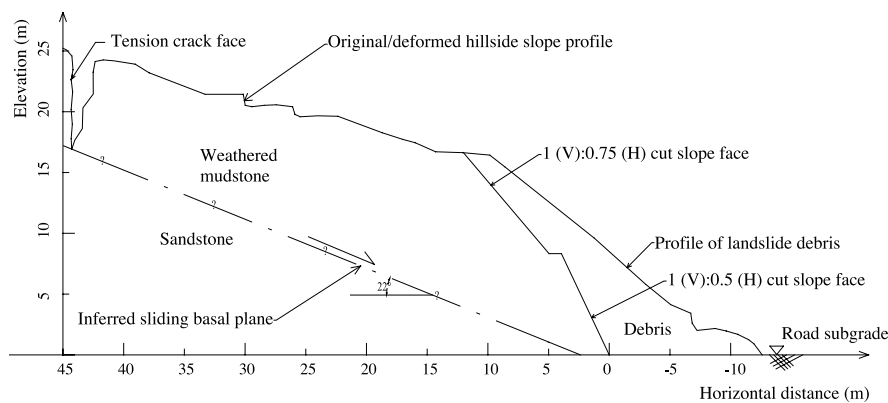
Fig. 11. Geological cross-section C-C.

Interestingly, the open space discontinues at the position where it intersects with the line of geological section C–C. At the cut slope toe of the section C–C, the sandstone sliding basal plane was about 0.5 m below the excavated road platform and not exposed on the cut slope surface. The unexcavated weathered mudstone above the basal plane and in front of the cut slope could offer some resistance to the landslide. The open space therefore discontinues and terminates at the upper region of the section C–C.
