# Experimental and Numerical Investigation of Post-tensioned Concrete Flat Slabs in Fire

**Abstract:** Four tests of post-tensioned high-strength self-compacting concrete flat slabs were conducted under fire conditions. Tendon distributions of the slabs including the Distributed-Distributed and Banded-Distributed patterns as well as various loading ratios were considered. Two of the specimens with lower moisture contents demonstrated excellent fire resistance performance, while the others with slightly higher moisture contents experienced severe concrete spalling. The test results are presented and discussed in respect of thermal profiles, deflections, crack patterns and concrete spalling. Moreover, numerical modelling employing the commercial package ABAQUS was conducted to help interpret the test results in order to get better understanding of such slabs in fire.

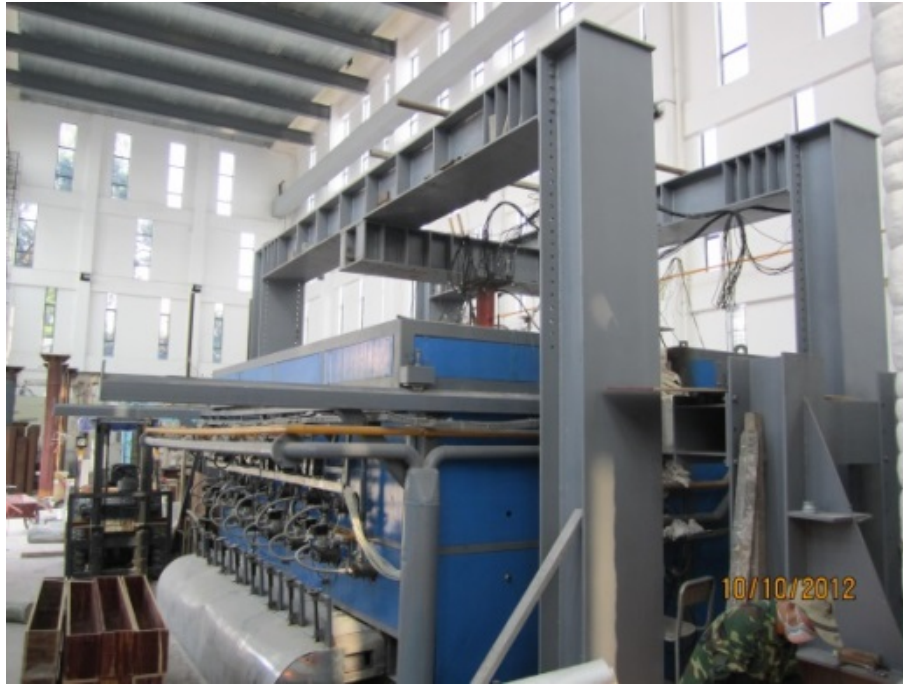
(a) Furnace

Figure 5: Test furnace and loading system

The furnace used as shown in Figure 5(a) has a clear height of 1.8 m, clear width of 3.0 m and clear length of 4.0 m. The loading system is comprised of a hydraulic jack with a loading capacity of 500kN and simply-supported steel beams in contact with four steel load spreaders, as shown in Figure 5(b). Firstly, loads were applied on the slab through the loading system and were kept constant for 15 mins for stability. Afterwards, fire was started in the furnace for testing with the applied loads maintained. The fire curves monitored in the four tests are compared with the ISO 834 standard fire curve in Figure 6, which shows reasonable agreement.

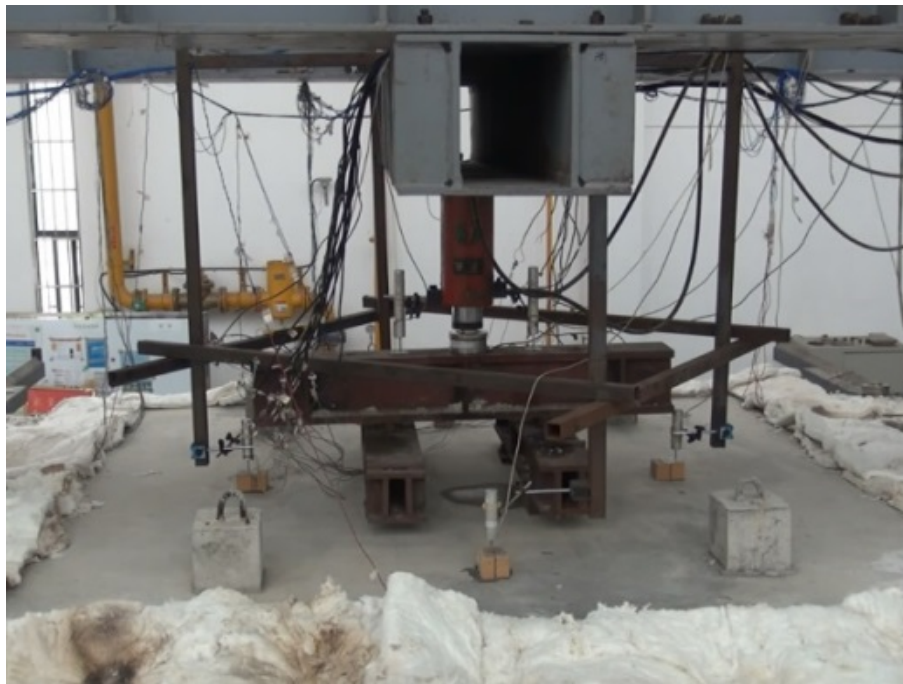
(b) Loading system

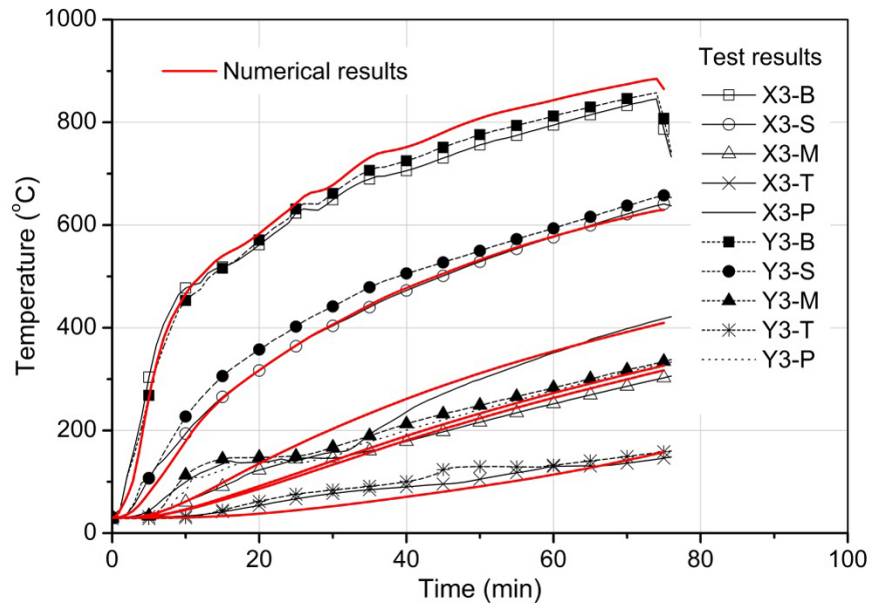
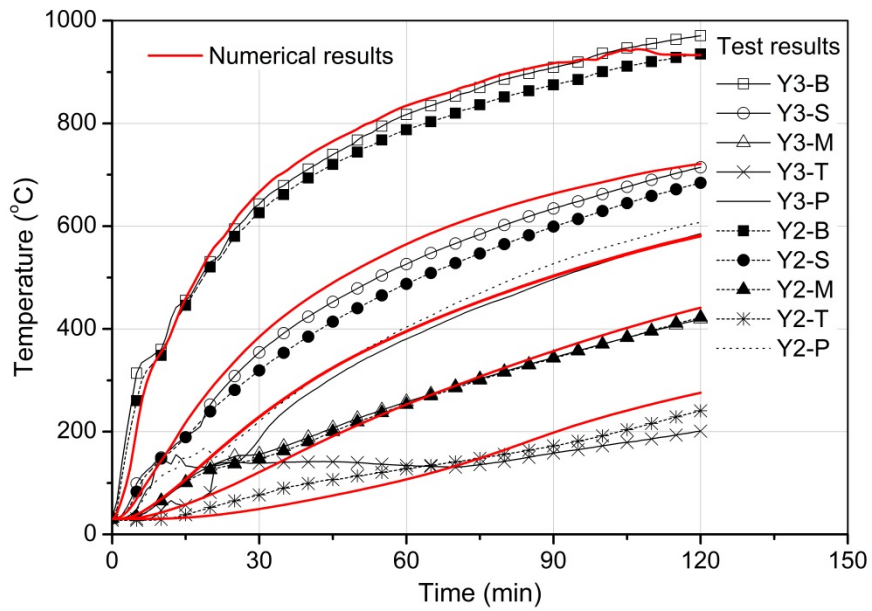
Figure 7: Temperature variations of central panel of slab

Figure 7 shows the variations of thermal profile in the slabs with time. While Figures 7(a) and 7(b) show relatively smooth temperature curves, Figures 7(c) and 7(d) appear irregular as a result of severe concrete spalling. As shown in Figures 7(a) and 7(b), the temperature of the slab soffit rose quickly after starting of fire due to heat transfer through radiation and convection. Obviously, with the increase of distance from the soffit, the temperature had a slower heating rate due to the relatively high thermal resistance of concrete. There are only slight differences between the temperatures measured at X3 and Y3 in Test-1, and Y3 and Y2 in Test-2 at the same level. However, in Test-1 the temperature of tendon X3 was much higher than that of Y3 as the concrete covers to them were 27.5 mm and 38.5 mm respectively. Therefore it can be concluded that the measured thermal profiles are reliable and reasonably accurate. Besides, Figures 7(a) and 7(b) show excellent agreement between the numerical results and test results, verifying that the thermal properties of materials and thermal parameters in the numerical model are reliable.

Interestingly, there are plateaus observed in the tendon temperatures in Figures 7(a), 7(b) and 7(c) in the range from about 130°C to 160°C. This may be caused by the melting of polypropylene sleeves in conjunction with moisture evaporation, but it cannot be achieved by the present numerical modelling. In addition, the thermal profiles were severely affected by the continuous concrete spalling since 5 minutes after the test began. For example, the temperatures of the soffit and reinforcement increased dramatically at the temperature of 200°C in Figure 7(c), and there is a temperature leap in Y2-B in Figure

The temperatures at the top surface of the central panel in the first two tests without concrete spalling are further examined. In Test-1, it reached 160°C after 75 minutes of fire exposure, and the fire was conservatively discontinued as the tendon temperature already exceeded the critical temperature of 350°C prescribed in BS EN 1992-1-2 [2]. In Test-2, it reached 240°C at 120 minutes after commencement. In accordance with the failure criteria in BS 476-20 [13] with respect to insulation, Test-1 did not violate the criteria but Test-2 did. Generally, Test-2 only had a fire resistance of 90 minutes according to the criteria, but it survived 120 minutes still with structural integrity and stability.

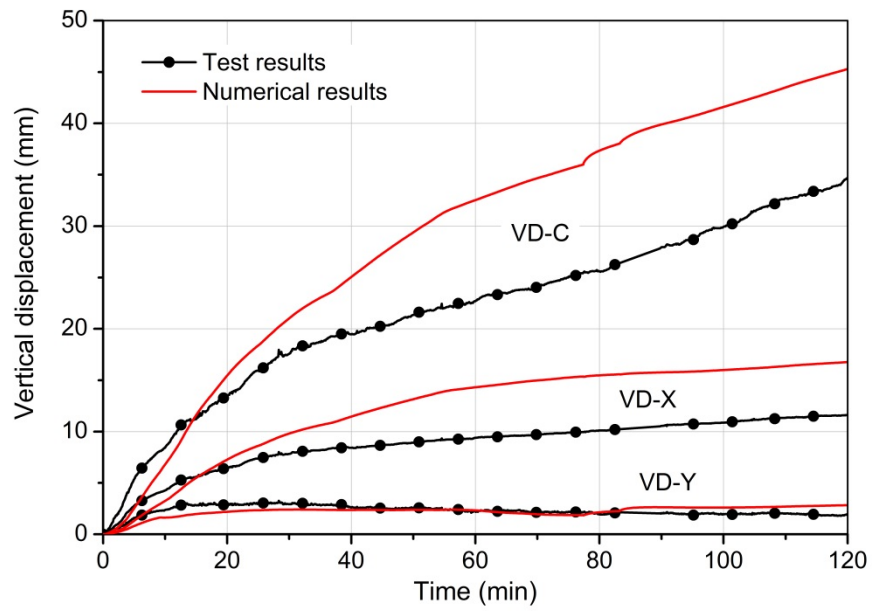
Figure 8: Vertical displacements of slabs

Figure 8 shows the vertical displacements of the slabs in Test-1 and Test-2. In the figure, VD-C is the average value of VD-1 and VD-2 denoting the vertical displacement of central panel; VD-X is the average of VD-3 and VD-5 denoting the vertical displacement of column strip in the X direction; and VD-Y is the average of VD-4 and VD-6 denoting the vertical displacement of column strip in the Y direction. The deflections of the slabs are mainly governed by the thermal gradients across the depth of the slabs and the consequent thermal expansions [14], as well as restraint-induced thermal thrust forces. Moreover, the mechanical properties of concrete, reinforcement and prestressing tendons

Figures 8(a) and 8(b) show that vertical displacements of the central panel increased rapidly in the initial 15 minutes. Afterwards, the increases of displacements gradually slowed down with time due to the reduced temperature gradient and increased thermal thrust forces due to restraints provided by the columns and the surrounding cold parts of slab. The vertical displacements of the column strips in the X direction and the Y direction also increased a lot in the first 15 minutes but they slowed down afterwards or even remained constant. The displacements are mainly caused by the flexural deformation of the central panel in the two orthogonal directions leading to the flexural deformation of the column strips. Moreover, VD-X is larger than VD-Y because the column strip span in the X direction is larger than that in the Y direction and hence the former has smaller flexural stiffness. Besides, as observed in Figure 8(b), after the initial 90 minutes, VD-C changed slightly faster, while VD-X and VD-Y had no obvious changes. This can be explained by the cracks that appeared in and parallel with the column strips. The cracks weakened the integrity of slab releasing the rotation restraints from the cold parts of slab, further leading to the increase of deflection in the central panel.

The predicted displacements obtained from numerical modelling show reasonable agreement with those obtained from Test-1 and Test-2, but obvious discrepancies still exist as shown in Figure 8. The discrepancies may be attributed to two aspects. One is that the thermal expansion of concrete considered in numerical modelling, which is taken

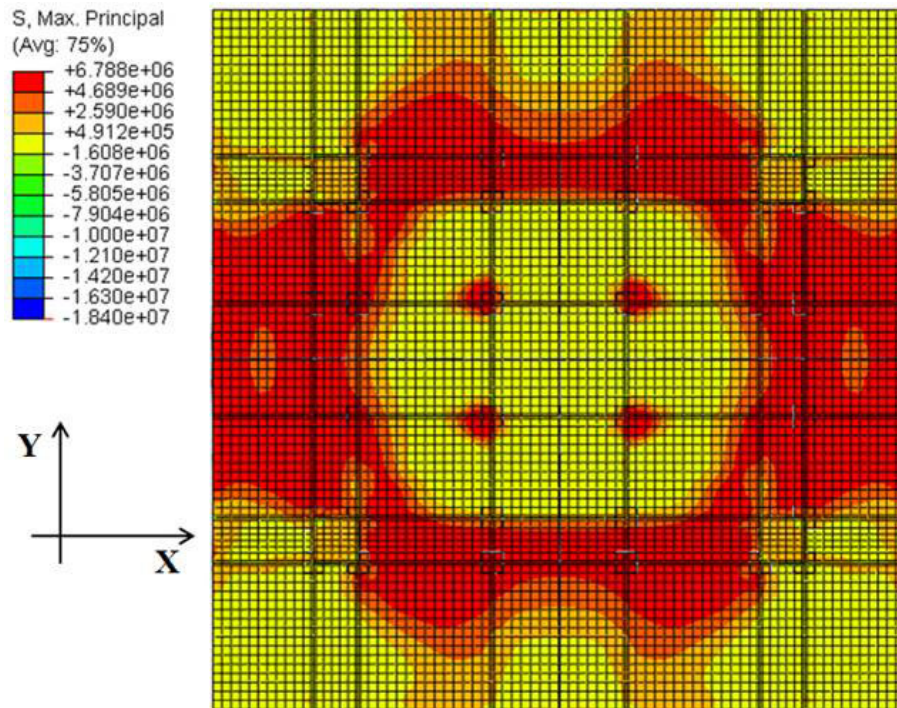
(a) Cracks at top surface after fire

(b) Stress distribution at top surface at 25 min in fire

(c) Cracks at soffit after fire

Figure 9(a) shows the crack distribution at the top surface of slab in Test-1 after fire. The cracks mainly appeared in the column strips adjacent to the cold parts of slab approximately in an elliptic pattern. As observed during the test, cracks first appeared in and parallel with column strips in the Y direction after the initial 25 minutes. Figure 9(b) shows the maximum principal stress distribution obtained from numerical modelling at that time. The maximum tensile stresses are mainly distributed in the column strips adjacent to the cold parts of slab, which is consistent with the crack distribution. Moreover, the tensile stresses are mainly caused by negative moments induced by the restraints of the adjacent cold parts of slab on the doubly curved deformation of the central panel. Interestingly, neither cracking nor spalling was observed at the soffit of the central panel as shown in Figure 9(c), because the in-plane concrete stresses at the soffit of slab were either slightly tensile or even compressive in two directions due to restrained thermal expansion.

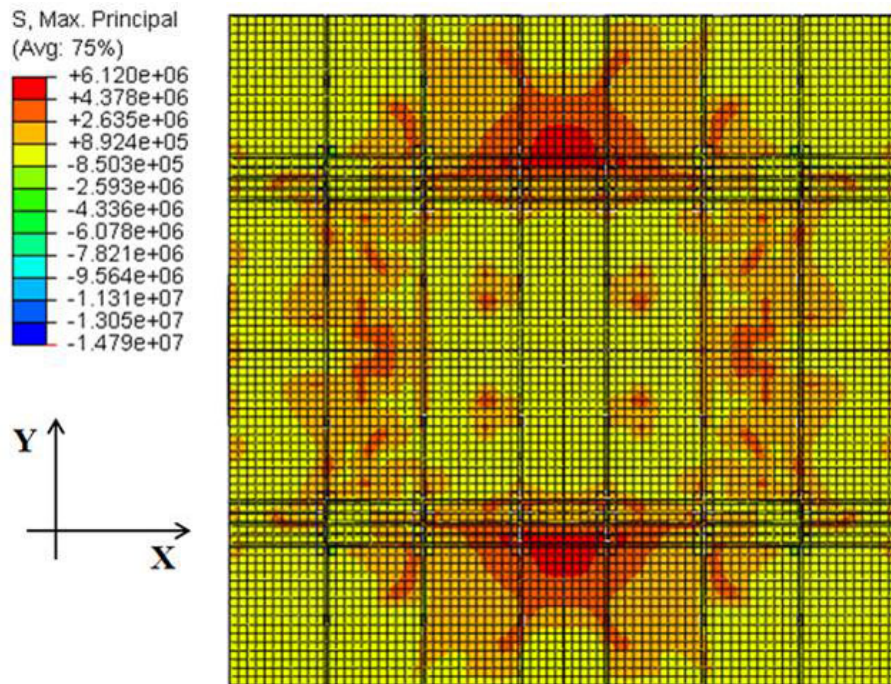
(a) Cracks at top surface after fire

(b) Stress distribution at top surface at 25 min in fire

(c) Cracks at soffit after fire

Figure 10 shows that the cracks and tensile stress distributions of the slab in Test-2 are similar to those in Test-1, and the soffit shows neither cracking nor spalling. However, Test-2 survived more than 120 minutes of fire exposure, which resulted in more cracks at the top surface, as shown in Figure 10(a). Besides, the tensile stress distribution of the

slab is slightly different as stress concentration is slightly more significant in column strips in the X direction than that in the Y direction as shown in Figure 10(b) because of the additional tensile stress perpendicular to the banded prestressing tendons. The tensile stress distribution is consistent with the crack distribution, which further validates the numerical model.
