# Cyclic behaviour of deep reinforced concrete coupling beams

A. K. H. Kwan and Z.-Z. Zhao

**Six half-scale models of reinforced concrete coupling beams with span/depth ratios  $\leq 2.0$  were tested under reversed cyclic load by a newly developed test method that can accurately simulate the boundary conditions of coupling beams in coupled shear wall structures. Five of them were conventionally reinforced and one was diagonally reinforced. Span/depth ratio and reinforcement layout were the main structural variables studied. Test results revealed that the deep conventionally reinforced coupling beams behaved quite differently from the ordinary beams in frame structures. Generally, shear failure was more likely to occur. Moreover, the additional longitudinal reinforcement bars (those placed near the centroidal axis) could contribute significantly to bending strength and therefore lead to an increase in shear demand. Nevertheless, the measured drift ratios of the conventionally reinforced coupling beams still reached 3.6–5.7%, which are not small for deep coupling beams. On the other hand, it was found that the provision of diagonal reinforcement radically changed the load resistin

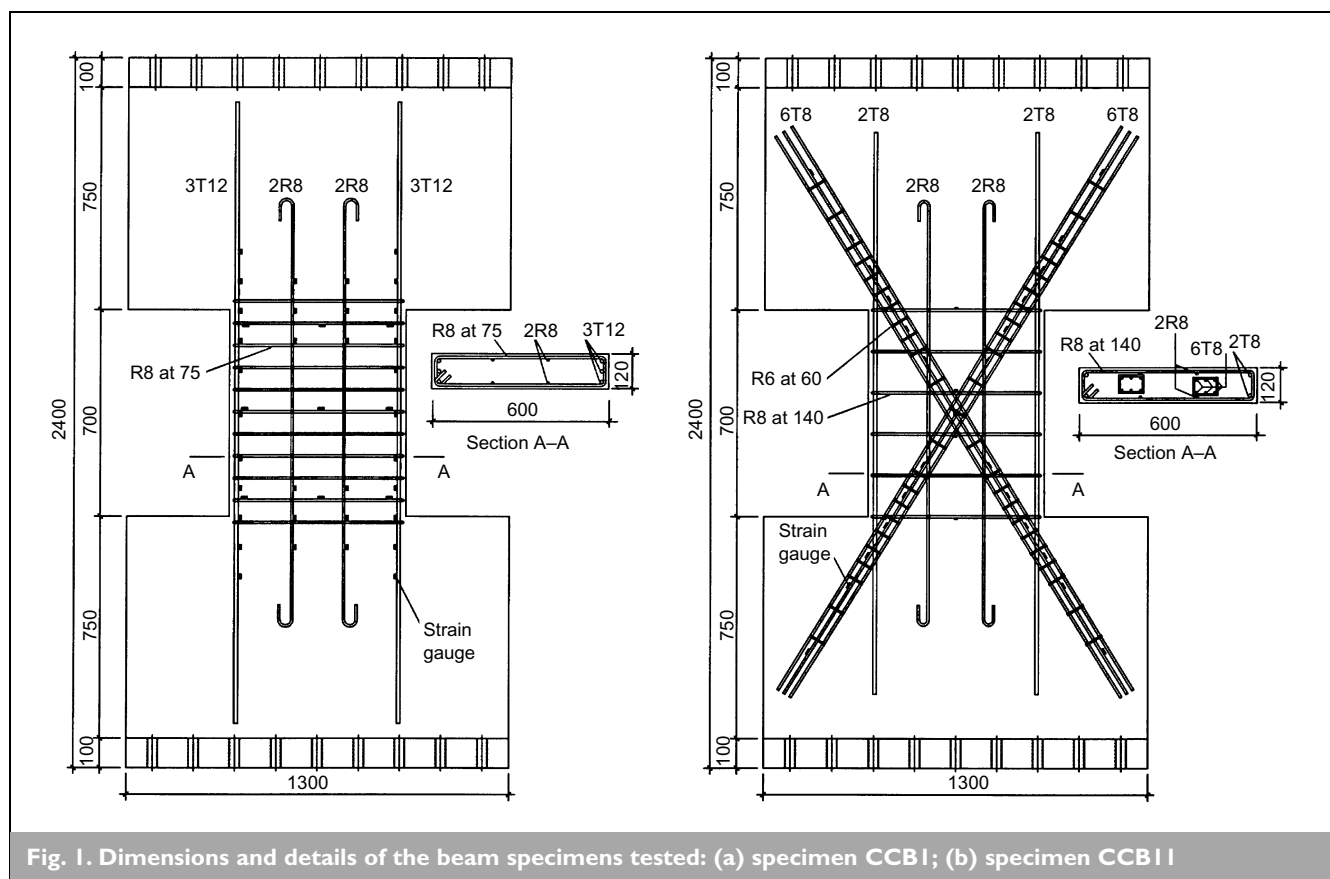
Fig. 1. Dimensions and details of the beam specimens tested: (a) specimen CCB1; (b) specimen CCB11

A total of six coupling beam specimens with dimensions and details as shown in Fig. 1 were fabricated and tested. They were basically half-scaled and could be divided into two series. The first series comprised of specimens CCB1, CCB2, CCB3 and CCB4, which have similar longitudinal reinforcement ratios and similar transverse reinforcement ratios but different span/depth ratios of 1.17, 1.40, 1.75 and 2.00, respectively. The second series comprised of specimens CCB1, CCB11 and CCB12, which have the same span/depth ratio of 1.17 but different layouts of reinforcement. Table 1 lists the structural parameters of the six specimens.

At each end of a beam specimen, a rectangular end block (1300 × 750 mm) having the same thickness as the beam and representing part of the wall connected to the beam was cast integrally with the beam as part of the specimen. These end blocks were to allow for local deformation at the beam–wall joints.

In each of the conventionally reinforced beam specimens, equal amounts of top and bottom longitudinal reinforcement were provided throughout the length of the beam. Additional longitudinal reinforcement was placed near mid-depth of the beam section. All longitudinal reinforcement bars in the beam were provided with generous anchorage into the end blocks. Stirrups were supplied in each specimen as shear reinforcement. On the other hand, the diagonally reinforced beam specimen CCB11 was designed according to the method proposed by Paulay and Binney.<sup>3</sup>

strain gauges were used to measure the load, displacements and strains, respectively. The locations of the strain gauges are marked on the specimens shown in Fig. 1.

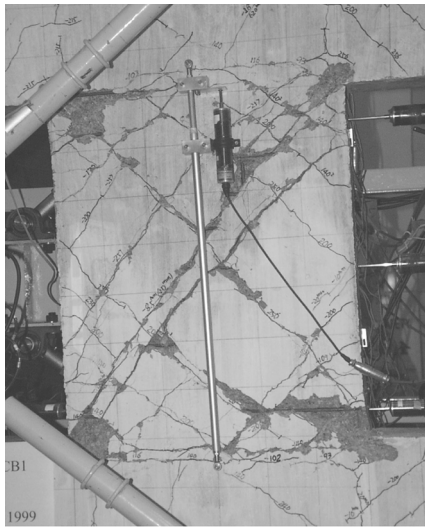
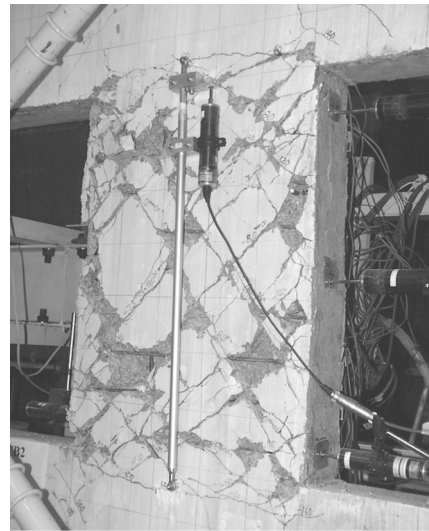
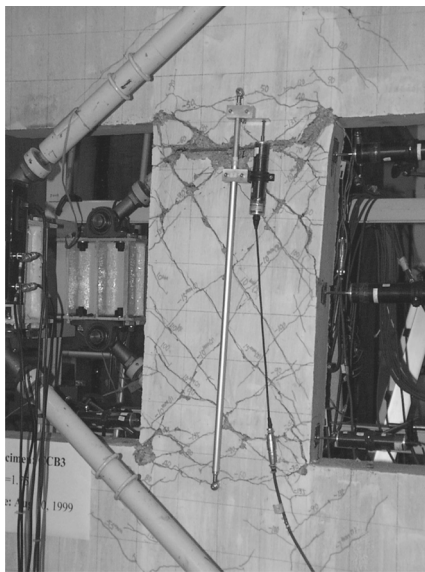
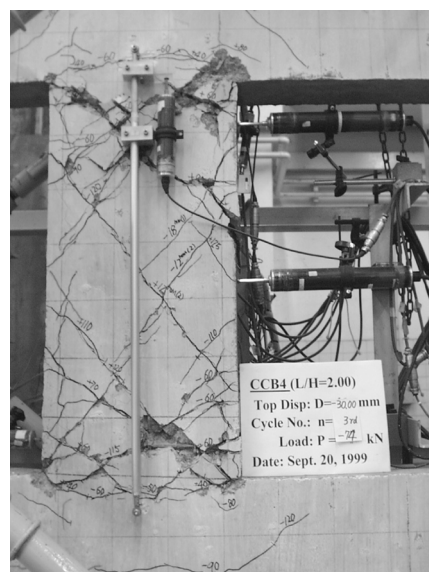
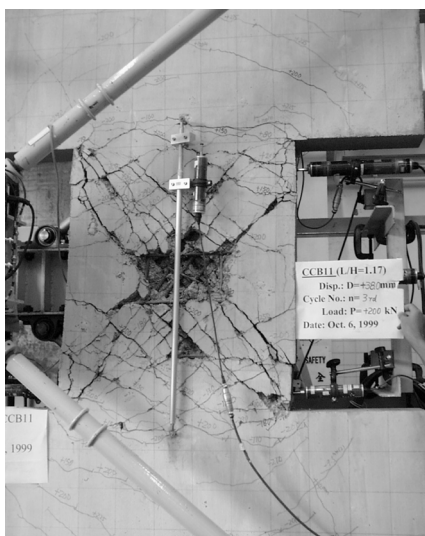
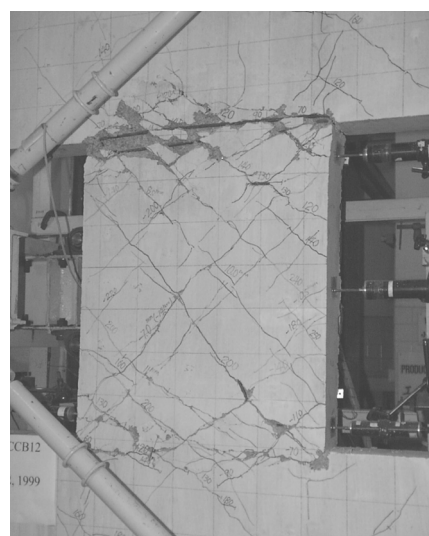
**Fig. 2. Crack patterns and failure modes: (a) CCB1 (shear-tension failure); (b) CCB2 (shear-compression failure); (c) CCB3 (shear-sliding failure); (d) CCB4 (flexural failure); (e) CCB11 (diagonal bar buckling failure); (f) CCB12 (shear-sliding failure)**

Before the main reinforcement bars started to yield, the beam specimens had similar crack patterns. In each beam specimen, two sets of cracks corresponding to the two opposite loading directions were formed. At the beginning, flexural cracks and combined flexural-shear cracks were found near the two ends of the beam specimen. Later on, some of the flexural cracks near the beam–wall joints formed by loads acting in opposite directions merged and developed into through cracks crossing the whole depth of the beam. Some fine cracks also appeared in the end blocks near the beam–wall joints. However, after the main reinforcement bars had yielded, the crack patterns of the six beam specimens became different, as shown in Fig. 2.

In beam CCB1, inclined shear cracks appeared along one diagonal soon after the main bars yielded. These diagonal cracks passed through almost the entire span and divided the beam into two triangular halves interconnected by the stirrups. Measured strains in the stirrups showed that some of the stirrups yielded immediately after the formation of the diagonal cracks. When peak load was reached, nearly all the stirrups yielded. Yielding of the stirrups and the main bars led to wide opening of the shear and flexural cracks. Minor crushing failure of the concrete at the compression corners also occurred. When the inclined shear cracks opened to 10 mm width, the test was stopped and the beam specimen was regarded to have failed in shear-tension mode.

The cracks in beam CCB2 were similar to those in beam CCB1 except that CCB2 had more inclined shear cracks formed. Intersection of the inclined shear cracks caused by the applied loads in the two opposite directions divided the concrete of the beam into many small zones tied together by the reinforcement bars. Repeated opening and closing of these cracks due to load

reversal led to serious spalling of the concrete. Although most stirrups had yielded at peak load, none of the inclined shear cracks had opened up. Eventually, the beam specimen failed in shear-compression mode.

In beams CCB3 and CCB4, all cracks were located near the beam-wall joints until the peak load was reached when inclined shear cracks started to appear near the centre of each beam. Although the appearance of the inclined shear cracks led to an immediate increase in tensile strain of the stirrups there, the stirrups near the centre remained unyielded. Even at the post-peak stage, only the stirrups near the beam-wall joints had yielded. Finally, beam CCB3 failed by shear-sliding due to sliding movement of a through crack near one beam-wall joint, while beam CCB4 failed by beam bending due to large local rotations of the two beam-wall joints.

In beam CCB11, which was provided with diagonal reinforcement, numerous inclined shear cracks were formed. These cracks remained very fine and stable until the peak load was reached. After reaching peak load, the diagonal reinforcement bars yielded in tension leading to a significant increase in crack width of the inclined shear cracks and large residual deflection when the applied load was removed. Moreover, the concrete near the centre of the beam was seriously damaged due to repeated opening and closing of the cracks there. Eventually, in one load cycle, the set of diagonal reinforcement bars under compression buckled near the centre of the beam and the load resisting capacity of the beam quickly dropped to less than 50% of the peak load.

In beam CCB12, which was similar to beam CCB1 except more stirrups were provided before the peak load was reached, the crack pattern was similar to that of beam CCB1. However, after the peak load was reached, beam CCB12 behaved quite differently; in beam CCB12, the inclined shear cracks did not open up even when virtually all the stirrups had yielded at the post-peak stage. In contrast, repeated opening and closing of the flexural cracks near the beam-wall joints led to gradual increase in crack width. Eventually, beam CCB12 failed by shear-sliding due to sliding movement of a through crack near one beam-wall joint, just like beam CCB3.

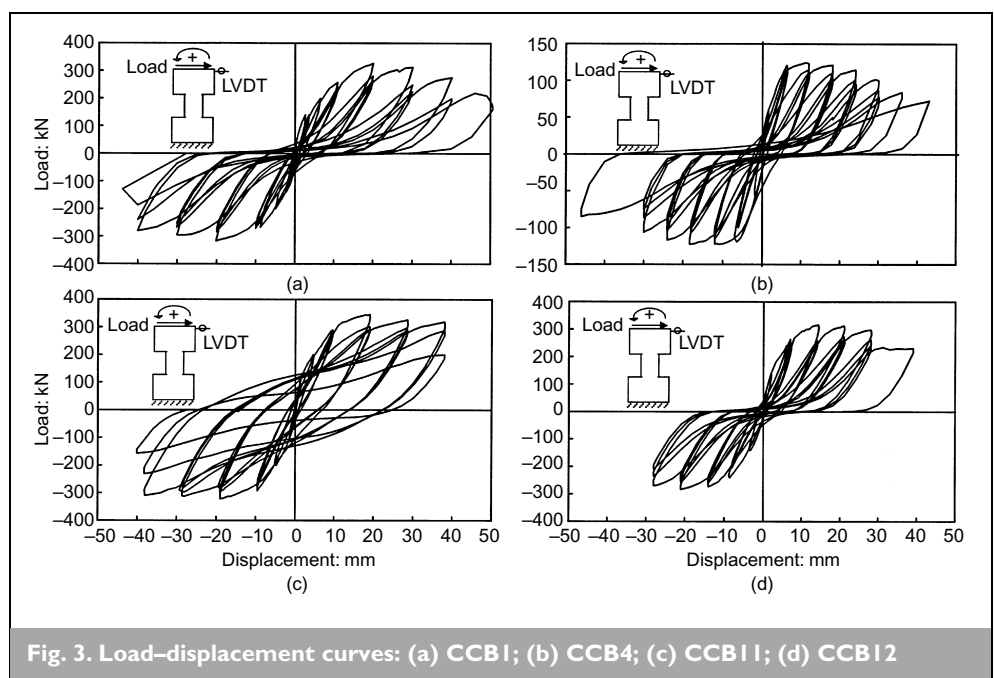
Fig. 3. Load-displacement curves: (a) CCB1; (b) CCB4; (c) CCB11; (d) CCB12

Figure 3 depicts the load-displacement curves of CCB1, CCB4, CCB11 and CCB12. (The load-displacement curves of CCB2 and CCB3 are similar to that of CCB4.) It is seen that all the load-displacement curves obtained are highly hysteretic.

coupling beams exhibit substantial pinching, especially at large deflection amplitude. Such pinching would lead to rapid stiffness degradation and relatively small energy dissipation. One possible reason for the pinching phenomenon was that the inelastic deflections of the conventionally reinforced coupling beams were due mostly to widening of the shear and flexural cracks, which remained open even when the applied load dropped to zero. When the applied load was reversed, the cracks had to be closed before the lateral resistance could recover, leading to small lateral resistance while the cracks were being closed and eventually pinching of the load-displacement curves.

In contrast, the load-displacement curve of the diagonally reinforced coupling beam exhibits no pinching and appears to be more stable. The reason behind this was that the applied load was resisted mainly by the tension in one set of diagonal reinforcement and by the compression in the other set of diagonal reinforcement. The compression developed in the concrete was not relied on and thus the opening/closing of the cracks in the concrete had relatively little effect on the lateral resistance of the coupling beam. However, buckling of the diagonal reinforcement bars could lead to sudden failure of the coupling beam. Therefore, sufficient lateral hoops should be provided along the diagonal reinforcement bars to keep the surrounding concrete in place and prevent, or at least delay, buckling failure.

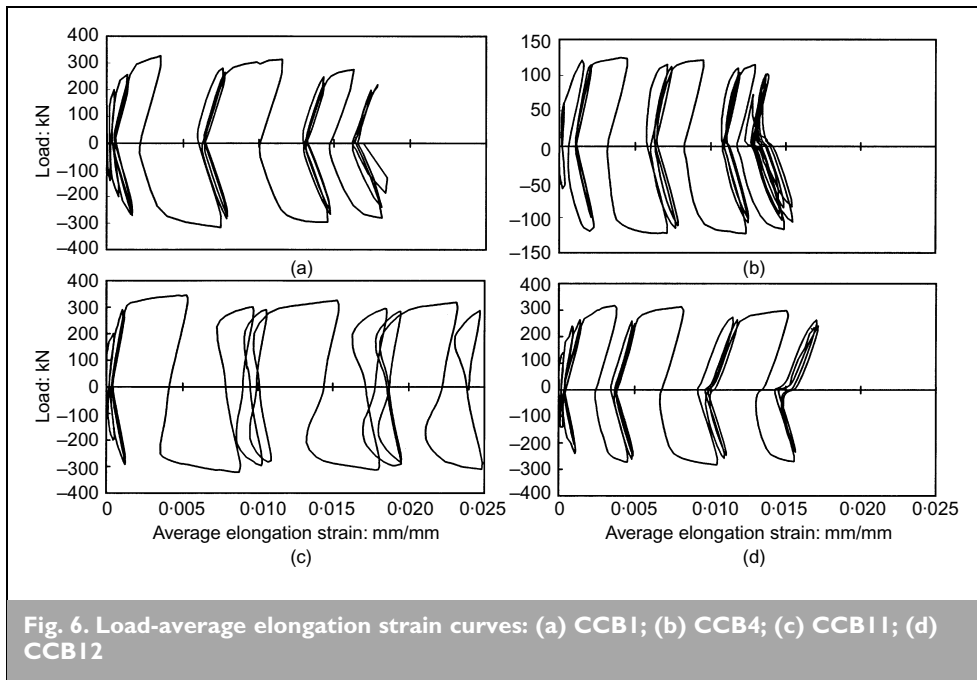
Fig. 6. Load-average elongation strain curves: (a) CCB1; (b) CCB4; (c) CCB11; (d) CCB12

As the longitudinal or diagonal reinforcement bars yielded, the coupling beams elongated. Fig. 6 shows the average elongation strain (axial elongation divided by clear span length) of each of the specimens CCB1, CCB4, CCB11 and CCB12.

In each beam, before the yield load was reached, the axial elongation of the beam was very small and there was almost no residual elongation when the beam was unloaded. However,

after reaching the yield load, the axial elongation increased quickly. Every time, when the lateral displacement amplitude was increased, there was significant increase in axial elongation. Moreover, a substantial portion of the axial elongation remained as residual elongation when the applied load was removed. Consequently, all the coupling beams became longer after the tests. The maximum average elongation strains recorded for the conventionally reinforced beams were around 1.2–2.0% and that for the diagonally reinforced beam was about 2.5%.

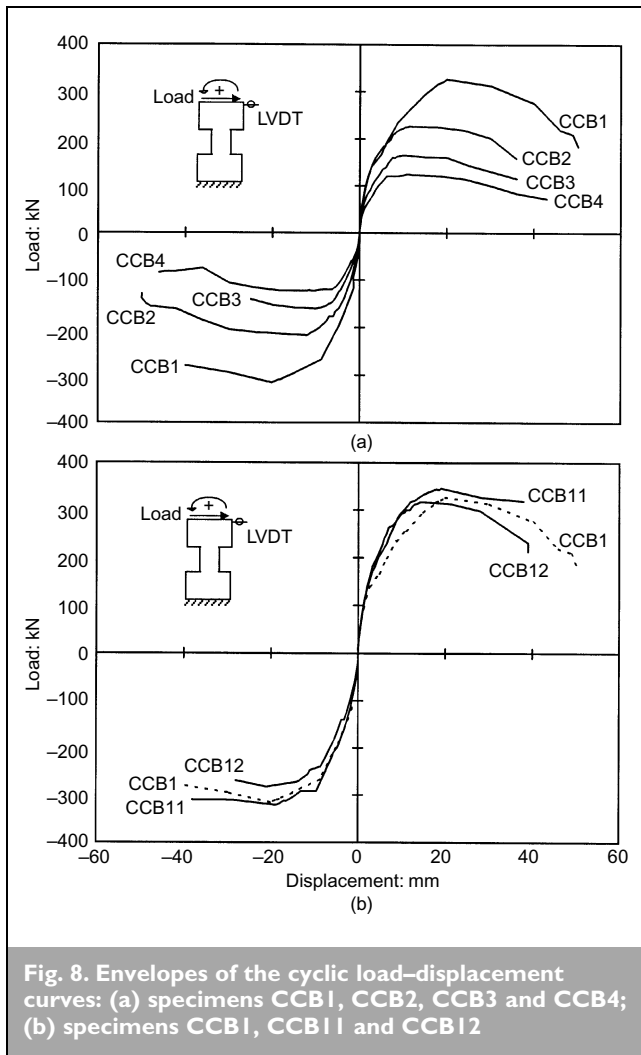
Fig. 8. Envelopes of the cyclic load–displacement curves: (a) specimens CCB1, CCB2, CCB3 and CCB4; (b) specimens CCB1, CCB11 and CCB12

Figure 8(a) shows the envelopes of the cyclic load–displacement curves for the beam specimens CCB1, CCB2, CCB3 and CCB4. Although the four conventionally reinforced coupling beams had similar flexural reinforcement ratios and

similar shear reinforcement ratios, because of their different span/depth ratios, their load resisting capacities were different and they failed in different failure modes. Basically, as the span/depth ratio of such a conventionally reinforced coupling beam decreased, the load resisting capacity increased but the ductility decreased. Figure 8(b) shows the envelopes of the cyclic load–displacement curves for the beam specimens CCB1, CCB11 and CCB12. Although these three beams have different reinforcement layouts, the envelopes of their load–displacement curves are very close to each other. This indicates that they had similar load resisting capacities and similar ductility.

Comparing the beam specimens CCB1, CCB11 and CCB12, which have the same span/depth ratio but different reinforcement layouts, it is seen that they have displacement ductility factors of 4.0, 4.0 and 4.3, respectively, and ultimate drift ratios of 5.7, 5.4 and 4.3%, respectively. Hence, roughly speaking, they have similar ductility and similar deformability. More importantly, the provision of diagonal reinforcement in
