2
3 **Repair of Fire-exposed Preloaded Rectangular Concrete Columns by Post-**
4 **compressed Steel Plates**

10 This paper describes an experimental study of axially loaded, fire-exposed, rectangular reinforced
11 concrete (RC) columns repaired with post-compressed steel plates. Seven RC columns with identical
12 section dimensions and reinforcement details were fabricated and tested. Six of them were exposed to
13 a four-hour fire load according to the ISO 834 Standard. After one month of cooling, five of the fire-
14 exposed columns were installed with precambered steel plates which were then post-compressed by a
15 method newly developed by the authors. All columns were tested under axial compression to
16 determine their ultimate load capacity, deformation and ductility. The effects of steel plate thickness,
17 initial precamber displacements and preloading level on the ultimate load capacity of repaired RC
18 columns were investigated. The test results show that up to 72% of the original capacity of the axial

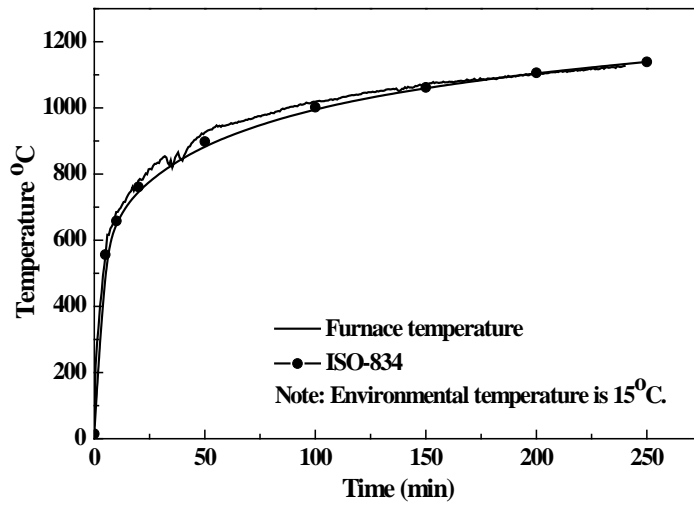
Fig. 4. Measured furnace temperature (T) versus time (t)

130 A large-scale furnace was built for full-scale fire tests on column, wall and floor elements at the Fire
131 Laboratory of RED Fire and Facade Consultants Limited in Hong Kong, as shown in Fig. 2(a). The
132 heat was provided by eight gas burners, with four burners on each side. The temperature of the
133 concrete was monitored by K-type thermocouples that were located at various cross sections, as shown
134 in Fig. 3. The column was exposed to fire following the ISO834 standard temperature-time curve (ISO
135 1975) for four hours, as plotted in Fig. 4.

$$136 \quad T = 345 \log_{10}(8t + 1) + T_0 \quad (1)$$

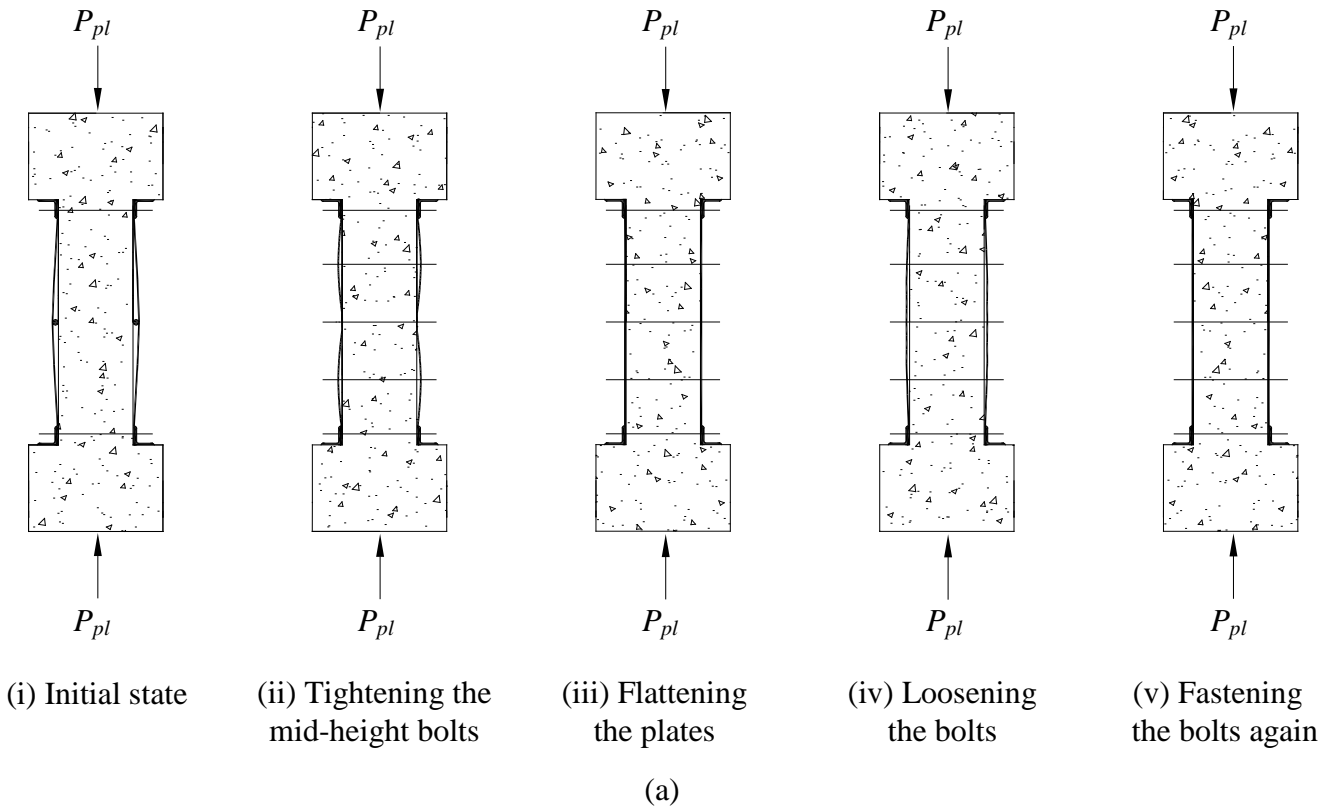
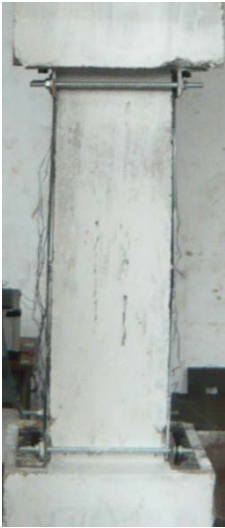
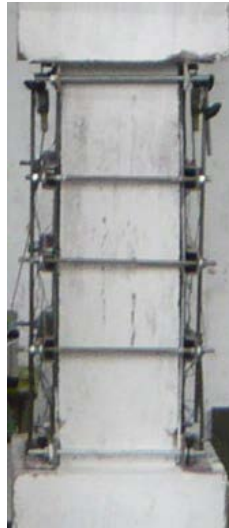
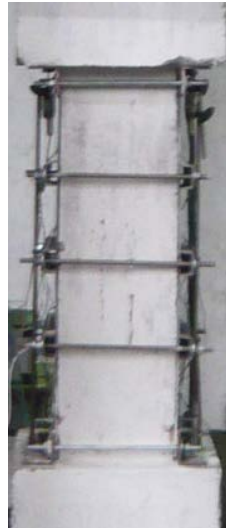
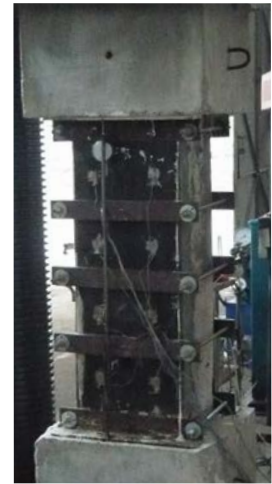
Fig. 8. Post-stressed procedure (a) Schematic diagram, (b) The Steps (i) to (iii) of FSC6 and (c) Strengthening details of FSC6

175 When the applied compression reached the preloading level, the post-stress procedure (Su and
176 Wang 2012) was adopted to avoid warping or buckling of steel plates during the decompression of the
177 RC column by flattening the precambered steel plates. Fig. 8(a) shows the post-stress procedure in
178 detail, which can be divided into the following steps: Steps (i & ii), bolts at the mid-height are
179 tightened, thus, the buckling mode of the precambered plates is changed to higher modes; Step (iii),
180 the plates are flattened by tightening the other bolts; and in Steps (iv & v), to achieve a more evenly
181 distributed internal stress in the plates, all the bolts are slightly loosened and re-fastened again. Fig.
182 8(b) and (c) show the post-stress procedure from Step (i) to Step (iii) and the strengthening details of
183 Specimen FSC6, respectively.

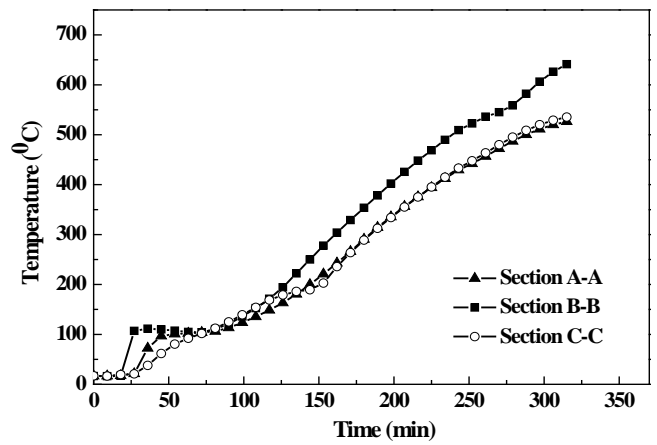
Fig. 9. Concrete temperature versus time: (a) Section B-B of FSC4; (b) Section B-B of FSC7; (c) 70 mm from the surface of FSC2; (d) 125 mm from the surface of FSC5

187 Figs. 9(a) and 9(b) show the concrete temperature at various depths of the mid-height cross section (B-
188 B). As shown in Fig. 9(a), after exposure to the ISO-834 standard fire for four hours, the concrete
189 temperature 15 mm from the surface reached 955 °C, which was 77.5% and 143.0% greater than the
190 concrete temperature at 70 mm (538 °C) and 125 mm (393 °C) from surface, respectively. As shown

191 in Fig. 9(b), after exposure to the fire for four hours, the concrete temperature at 50 mm from surface
192 was 622 °C, which was 27.5% greater than the concrete temperature at 100 mm (487 °C) from surface.

193 Figs. 9(c) and 9(d) show the concrete temperature at various heights for the same distance from the
194 concrete surface. As shown in Fig. 9(c), after exposure to the fire for four hours, the concrete
195 temperatures were 477 °C, 513 °C and 444 °C at Sections A-A, B-B and C-C, respectively. As shown
196 in Fig. 9(d), after exposure to the fire for four hours, the concrete temperatures were 417 °C, 471 °C
197 and 412 °C at Sections A-A, B-B and C-C, respectively. The fire test results show that smaller
198 distances from the concrete surface can lead to higher concrete temperatures, while the concrete
199 temperature at the same concrete depth was evenly distributed along the column height.

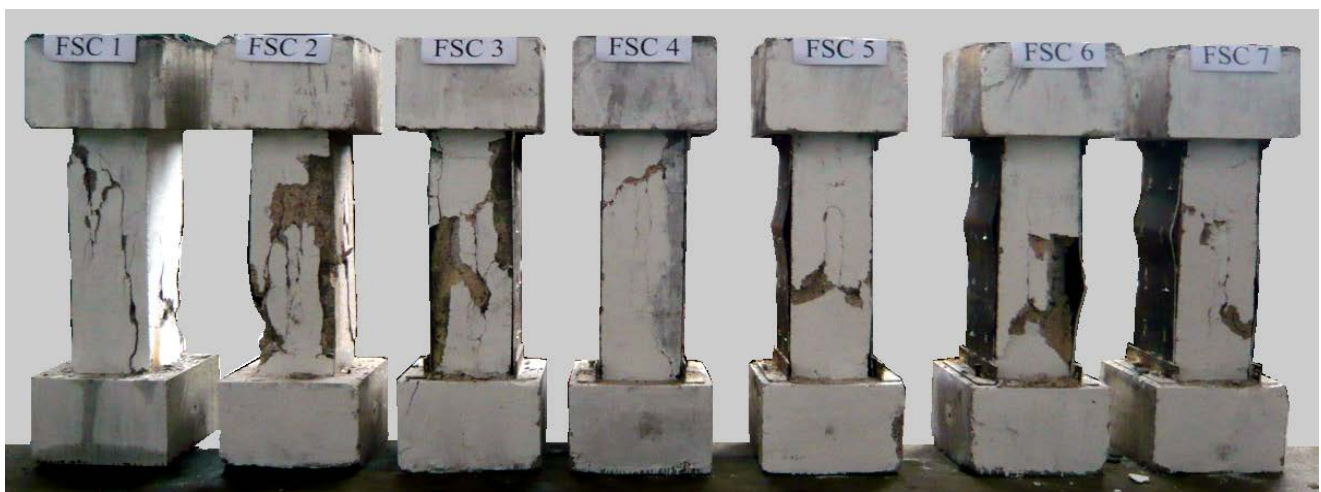
Fig. 11. Crack patterns and failure mode

228 The concrete crack patterns of all of the specimens were quite similar after load tests. The initial
229 concrete cracks usually occurred at the mid-height of the columns and then propagated in the vertical
230 direction. With an increasing applied load, the major cracks were extended, and the concrete was
231 spalled, as shown in Fig. 11. Judging from the readings of the strain gauges attached to the steel plates,
232 the failure modes of specimens were identified. To avoid plate local buckling, the bolt spacing of 180
233 mm was adopted so that the critical buckling stress was larger than the yield stress of steel plates.
234 According to the strain readings, once the concrete crushing occurred, the steel plates reached their
235 yield strength rapidly because the resistance force originally provided by the concrete was changed to
236 that provided by the steel plates.
