Title: *Fire Behavior of Two-Way Post-Tensioned Concrete Slabs Provided with Bonded Tendons: an Experimental Study.*

Authors: Li Zhang
Ya Wei
Francis Tat Kwong Au
Jing Li

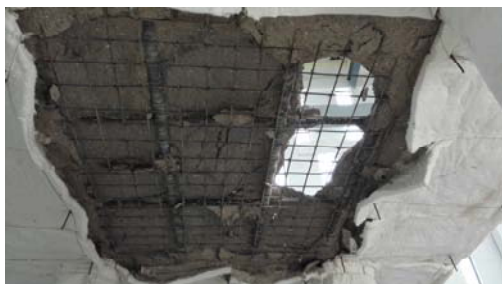
(a) Test 2

The lost area at the soffit of Specimen 2 caused by concrete spalling accounted for more than 60% of the central panel while the depth of concrete spalling in most part was over 50mm, as shown in Figure 6(a). The majority of reinforcing bars and tendons X3, X4 and Y4 were exposed to fire. As no ruptured reinforcing bars were found, the tensile stresses in the bars should be relatively low at the corresponding temperatures. The through hole occurred near the intersection between tendons X4 and Y4 where one of the load spreader sat. Obviously before the formation of through hole by severe spalling, the concrete depth of the heated area was reduced, thus weakening the concrete seriously. Afterwards the adjacent concentrated load failed the thin layer of the concrete by combined flexure and shear.

Figure 6. Concrete spalling of Tests 2 and 3

After the fire tests, the cracks and concrete spalling were closely examined. Figure 6 shows the concrete spalling at the soffit of Specimens 2 and 3. Both Specimens 1 and 2 had severe concrete spalling, while that of Specimen 3 was less severe. Concrete spalling at elevated temperature obviously influenced the structural integrity and temperature distribution, possibly causing premature failure.

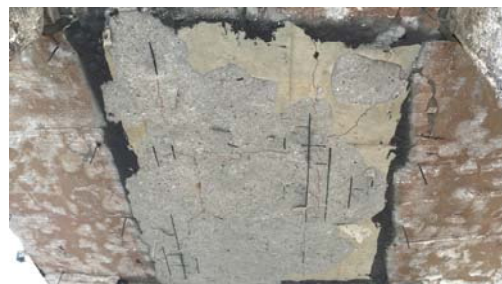
(b) Test 3

The severity of concrete spalling in Specimen 3 as shown in Figure 6(b) was much less severe as compared to Specimen 1 and 2. The depth of concrete spalling was around the thickness of concrete cover (i.e. 10mm) and cracks in line with tendons X3 and X4 were also found at the soffit. A few reinforcing bars were exposed but the tendons were still well protected.
