1 **Post-tensioned concrete bridge beams exposed to hydrocarbon fire**

2 Xi-qiang Wu¹; Ting Huang²; Francis Tat Kwong Au, M.ASCE³; Jing Li⁴

4 This paper presents the experimental and numerical investigations of two types of
5 bonded post-tensioned concrete bridge beams under hydrocarbon fire, including the
6 box and tee beams. The factors considered included the load level and fire exposure
7 duration. Six specimens were tested. The surface temperatures, strand temperatures and
8 mid-span deflection of specimens were measured. Results showed that the box beam
9 under service load could sustain fire for 184 minutes, while the tee beam could only
10 endure for 105 minutes before collapse. The overloaded box beam could withstand fire
11 for around 165 minutes. For exposure to fire for 90 minutes followed by cooling down
12 to ambient temperature, the box and tee beams lost 11% and 38% of load-carrying
13 capacity, respectively. Post-fire observation also showed severe spalling at the mid-
14 span and support regions of the specimens. The test results were also used to validate

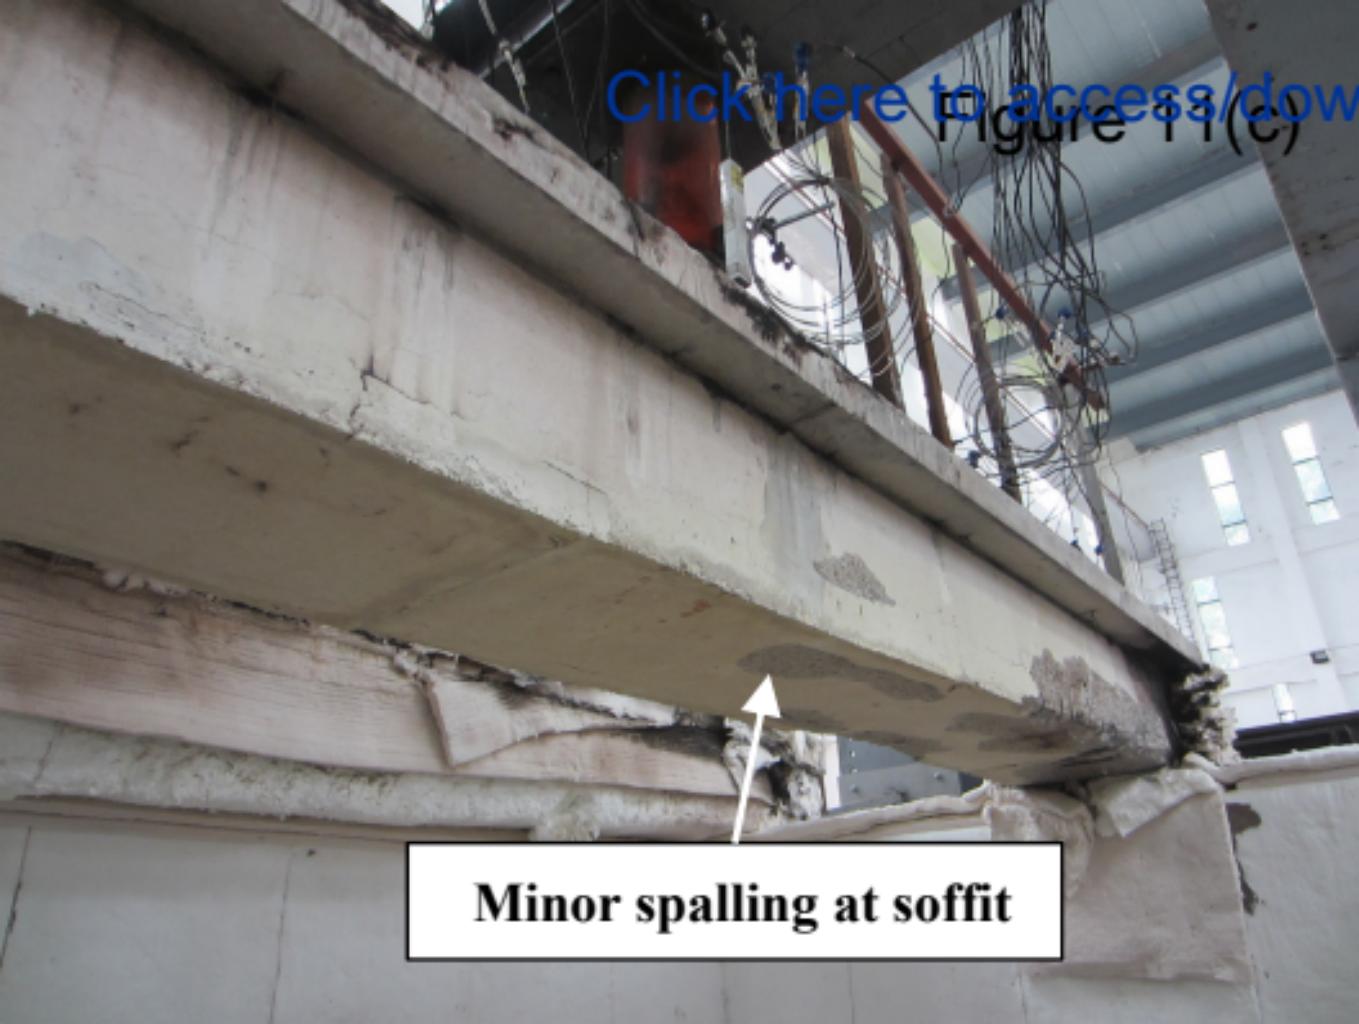
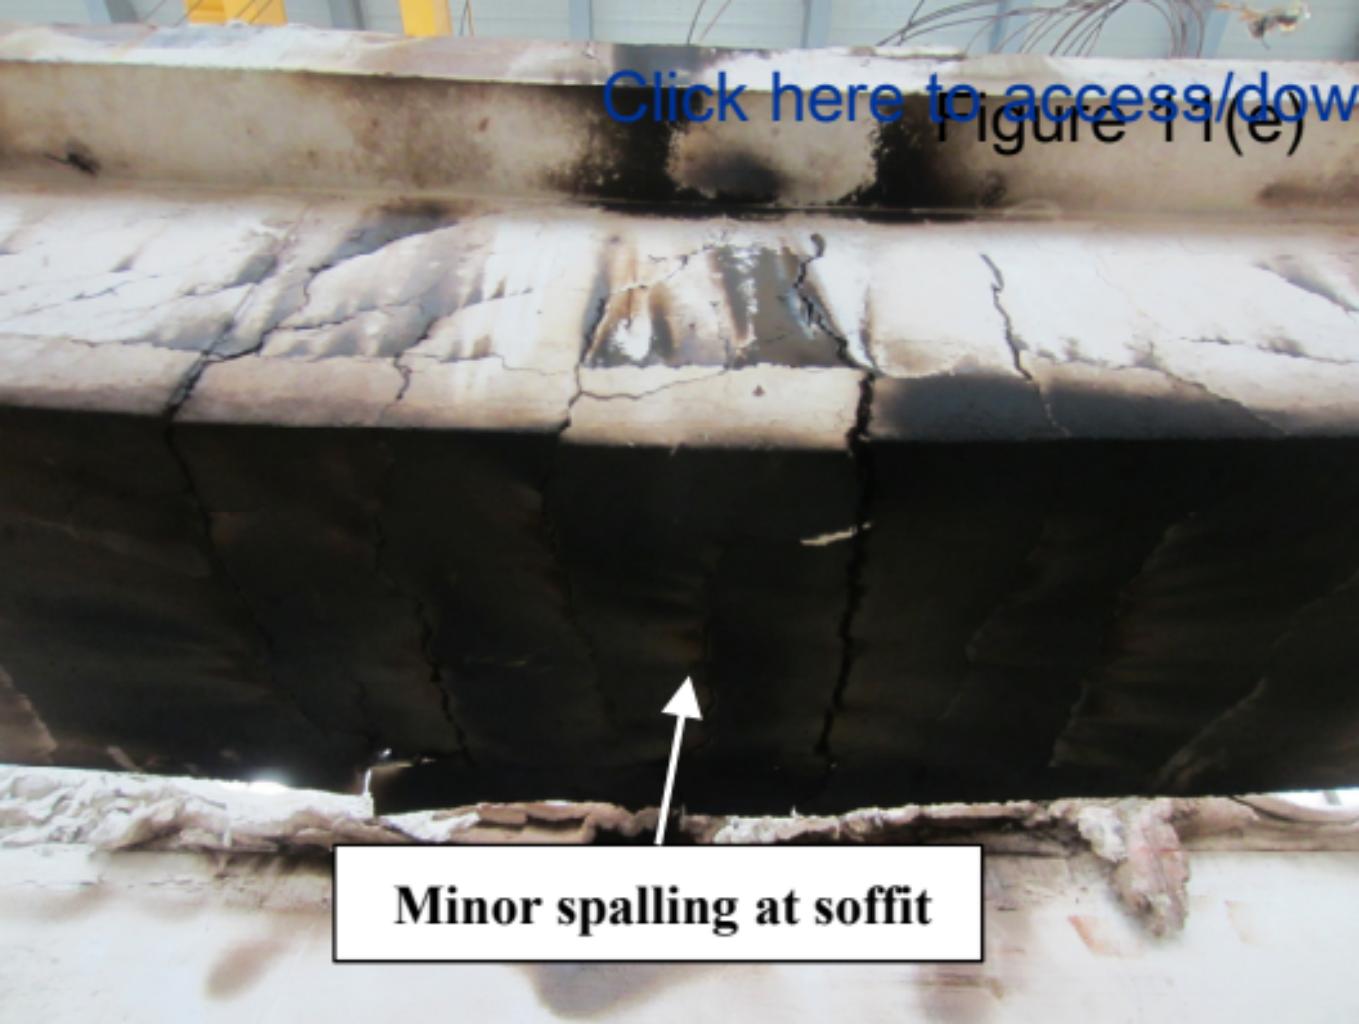
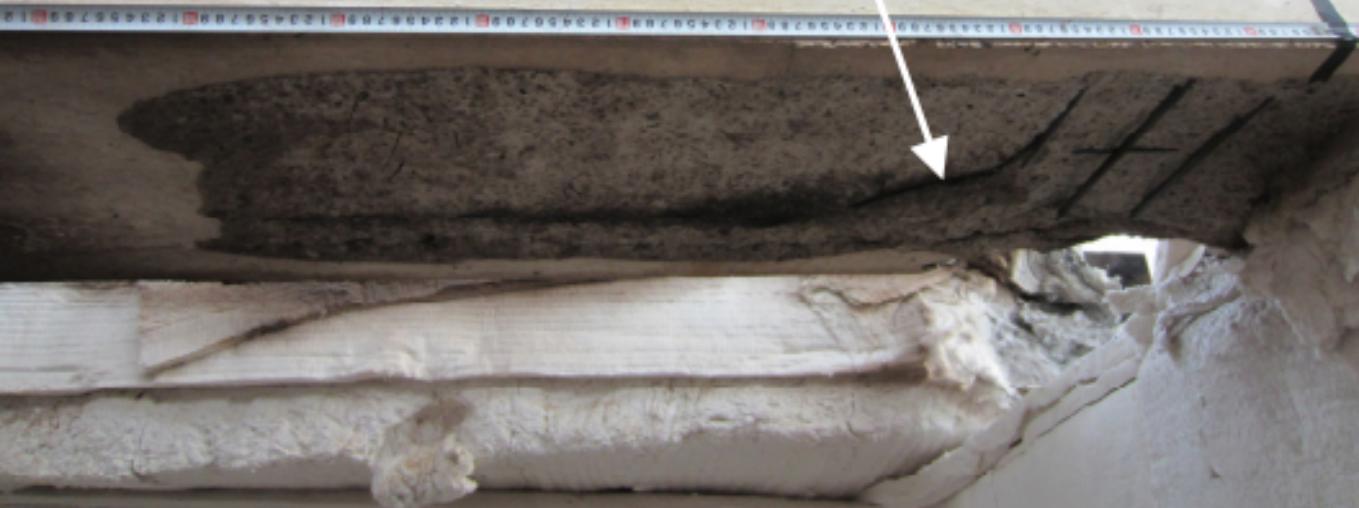
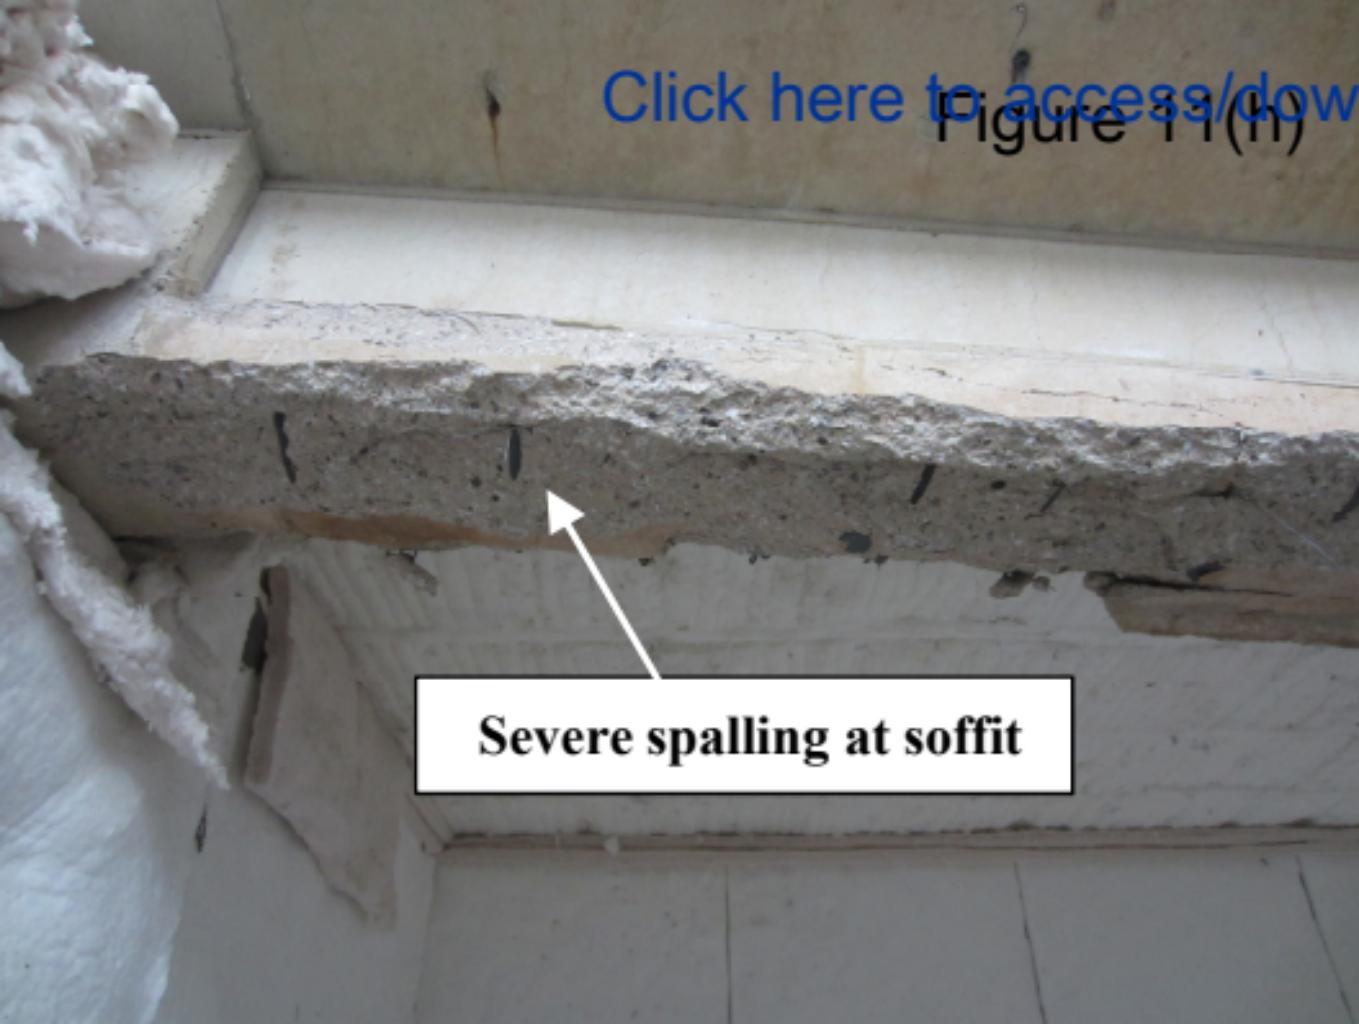
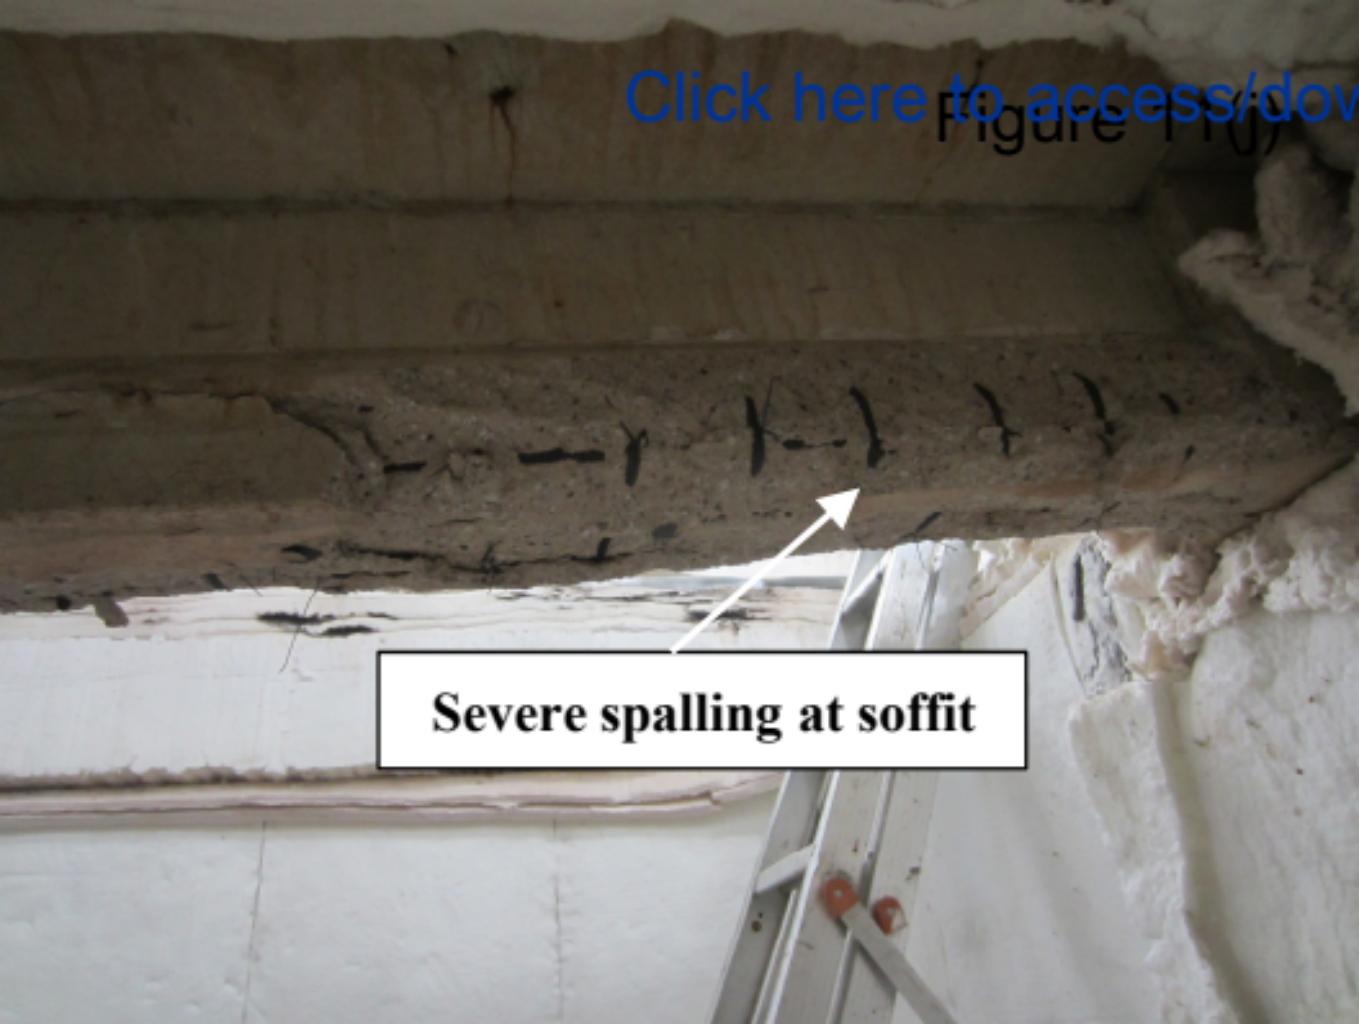
594 Fig. 11. Concrete spalling of specimens: (a) F1 at mid-span; (b) F1 at support; (c) F2 at mid-span; (d) F2 at support; (e) F3 at mid-span; (f) F3 at support; (g) F4 at mid-span; (h) F4 at support; (i) F5 at mid-span; (j) F5 at support

414 Spalling was mostly found around the mid-span and support regions. The spalling
415 phenomena in these two regions of each specimen are shown in Fig. 11. Severe spalling
416 had occurred to Specimens F1, F4 and F5 due to either protracted fire exposure or easy
417 heat penetration. Most of the concrete cover at the soffit and / or the bulb part of bottom
418 flange had spalled and spalling even extended upwards over a certain height of the web.
419 The outside of transverse reinforcement was generally exposed after concrete spalling.
420 The spalling could even reach the longitudinal reinforcement as shown in Figs. 11(a)
421 and 11(j). The thickest spalled layer was found to be 60 mm. Less severe spalling was
422 generally observed for prestressed concrete beams tested under the ISO 834 and ASTM
423 E119 fire curves (Ashton and Bate 1960, Gustaferro 1973, Hou et al. 2015).

424 Although being exposed to fire for limited time, Specimen F2 also suffered from
425 some minor spalling at mid-span and more severe spalling close to the support.
426 Specimens F1 and F2 were essentially the same in construction except that F2 was
427 subjected to a shorter fire exposure of 90 minutes only. The concrete spalling might
428 have started from the region near the support, as the soffit of bottom flange near the end
429 was under higher compression because of prestressing, while that around mid-span was
430 under lower compression or even tension under the combined effects of prestressing
431 and external loading. That more severe spalling occurring close to the support than
432 around mid-span was also observed on Specimen F3. Specimen F3 did not have as
433 much spalling as Specimen F1 around mid-span over slightly shorter fire exposure, as
434 the existing cracks on Specimen F3 under a higher service load level might have helped

**Severe spalling at
soffit and corner**

Minor spalling at soffit

**Severe spalling at corner
with 1.5m from support**

**Severe spalling at
soffit near support**

**Severe spalling at soffit
within 1.5m from support**

Severe spalling at soffit

- 474 • Compared to the standard fire curve for buildings, the potential hydrocarbon fire
475 that may occur to bridges can cause more severe spalling, which can even reach the
476 longitudinal reinforcement. More severe spalling was observed at the support region
477 due to the high compressive stresses caused by the prestressing.

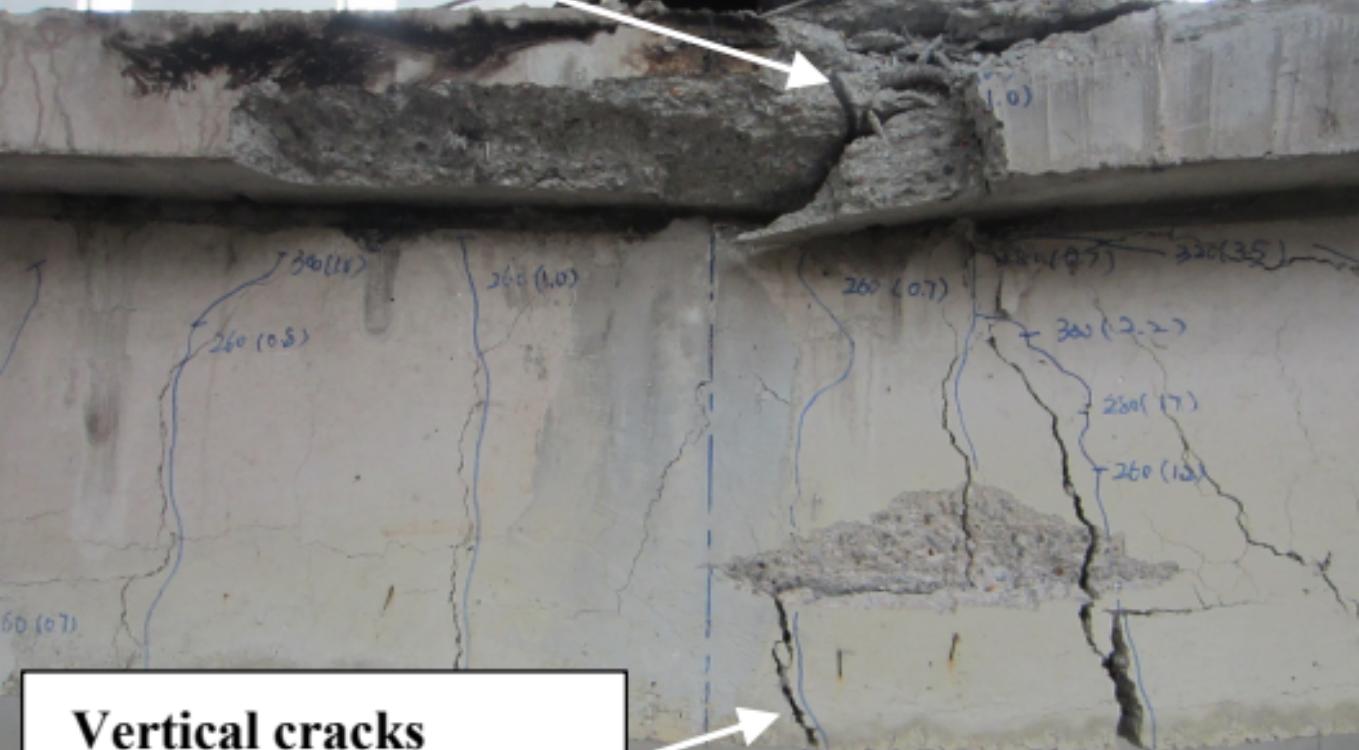
595 Fig. 12. Flexural cracks near mid-span for specimens: (a) S1; (b) F1 and F3; (c) F2; (d) F4 and F5

436 All specimens exhibited some form of flexural failure. Fig. 12 shows typical
437 flexural cracks near mid-span position of specimens. These cracks originated from the
438 bottom flange and extended towards the top flange. During all the tests, with the
439 exception of Specimen F2, a loud noise probably associated with the fracture of strand
440 was heard just before the crushing of concrete beneath the loading beam, soon after
441 which the specimen failed. Specimen F2 also failed by crushing of concrete at the top
442 flange beneath the loading beam, but without the loud noise.

Vertical cracks originated from soffit

Cracks developed to
the top concrete fibre

Vertical cracks
originated from soffit

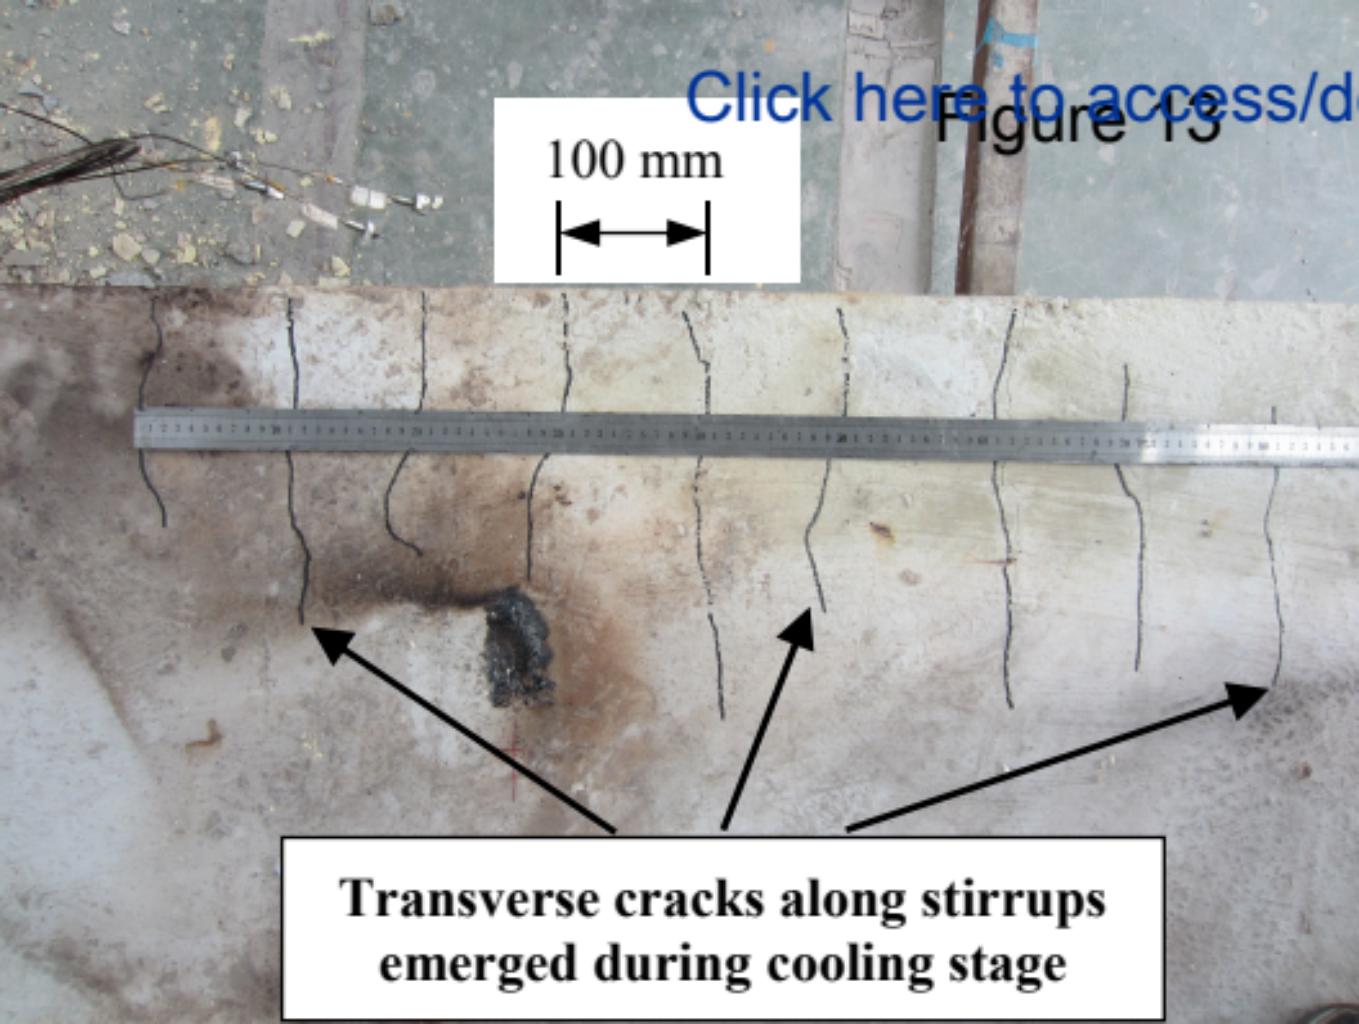
596 Fig. 13. Typical thermal contraction cracks on top flange

443 Transverse cracks were observed on some of the surfaces unexposed to fire, e.g.
444 the top surface of the top flange. These cracks were distributed along the beam and
445 typically aligned with the stirrups as shown in Fig. 13. The simulation results also show
446 that the concrete at the top flange are in tension upon cooling. The location of these
447 cracks coincided with the stirrups since the tensile resistance of concrete at the cross
448 section where a stirrup was located had been slightly reduced compared with that of the
449 cross section without a stirrup.
