The effectiveness of FRP strips in repairing moderately and severely damaged RC beam–column connections

Rijun Shrestha

Scott T. Smith

Bijan Samali

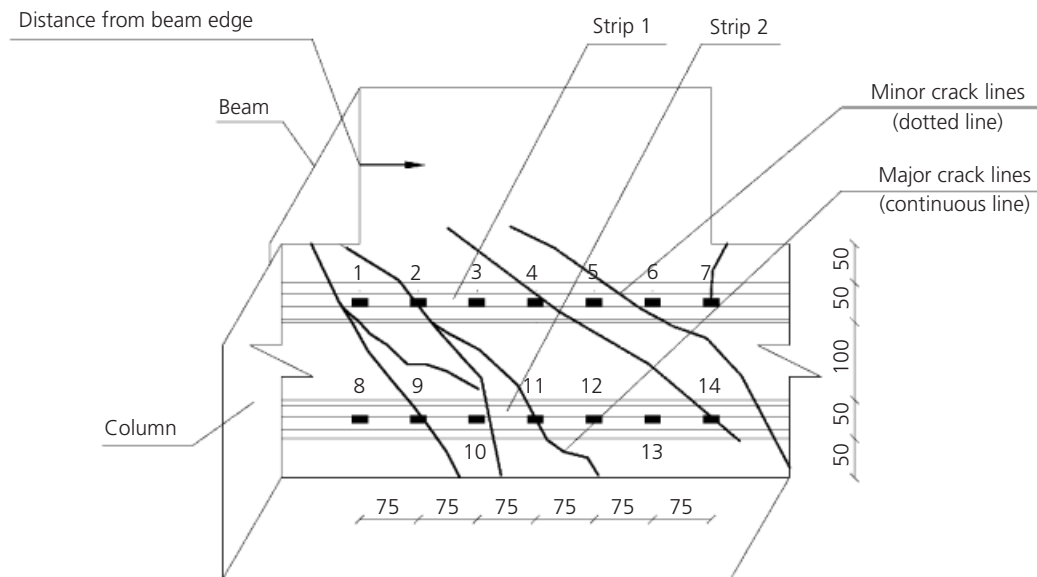
Figure 5. Column strip repair: extent of damage (and repair) and strain gauge layout of RM1 and SM1

considerable shear cracking in the joint region, although, the damage was not excessive, as shown in Figure 4(a) (see diagonal cracks in the boxed area) and Figure 5. This connection is herein referred to as 'moderately damaged' and distinction is made in Figure 5 between major cracks (cracks of large width) and minor cracks (cracks of small width). Prior to application of the FRP, the loose concrete in the cracked joint region was removed and the surfaces cleaned by spraying with compressed air; however, it should be noted from Figure 4(a) that little or no concrete cover in the joint region had fallen off, thus indicating the less severe nature of the damage. Voids left after removal of damaged concrete were filled with an epoxy adhesive, known as Megapoxy PF, prior to application of the FRP repair. According to the manufacturer's specification, the epoxy adhesive had a setting time of seven minutes and attained more than half of its ultimate strength within 15 min of mixing. As the extent of damage and the size of the major cracks were not excessive, repair adhesive, as opposed to repair mortar, was deemed suitable to patch up the damaged region sufficiently for the FRP repair to be adequately applied.

Figures 4(b) and 4(c) show connection RM1 which has been repaired with two two-layered column strips applied to both sides of the joint face, although no significant repair work is evident from these photographs. The ends of the column strips have been anchored by wrapping two layers of FRP around the perimeter of the column.

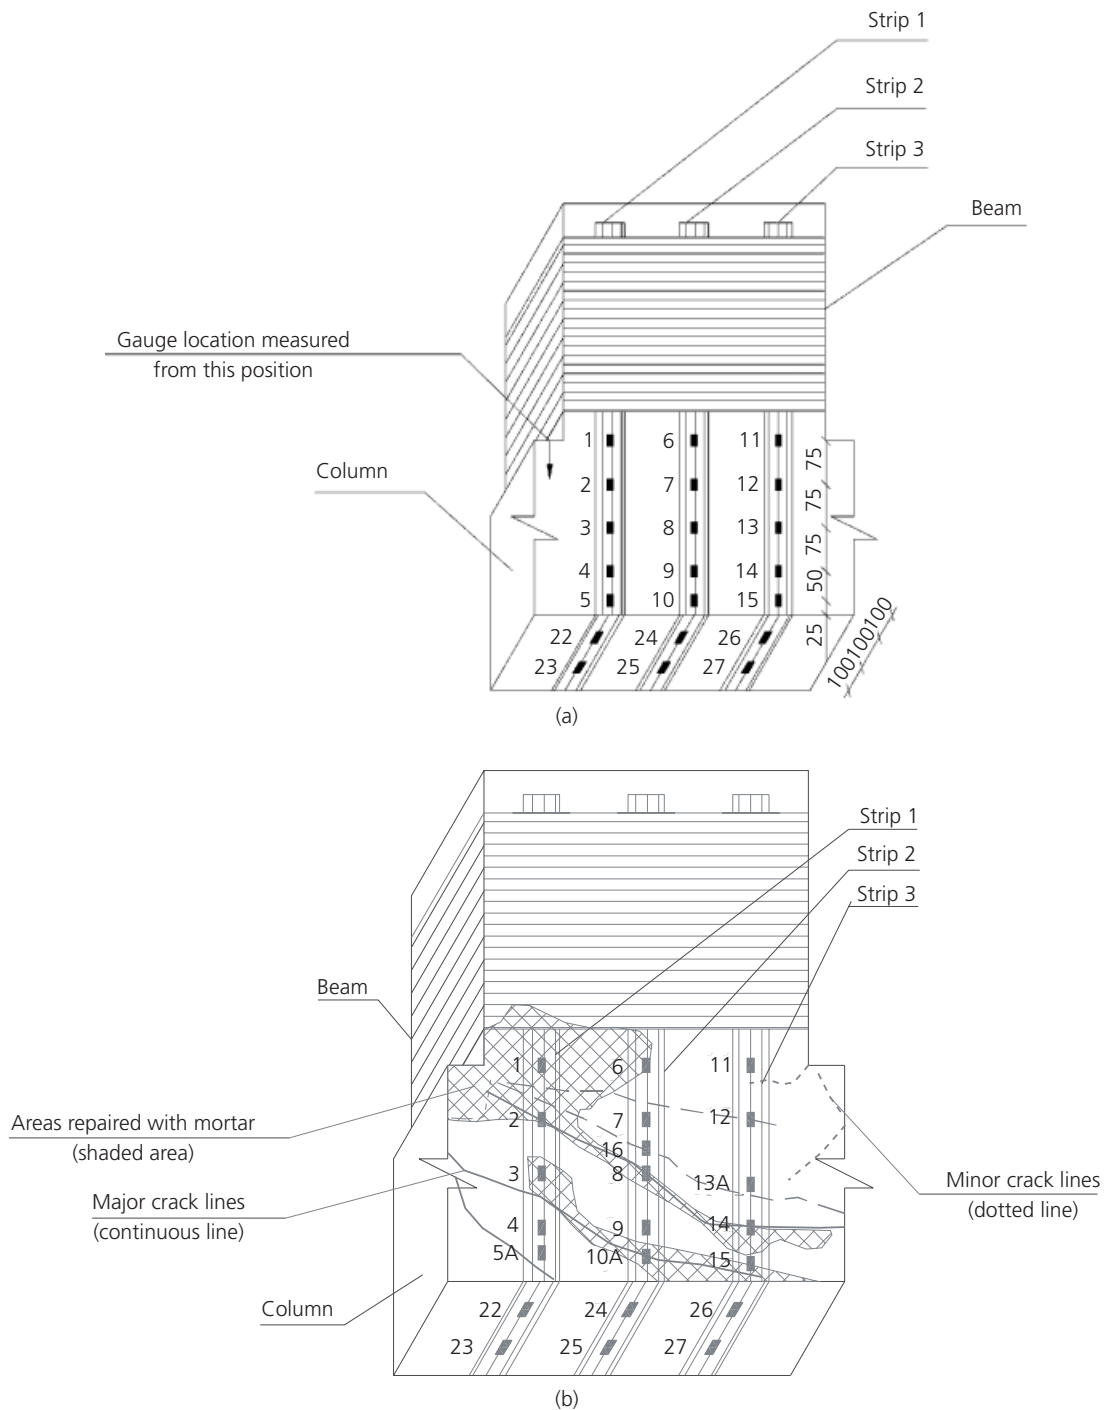
Figure 7. Beam strip repair: extent of damage (and repair) and strain gauge layout of SM2 and RM2: (a) specimen SM2; (b) specimen RM2

consisted of three two-layered FRP strips oriented parallel to the beam and applied to both faces of the joint region. The FRP strips were continuous across the width of both joint faces and over the back face of the column, and anchored at both sides of the beam by wrapping, as shown in Figure 2(b). Connection SM2 reached a peak load of 122 kN at 39.1 mm displacement, and was then loaded until the load-carrying capacity had decreased to 40% of the peak load (i.e. load = 52 kN and deflection = 92 mm). Such considerable deformation produced quite extensive damage to the joint region and the immediate vicinity of the adjoining column and beams (herein 'severe damage'). At the peak load level of SM2, all three FRP strips had debonded, and when a deflection of 92 mm was reached all three strips had ruptured, generally in the bend portion around the joint edge.

To repair connection SM2 before being tested as connection RM2, all the loose and broken concrete was removed after the connection was unloaded and removed from the test frame. Owing to the severe level of damage, large voids remaining after removal of the damaged concrete were filled with repair mortar. Figure 6(a) shows the connection prior to the application of the repair mortar (heavily damaged areas circled with concrete cover removed), while Figure 7 is a detailed schematic of the cracking, damage and extent of repair mortar. After application of the mortar (Figure 6(b)), the connection was then repaired with FRP strips which were again oriented parallel to the beam (Figure 6(c)).

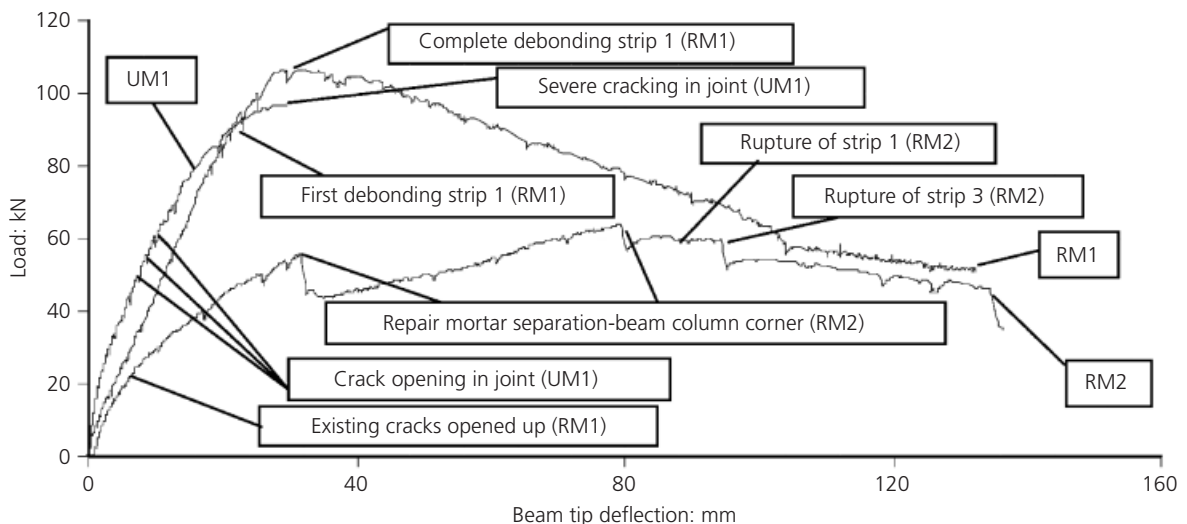
Figure 9. Load-deflection responses

The load-deflection plots for the two repaired connections (RM1 and RM2) are shown along with the control connection (UM1) in Figure 9, and a summary of the peak loads are presented in Table 2. Inspection of the load-deflection curve for RM1 reveals the FRP repair was able to restore not only the stiffness of the connection but also the load-carrying capacity. In fact, the load-carrying capacity was even enhanced by about 10%, although the effectiveness was limited by FRP debonding. Although the connection had significant cracking, especially in the joint region, owing to shear failure in its unstrengthened state, the FRP was able to maintain the integrity of the connection. Debonding of the FRP was, however, a real problem that required rectification. Some comments regarding prevention of debonding consist of (a) anchorage of the FRP (e.g. with FRP anchors; Kim and Smith, 2009, 2010; Smith *et al.*, 2011; Zhang *et al.*, 2011) in the joint region for two-dimensional connections, and (b) debonding will not be an issue in three-dimensional connections owing to the presence of the transverse beams. Unlike the moderately damaged connection RM1, FRP strengthening was less effective in the severely damaged connection RM2 even through the FRP strengthening delayed the failure following the separation of repair mortar. About 66% of the original connection strength was achieved, primarily owing to the FRP. The primary mode of

failure was attributable to separation of repair mortar used to fill the cracks, which was followed by FRP rupture, indicating that the concrete and mortar contributed little to load-carrying capacity and the FRP repair carried the majority of the load at an

early stage. This was to be expected, considering the repair was largely cosmetic. Crack injection may enable the concrete to resist higher load and hence bring the strength of the repaired connection to at least that of the control UM1, but this can be left

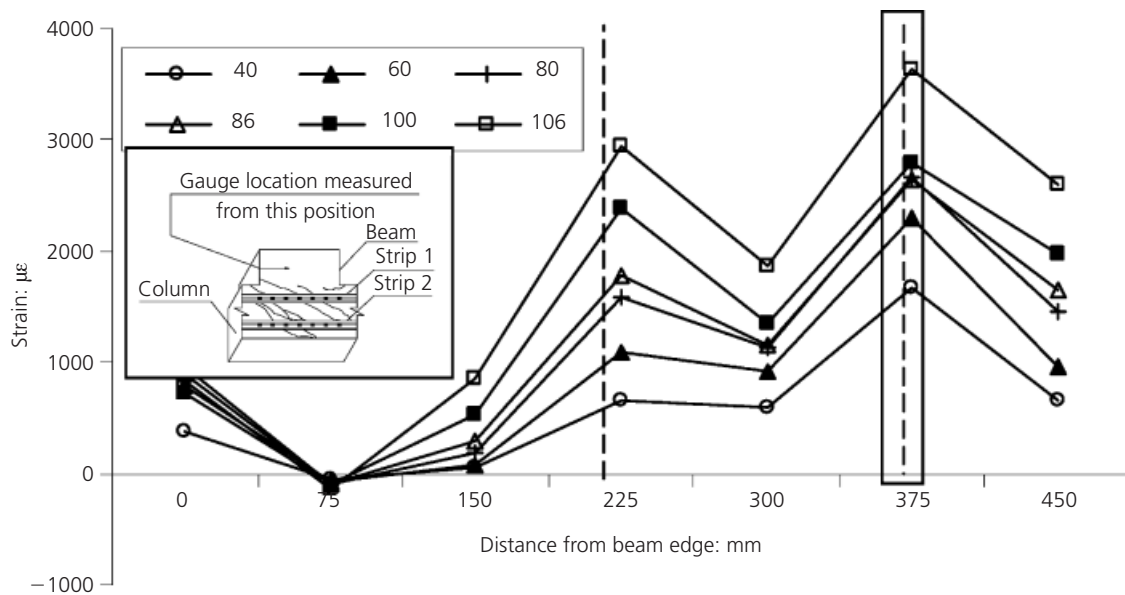
Figure 10. FRP strain distribution along strip 1: RM1

The distribution of strain along the length of strips 1 and 2 (refer to Figure 5 for strip and strain gauge location) on the front heavily instrumented face of the joint for the moderately damaged connection RM1 at different load levels are shown in Figures 10 and 11, respectively. Locations where the shear cracks in the joint regions intersected the FRP are also shown (shear cracks denoted by vertical dashed lines). High strains can be observed in the region adjacent to shear cracks indicating debonding of the FRP, while low FRP strain regions are those where the bond between FRP and concrete was not lost and full shear transfer between the two was maintained. Also, relatively

higher strain values were observed in strip 1 compared with strip 2, indicating that strip 1 was the main shear-resisting strip. On the whole, the peak strains (as measured by the strain gauges) are well below the 1.1% rupture strain limit of the FRP. Similar behaviour of the FRP strips on the back face of the connection was observed, although only a limited number of gauges were used on these FRP strips, and the results are not shown here.

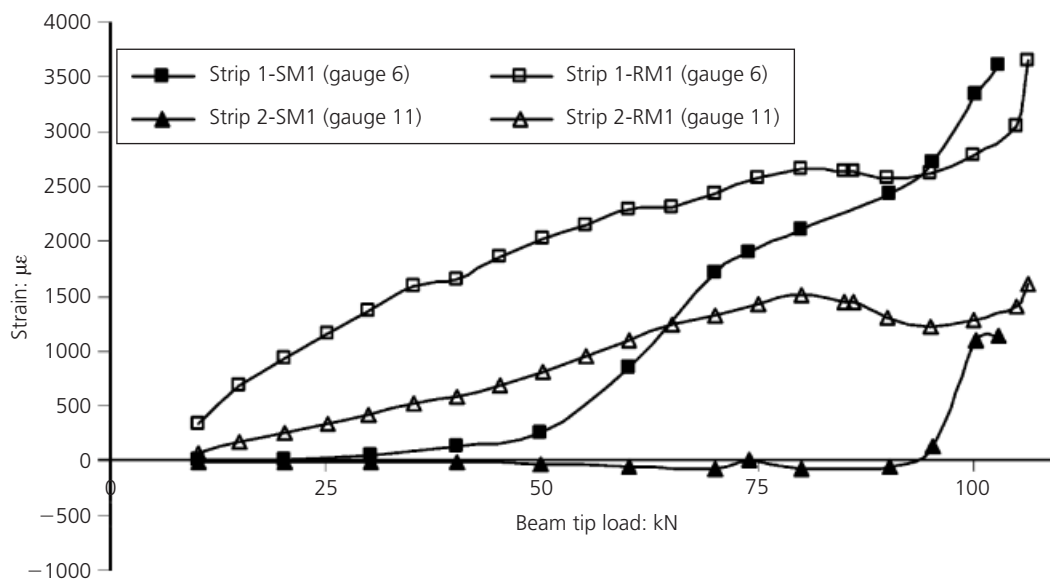
Figure 14. Comparison between RM1 and SM1 at identical locations

these gauges have also been defined on Figures 10 to 13 by vertically oriented rectangular boxes). Figure 14 shows that strip 1 carries significant load after about 50 kN in connection SM1, with the same strip carrying load from the onset of loading in RM1. Similar broad conclusions can be drawn for strip 2 in SM1

and RM1, and in both cases strip 1 is the main load-carrying strip. It is hypothesised that if strip 1 is secured along its lengths, such as with FRP anchors (Smith *et al.*, 2011), then its debonding resistance should be enhanced and the connection made to carry a higher load.

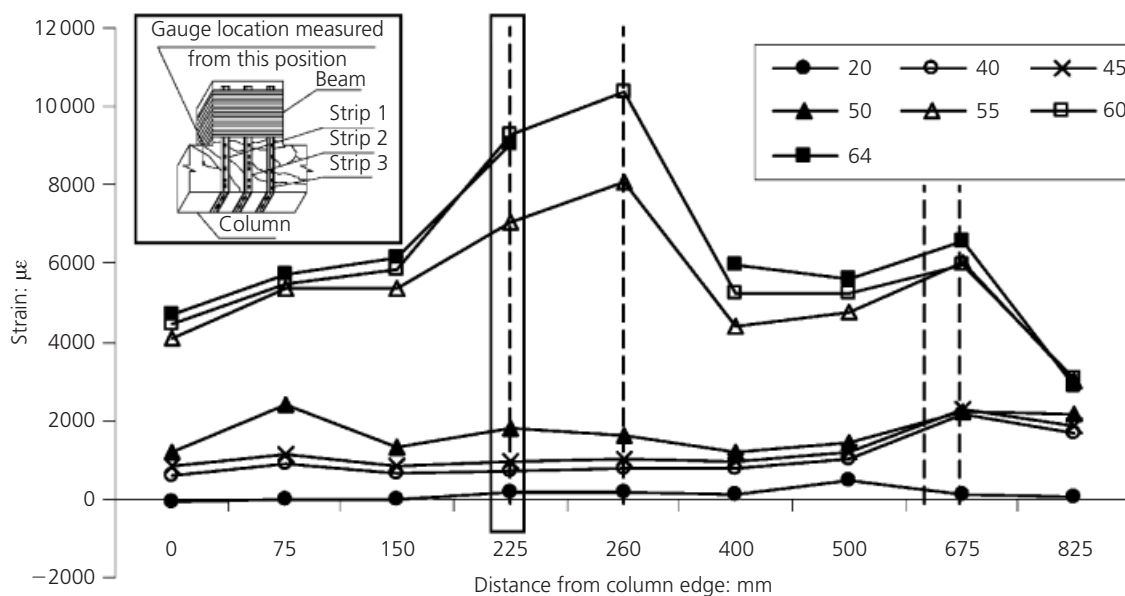
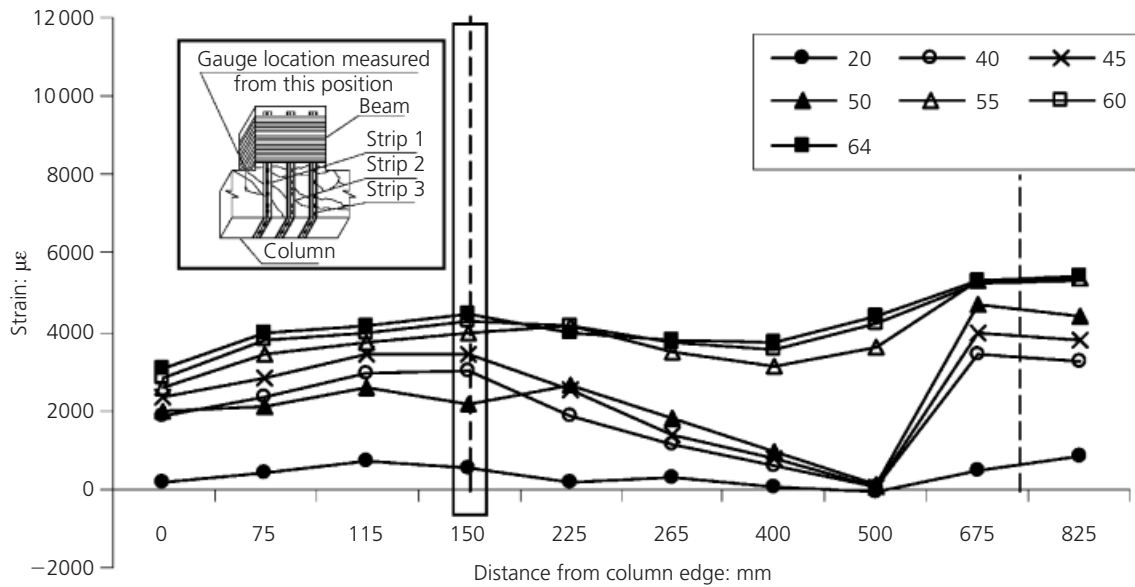
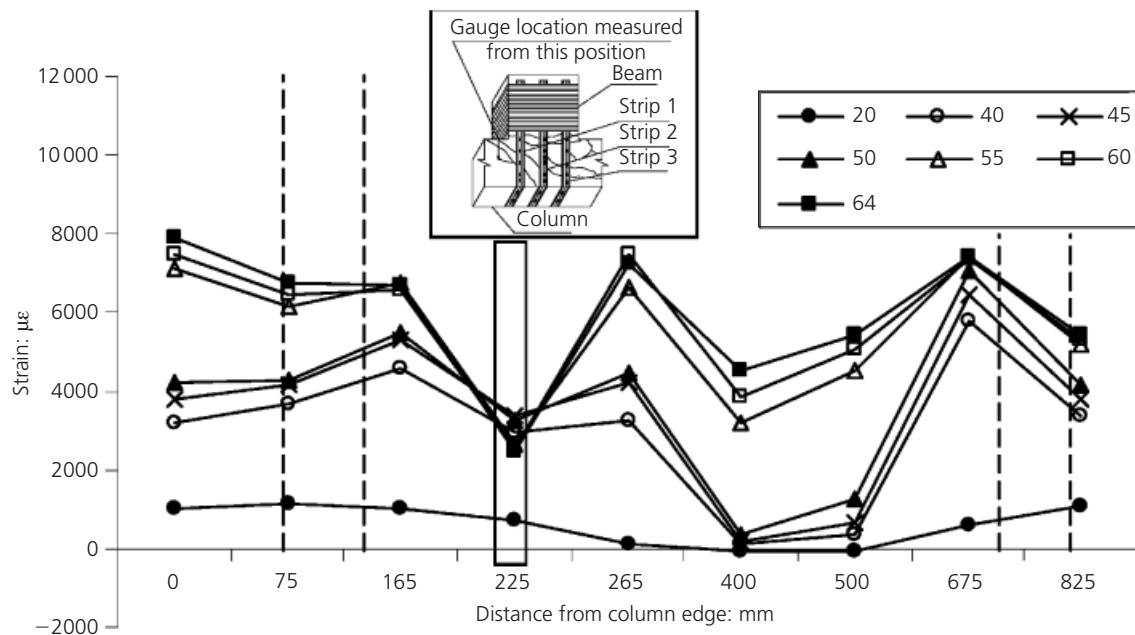
Distribution of strain along FRP strips 1, 2 and 3 for the severely damaged connection RM2 at different load levels are given in Figures 15, 16 and 17, respectively. Locations where the cracks intersect the FRP strips are also marked by vertical dashed lines. These plots show that there is an increase in the FRP strain, especially for strips 1 and 3, corresponding to the separation of repair mortar at 55 kN load, which indicates that the majority of the load was carried by FRP strips then onwards.

The high strain values for strip 1 are approaching the 1.1% rupture strain limit of the FRP. In addition, the lower levels of strain for strip 2 suggest the strip is less effective than the other two strips.

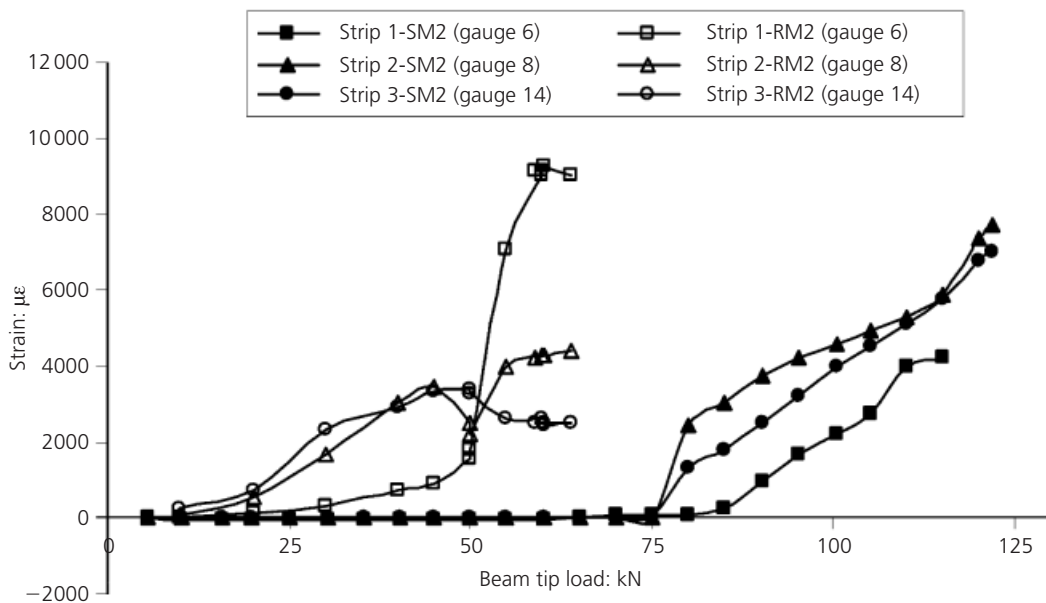
Figure 21. Strain comparison between RM2 and SM2 at identical locations

region, FRP strips were subjected to high levels of strain from the beginning of the test resulting in rupture of the FRP strips at much lower load. Comparison of strain at the same locations close to the cracks where highest strains were recorded (i.e. gauges 4 for strip 1, gauge 8 for strip 2, and gauge 14 for strip 3 as defined in Figures 7(a) and 7(b)) for connections RM2 and SM2 for all three strips are given in Figure 21. In

all cases the FRP resists load much earlier in RM2 than SM2. On the whole, beam oriented strips are much more effective than column oriented strips as the level of strain developed is much higher, thus leading to a better use of the FRP. Despite the FRP strips debonding, before rupture, they are still able to achieve rupture strains and are able to resist joint shear distortion better than column oriented strips.
