**The crooked rod sign: a new radiological sign to detect deformed threads in the distraction mechanism of magnetically controlled growing rods and a mode of distraction failure**

**Study Design:** Case report

**Objective:** To report a unique mechanical failure of magnetically controlled growing rods (MCGR) that is related to continuous rod slippage.

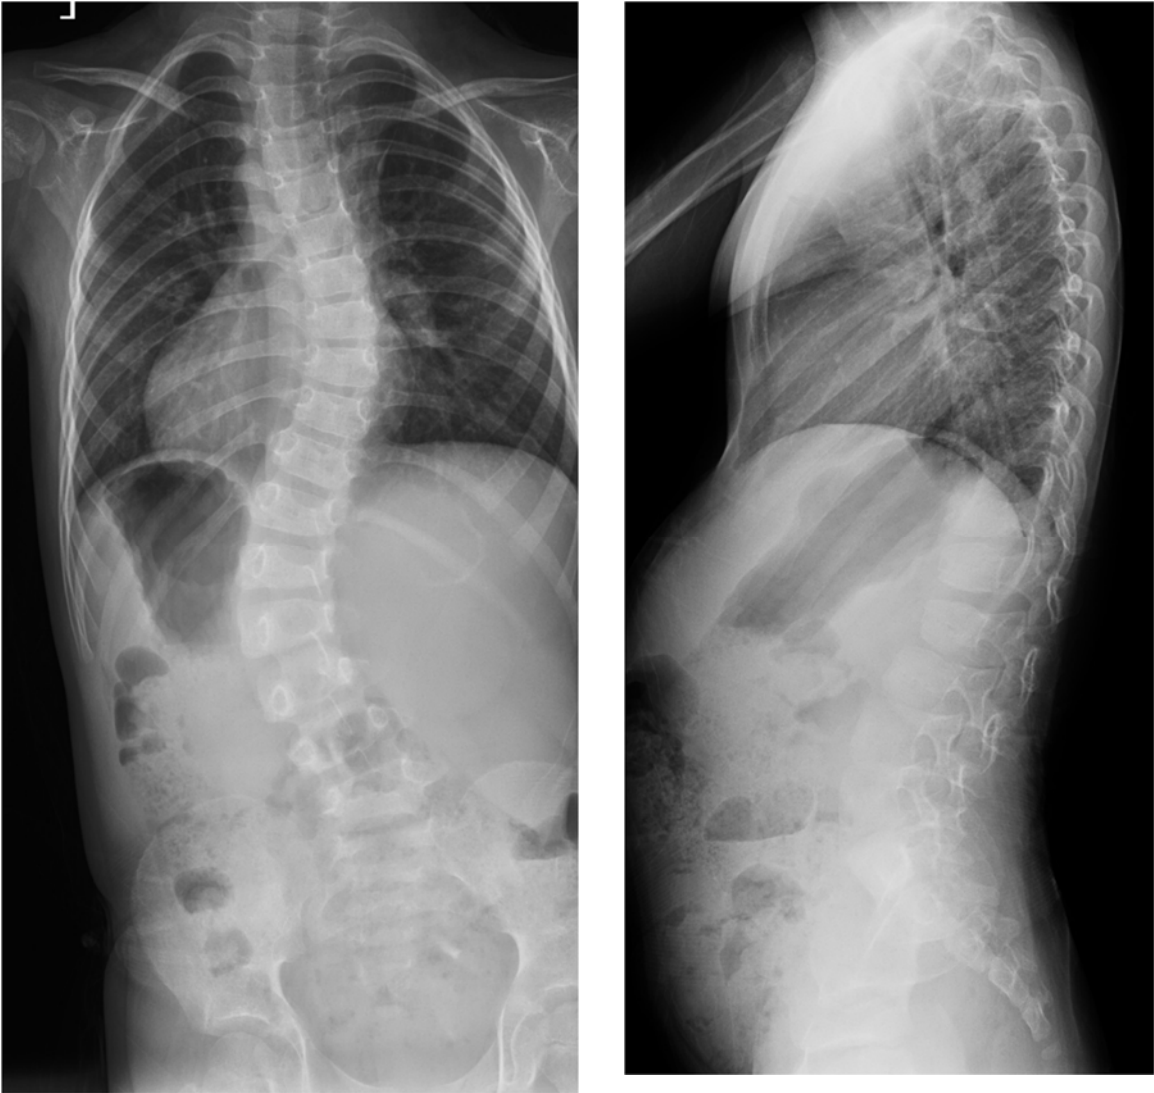
10 A girl diagnosed with Sotos syndrome presented at age of 3 years with a double major  
11 curve of 41° from T6-11 and 44° from T11-L4. MRI showed no intraspinal pathology. Despite  
12 good compliance to bracing, there was progression of the deformity to 54° at T11-L4 (**Figure 1**).  
13 Dual MCGRs in standard and offset configuration were implanted at T5-L4 (**Figure 2**) with claw  
14 construct at the proximal foundation (T5-T6) and pedicle screws at the distal foundation (L3-L4).  
15 Postoperatively she was given a corset with shoulder straps for 3 months before monthly outpatient  
16 distractions were performed.

**Figure 1:** Posteroanterior (A) and lateral (B) radiographs pre-MCGR implantation.

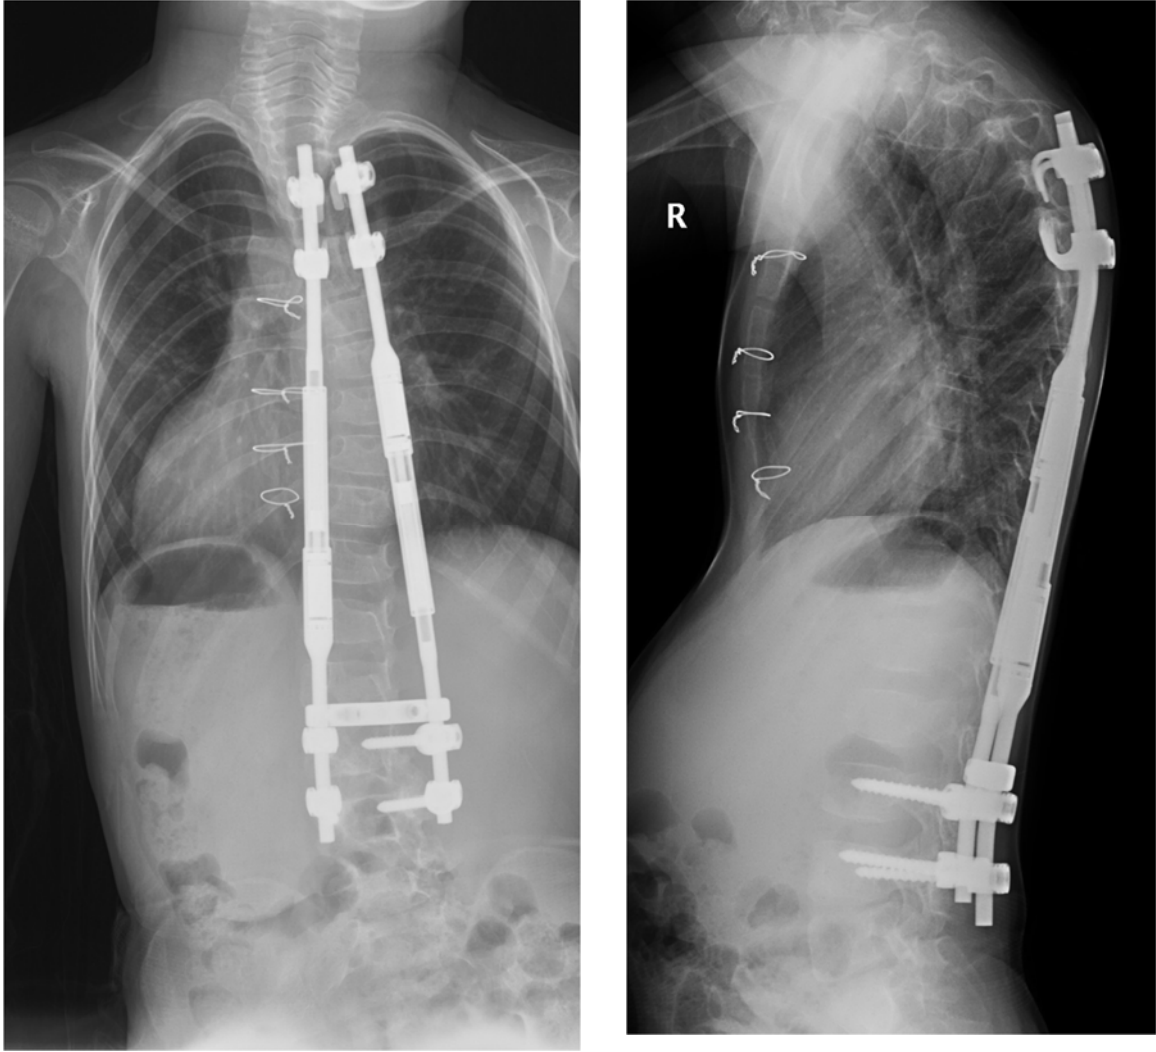
**Figure 2:** Posteroanterior (A) and lateral (B) radiographs post-MCGR implantation.
