# Slope failure in underconsolidated soft soils during the development of a port in Tianjin, China. Part 1: Field investigation

S. Li, Z.Q. Yue, L.G. Tham, C.F. Lee, and S.W. Yan

*Key words:* port development, land reclamation, dredge excavation, landslide investigation, soft soils, case studies.

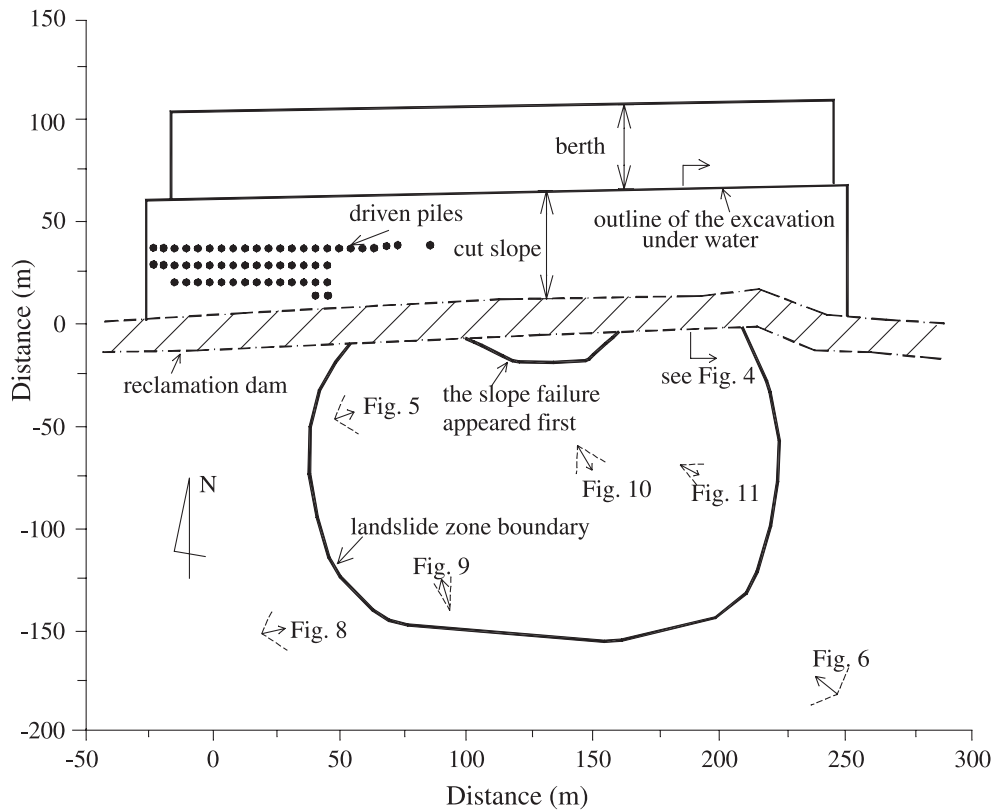
**Fig. 3.** General layout of the wharf design and construction and the locations and orientations of the site photographs in Figs. 5, 6, and 8–11.

Figure 3 illustrates the general layout of the reclaimed land, the dam, the dredged (cut) slope, the berth, the installed piles, and the slipped land area. In Fig. 3, a rectangular coordinate system is used to illustrate the layout of the wharf construction. The horizontal axis is parallel to the shoreline of the dredged slope, in the west–east direction, and the vertical axis is perpendicular to the shoreline and toward the berth, in the south–north direction. This coordinate system was also used in the landslide investigation. Figure 4 illustrates a typical cross section of the wharf design. The dredged slope dipped toward the berth in a northerly direction.

The plan boundary of the entire landslide zone in the reclaimed land behind the dam is identified in Figs. 3 and 7. From the plan boundaries of the dredged slope and berth area in Fig. 3, it is clear that the landslide occurred in the central region of the dredged slope along the shoreline. Furthermore, the main direction of the landslide was toward the north, where the berth was located.

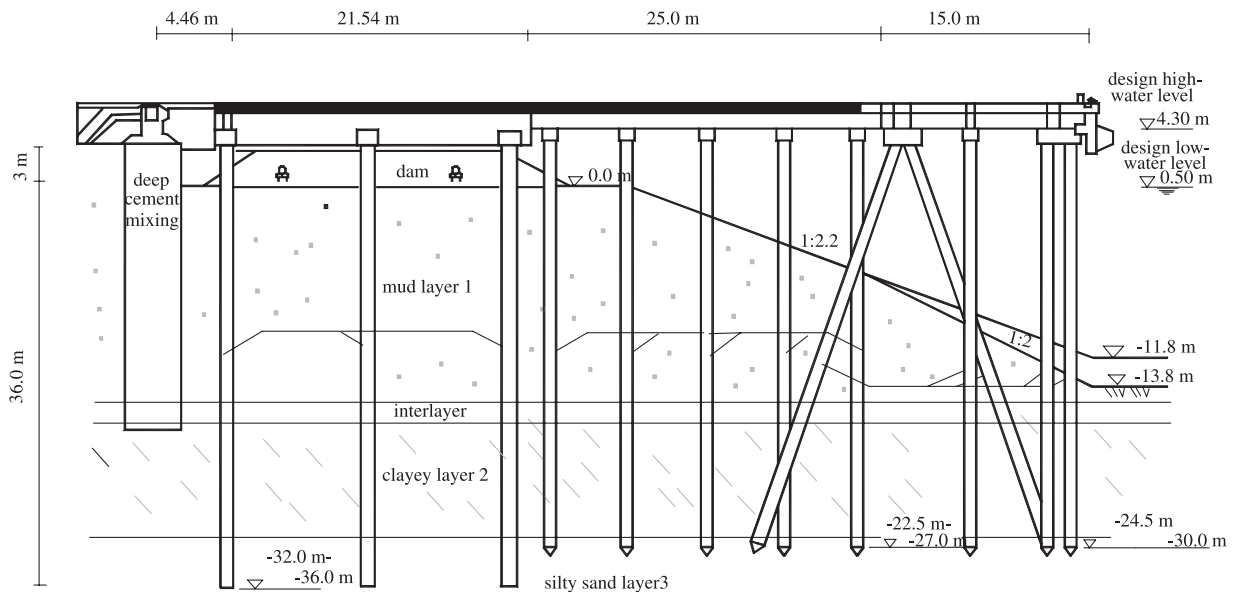
**Fig. 4.** Design cross section for wharf development.

The ground conditions at the landslide site, as determined by the ground investigation, are shown in Figs. 4 and 15. Figure 4 shows the simplified soil profile that was used for wharf design. Figure 15 shows a detailed soil profile that was refined with the use of the ground investigation data from before and after the landslide. The figure depicts the geological conditions along cross section C–C in Figs. 7 and 14. This cross section is also the central line of the landslide

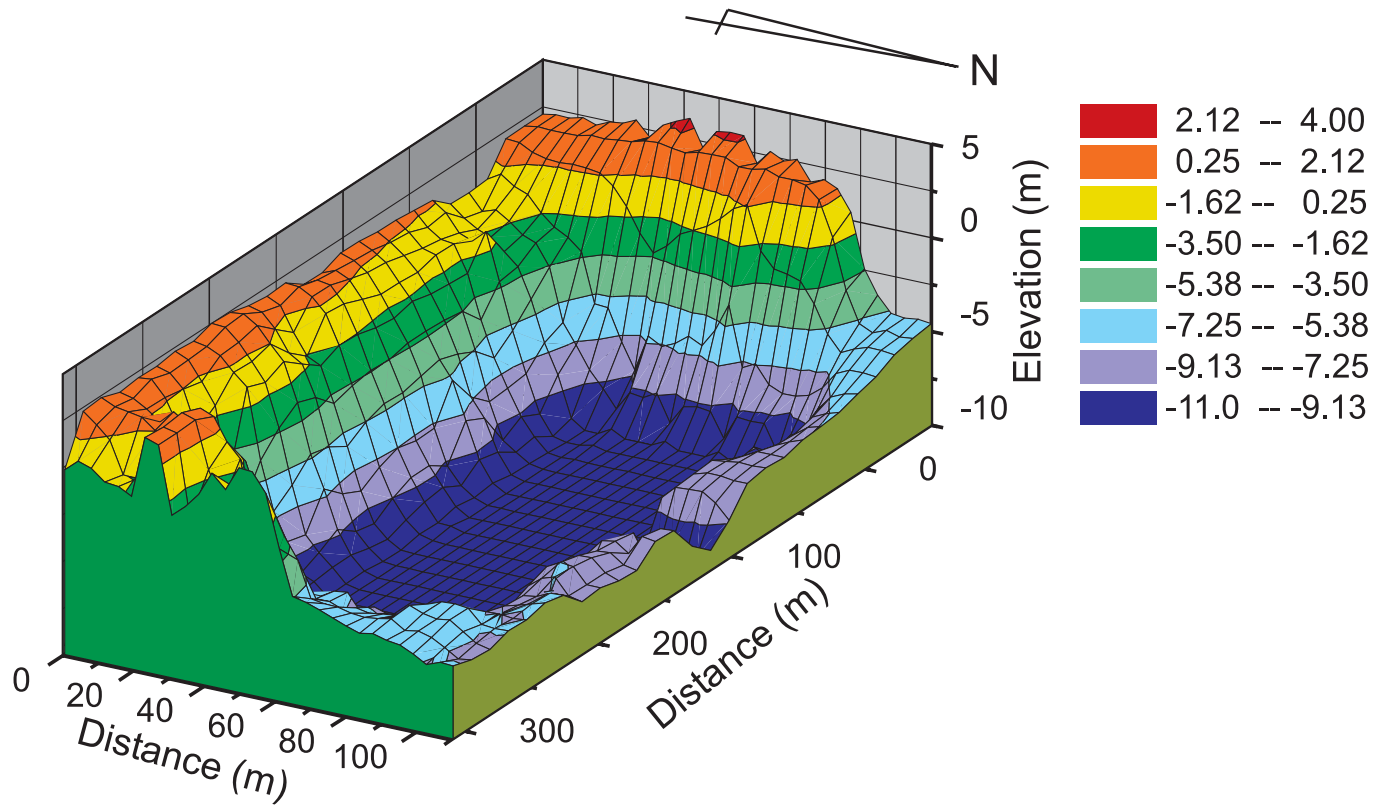
**Fig. 12.** Three-dimensional topography of the dredged slope and berth submerged in seawater before the landslide.

Before the landslide, a topographical survey was carried out to check the dredge excavation of the slope and the berth for wharf construction. Results of the topographical survey are shown in Fig. 12 for a three-dimensional presentation of the submerged slope and berth areas before the landslide. From Fig. 12, it is evident that the dredged berth had a relatively flat base about 8 m below the mean sea level. The berth had a rectangular geometry. It was surrounded by the three dredged slopes on the eastern, southern, and western boundaries. The dredged slopes were about 12–13 m high. A majority of the dredged slopes were submerged in seawater.

Comparing the topographies in Figs. 12–14, we can observe the changes in the ground surface profiles of the submerged slope and berth. The landslide occurred between 100 and 250 m along the shoreline coordinate. This region was the central region of the slope and berth. The western part of the slope and berth, between –50 and 100 m along the shoreline coordinate, was slightly affected by the landslide, whereas the eastern part of the slope and berth, between 250 and 300 m along the shoreline coordinate, was affected significantly. As noted above, there were 55 driven piles installed in the western part of the dredged slope (see Fig. 3). The much smaller degree of damage in the western part of the dredged slope may indicate that the driven piles had some stabilizing effect on the western dredged slope.

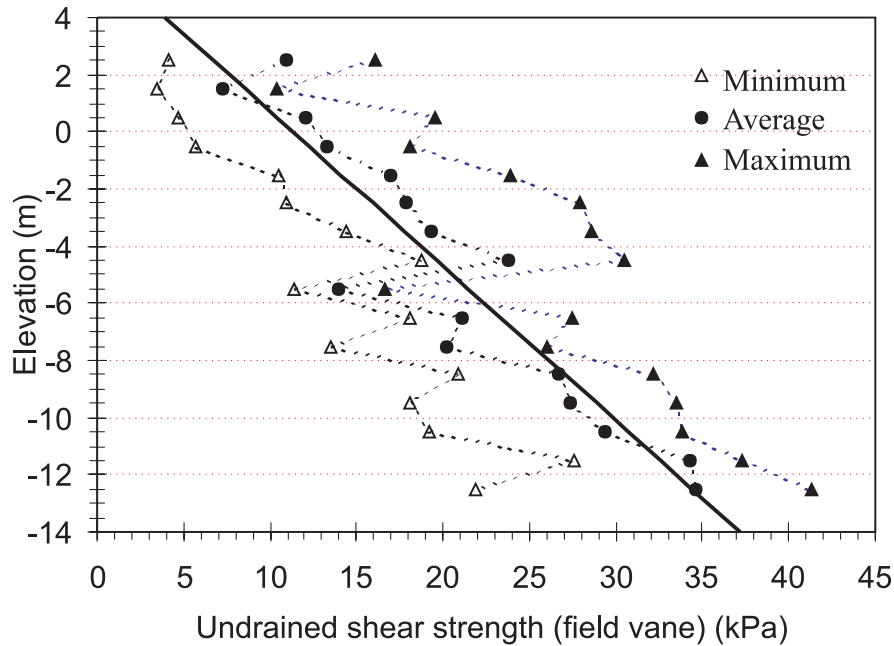
It is evident that the undrained shear strength from the field vane tests increased as elevation decreased. A linear regression equation for the variation of the average undrained

**Fig. 16.** Variation of undrained shear strength (field vane) with elevation before the landslide. The data shown in this figure were obtained from boreholes M8, M10, M12, M14, L1, L3, L5, and L7, and their locations are shown in Fig. 7.

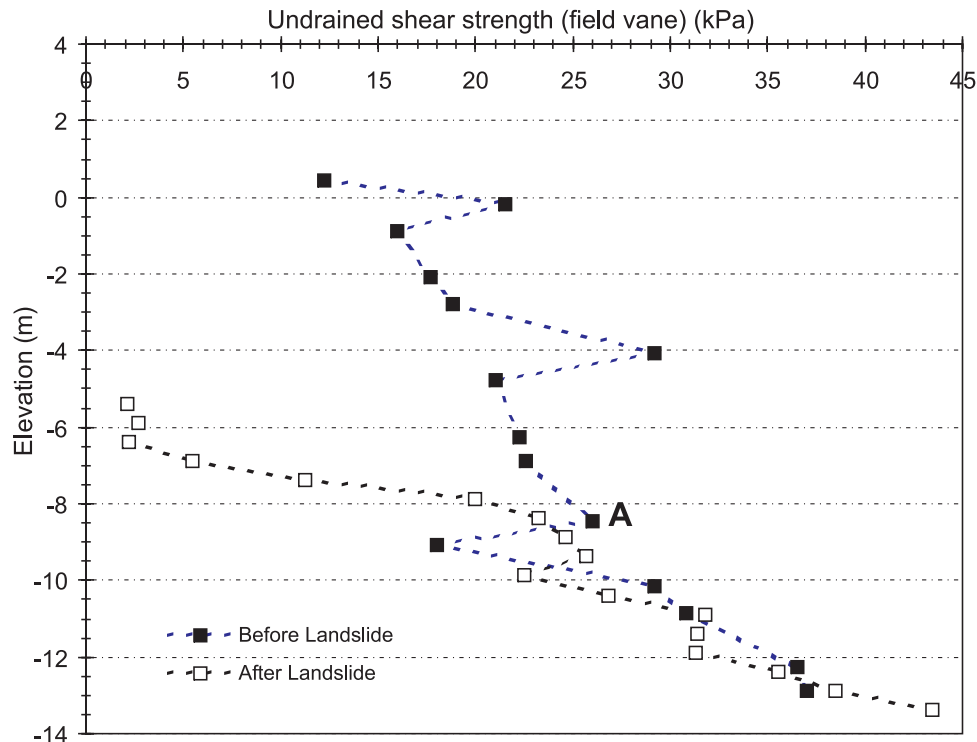
**Fig. 17.** A typical comparison between the undrained shear strength values determined with field vane tests in borehole M10 before the landslide and in borehole B6 after the landslide.
