A plane slide that occurred during construction of a national expressway in Chongqing, SW China

Z.Q. Yue and C.F. Lee

Quarterly Journal of Engineering Geology and Hydrogeology 2002; v. 35; p. 309-316
doi:10.1144/1470-9236/01004

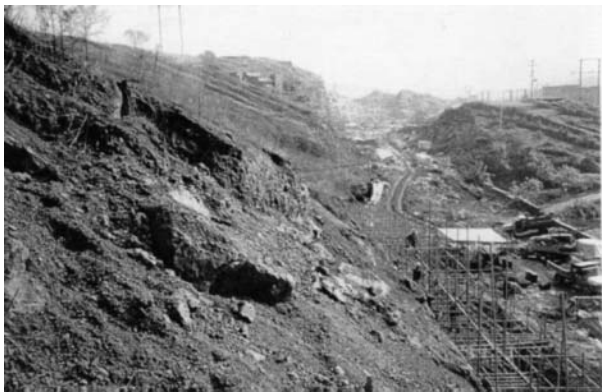
Fig. 2. Site photograph illustrating the general hilly terrain where the Yuqian National Expressway was being constructed.
